ACCIDENT

Aircraft Type and Registration:	Replica Fokker EIII, G-CHFS	
No & Type of Engines:	1 Warner Aircraft Corp Scarab 145 piston engine	
Year of Manufacture:	2012 (Serial no: LAA 279-14805)	
Date & Time (UTC):	27 April 2013 at 1552 hrs	
Location:	Middle Wallop Airfield, Hampshire	
Type of Flight:	Private	
Persons on Board:	Crew - 1	Passengers - None
Injuries:	Crew - 1 (Fatal)	Passengers - N/A
Nature of Damage:	Aircraft destroyed	
Commander's Licence:	Private Pilot's Licence	
Commander's Age:	68 years	
Commander's Flying Experience:	1,903 hours (of which 10 hours were on type) Last 90 days - 3 hours Last 28 days - 2 hours	
Information Source:	AAIB Field Investigation

Synopsis

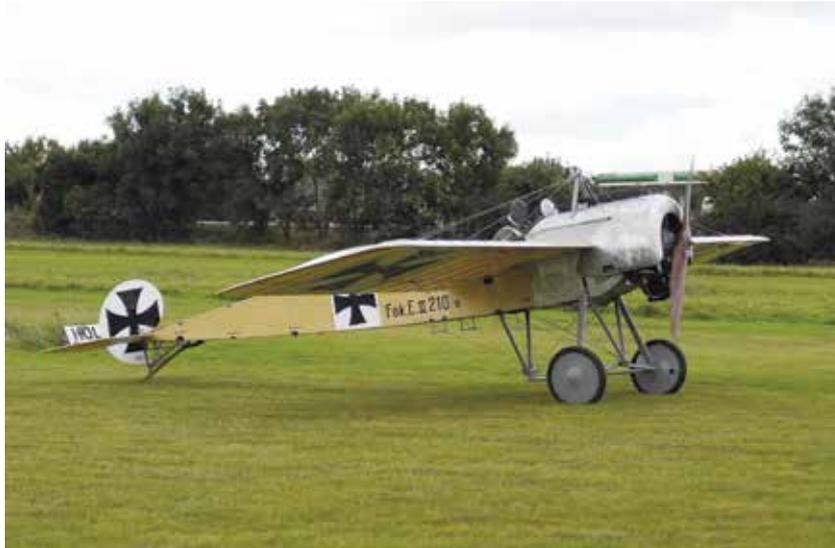
Figure 1

general view of the aircraft
(picture courtesy of Philip Whiteman)
