**ACCIDENT**

<b>Aircraft Type and Registration:</b>	28-5ACF Super Catalina, N9767	
<b>No &amp; Type of Engines:</b>	2 x Pratt & Whitney R-1830 piston engines	
<b>Year of Manufacture:</b>	1943	
<b>Date &amp; Time (UTC):</b>	24 September 2011 at 1205 hrs	
<b>Location:</b>	Gublusk Bay, Enniskillen, Northern Ireland	
<b>Type of Flight:</b>	Private	
<b>Persons on Board:</b>	Crew - 3	Passengers - 4
<b>Injuries:</b>	Crew - None	Passengers - None
<b>Nature of Damage:</b>	Right elevator damaged	
<b>Commander's Licence:</b>	Airline Transport Pilot's Licence (A)	
<b>Commander's Age:</b>	62 years	
<b>Commander's Flying Experience:</b>	18,000 hours (of which 400 were on type) Last 90 days - 50 hours Last 28 days - 20 hours	
<b>Information Source:</b>	AAIB Field Investigation

**Synopsis**

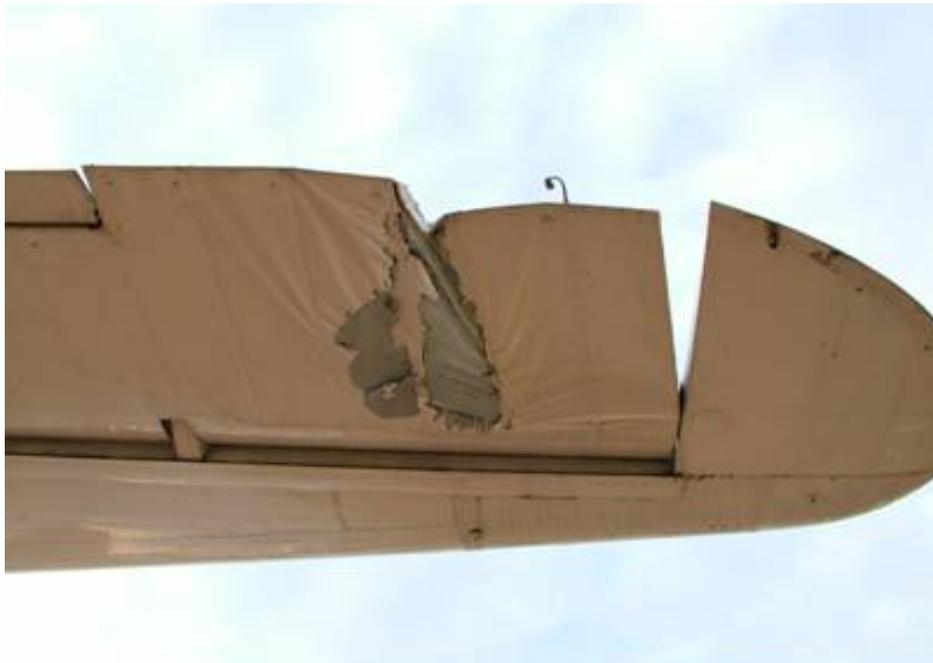
**Figure 2**

Damage to the Catalina's elevator

The accident was as a result of different expectations, by the Catalina crew and the marshal boat crews, on how the aircraft was to moor up following landing. This could have been resolved during the pilot's brief, held on the morning of the event.
