No: 1/89

Ref: EW/C1077

Aircraft Type and Registration: Sikorsky S-61N, G-BEID

Nature of Damage: Aircraft destroyed by fire

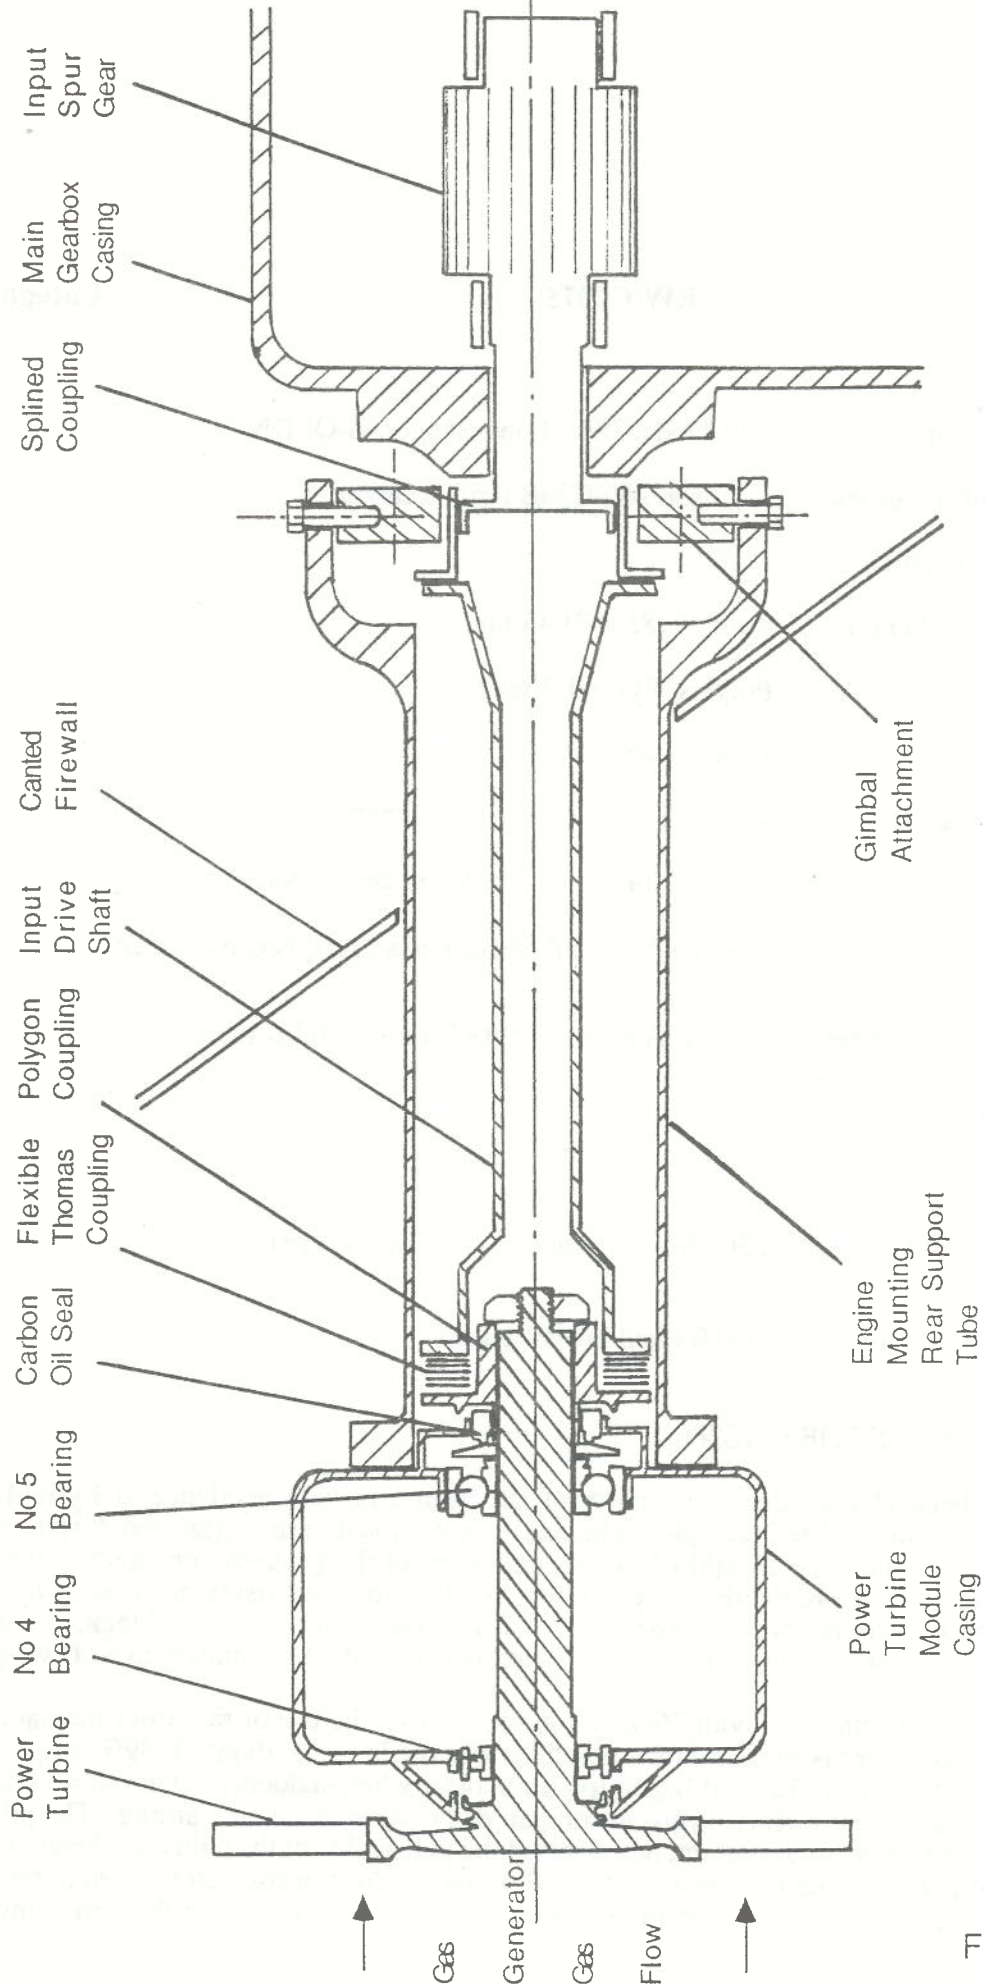
Figure 1

Each engine comprises a free PT (Fig 1) driven at a normal nominal operating speed of 18966 rpm by the gas flow from a gas generator. The PT rotor shaft is supported by the No 4 Roller Bearing and the No 5 Ball Bearing, and protrudes via a carbon oil seal through the aft end of the module casing, where it fits into the three-lobed socket of a polygon coupling. An input drive shaft (IDS) connected to the

polygon coupling via a flexible Thomas coupling drives a main transmission input spur gear via a splined coupling. Both the Thomas and the splined couplings are designed to tolerate a degree of axial misalignment. The polygon coupling and the IDS run inside the engine mounting rear support tube which, by virtue of rigid attachment to the rear of the PT module casing and gimbal-mounting to the main gearbox casing, provides a rear mount structure for the engine carcass. Normal radial clearance between the Thomas coupling assembly and the mounting rear support tube is approximately 0.13 inches.

The PT module damage consisted of extensive break-up of the cage of the No 5 Bearing and gross eccentric re-profiling of its inner race, which showed evidence of severe overtemperature, together with severe rubs of various parts of the PT rotor assembly against static parts of the PT module. Parts of the Thomas coupling assembly and the forward flange of the IDS had heavily rubbed the interior of the rear mounting tube, and the tube had parted circumferentially at this point.

A marked eccentricity of the damage to the PT rotor assembly and IDS components showed that the rotor assembly had operated for a period with a rotating angular displacement of its axis, centred on the No 4 Bearing, such that the shafting at the position of the No 5 Bearing and the Thomas coupling was undergoing a significant degree of orbiting at its rotational speed. Further investigation is being directed towards determining the cause(s) of the No 5 Bearing failure.
