AAIB Bulletin S2/2006

ACCIDENT

Aircraft Type and Registration:	Socata TB10, G-BNRA
No & Type of Engines:	1 Lycoming O-360-A1AD piston engine
Year of Manufacture:	1987
Date & Time (UTC):	16 February 2006 at 1120 hrs
Location:	Nottingham Airport (Tollerton), Nottinghamshire
Type of Flight:	Training
Persons on Board:	Crew - 2 Passengers - None
Injuries:	Crew - None Passengers - N/A
Nature of Damage:	Propeller blade shed; propeller and drive flange separated from engine; crankcase damaged and engine partly separated from mounting structure
Commander's Licence:	Commercial Pilot's Licence
Commander's Age:	41 years
Commander's Flying Experience:	2,198 hours (of which 10 were on type) Last 90 days - 90 hours Last 28 days - 30 hours
Information Source:	Aircraft Accident Report Form submitted by the pilot; debris plot made by the maintenance company; photographs of damaged aircraft; examination of failed propeller components and of maintenance documentation by AAIB.

Synopsis

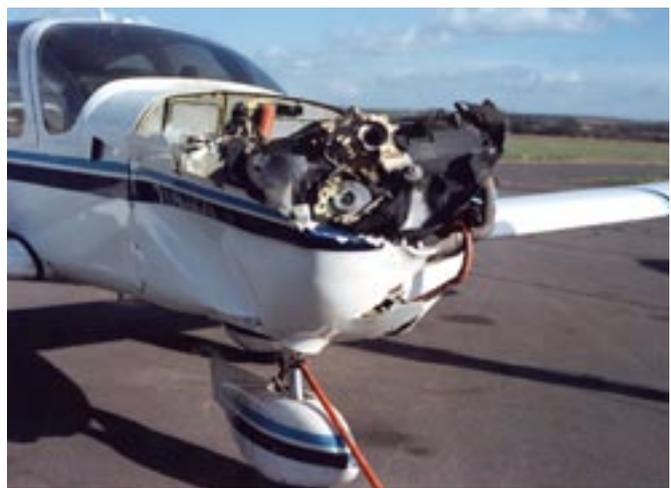
Figure 1

Analysis of the photographs provided to the AAIB confirmed that the engine had partly separated from the aircraft structure and had become re-orientated both in plan and in side elevation at angles between 30 and 40 degrees to the normal location (Figure 1). The two bladed, constant speed propeller was absent. It was found with one blade missing, alongside the runway close to the point at which the aircraft came to a halt. The missing blade was on the other side of the runway closer to the touch-down point. Two depressions in the paved surface indicated where propeller debris had impacted with considerable force.

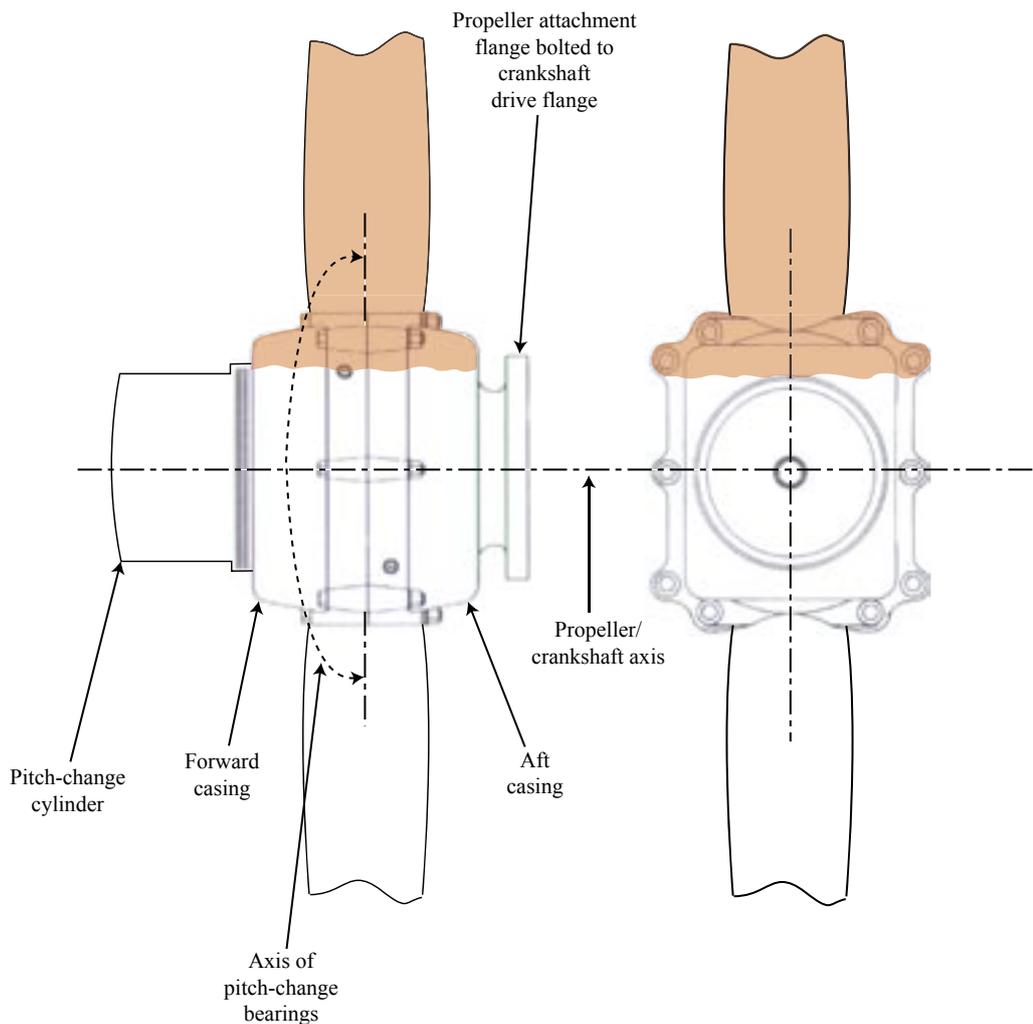
This model of propeller is of the variable pitch type in which the blades are located by thrust bearings within a two piece hub (See Figure 2). The hub components consist of an aft casing bolted to the drive flange of the

crankshaft and a forward casing upon which is mounted the cylinder and piston of the pitch change mechanism. The two casings are secured together by a series of bolts whose axes are parallel to that of the crankshaft. The plane of the joint between forward and aft casings coincides with the axes of the blade pitch change bearings.

Examination of the separated components indicated that the engine crankshaft had fractured close to its forward end, as had part of the crankcase casting in which it was located. The isolated blade appeared to have been released as a result of the fracture of part of the hub which carried a blade pitch change bearing and hence the centrifugal blade force.

Figure 2 (left)
Schematic view of propeller hub with separated portion shown in red

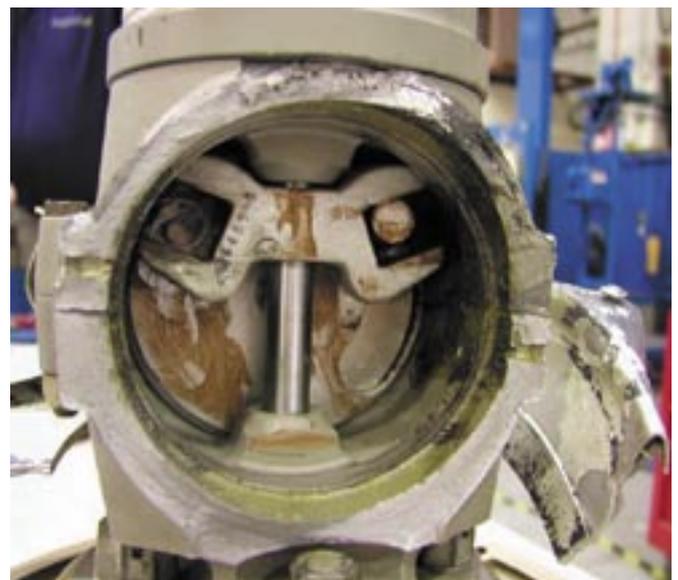
examined under laboratory conditions (Figure 3). It was noted that the pitch change bearing of the blade which remained attached was fully charged with grease, whilst

those components of the bearing securing the separated blade, recovered from the proximity of the accident site, indicated a marked lack of lubrication.

Initial metallurgical examination of the fracture faces of the hub indicated that although the fracture of the aft section of the casing appeared to be in simple overload, the forward section had a more complex failure mechanism which included some fatigue.

Figure 3
Hub fracture faces

The similarity of the position of the unusual fracture face on the hub to the area highlighted in the Manufacturer's Service Bulletin, as well as the absence of grease from the pitch-change bearing of the separated blade, strongly suggest that the failure was of the type which the Service Bulletin is intended to address. The absence of an Airworthiness Directive on the subject has inhibited the ability of maintenance companies and operators to identify the propellers at risk of blade loss and to take steps to prevent such hazardous accidents from occurring.

It is recommended that the CAA take immediate action to alert M3 organisations and other relevant maintainers in the UK to the existence and importance of Hartzell Service Bulletin HC-SB-61-269.

It is recommended that the FAA take urgent steps to issue an Airworthiness Directive making the inspection requirements of Hartzell Service Bulletin HC-SB-61-269 mandatory.

It is recommended that the EASA take urgent steps to issue an Airworthiness Directive making the inspection requirements of Hartzell Service Bulletin HC-SB-61-269 mandatory.
