ACCIDENT

| Aircraft Type and Registration: | Mickleburgh L107, G-BZVC |

Synopsis

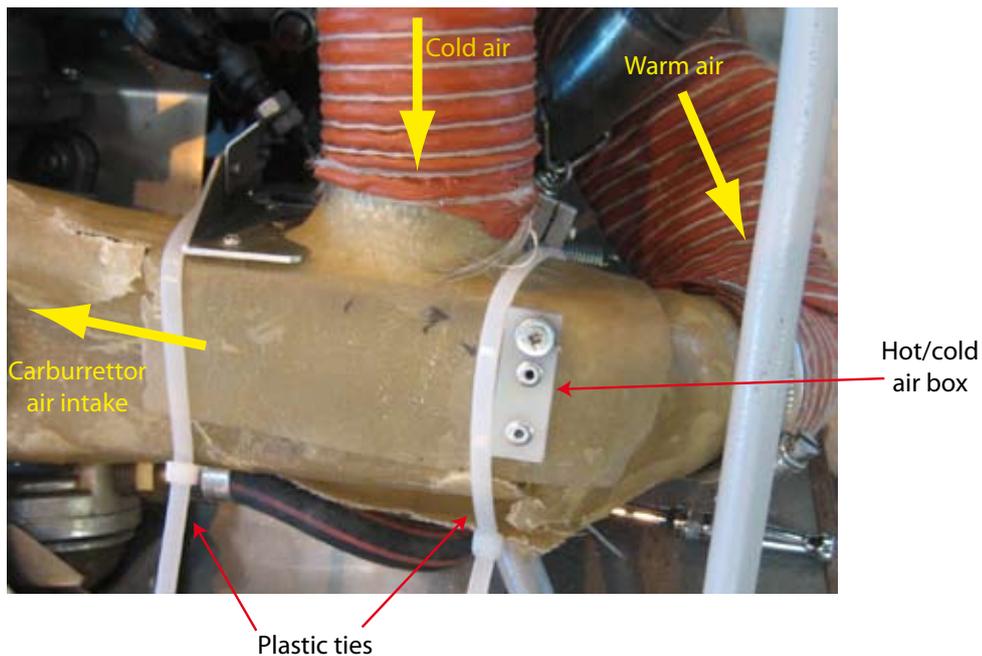
Figure 1
Carburettor hot/cold air system

The carburettor hot/cold air box on this aircraft was constructed from two 'U' shaped rectangular lightweight composite channels, mounted one over the other to form a rectangular box, and held together using two plastic ties, Figure 1.

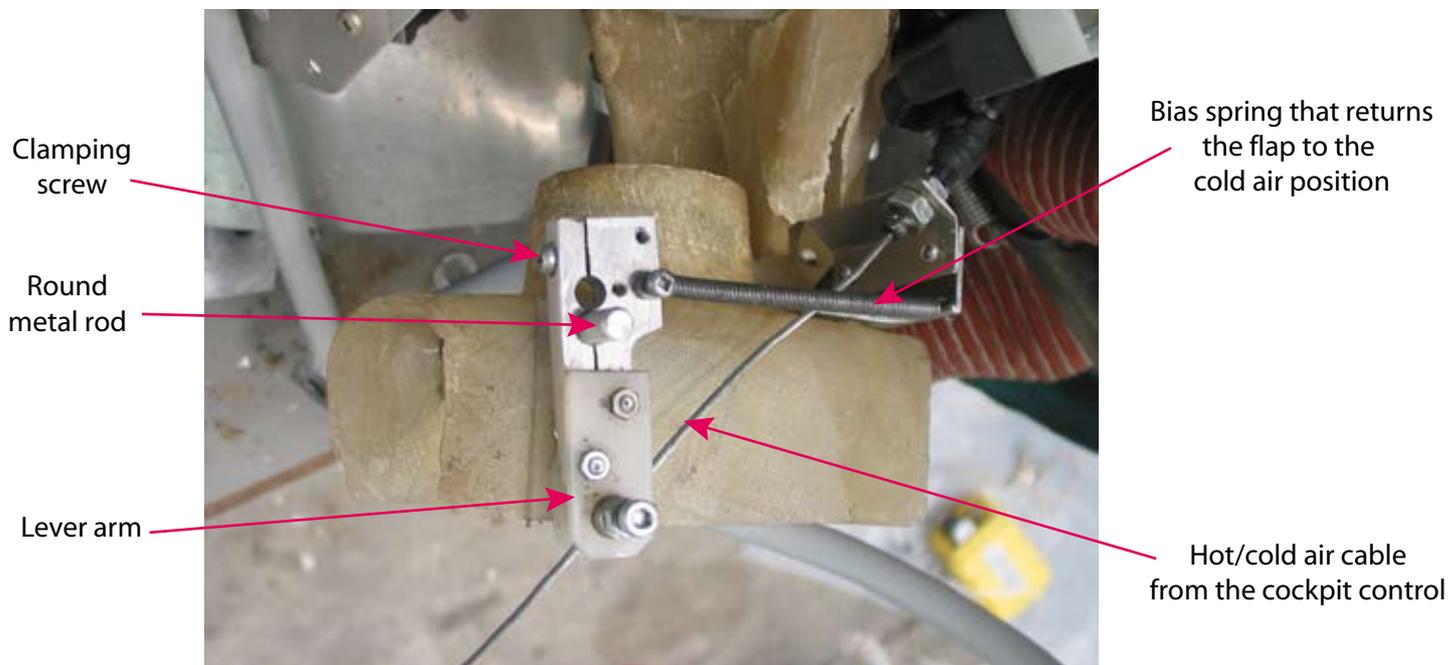
Figure 2
Hot/cold air lever arm mechanism

The movable flap was located inside the upper channel section and attached to a round metal rod which formed the pivot for the flap, mounted across the inside of the section. An operating lever arm was located at one end of the rod and secured by the clamping action of a small screw. A spring attached to the lever arm biased the moveable flap towards the cold air position. The Bowden cable from the carburettor heat control in the cockpit was attached at the end of the lever arm, Figure 2.

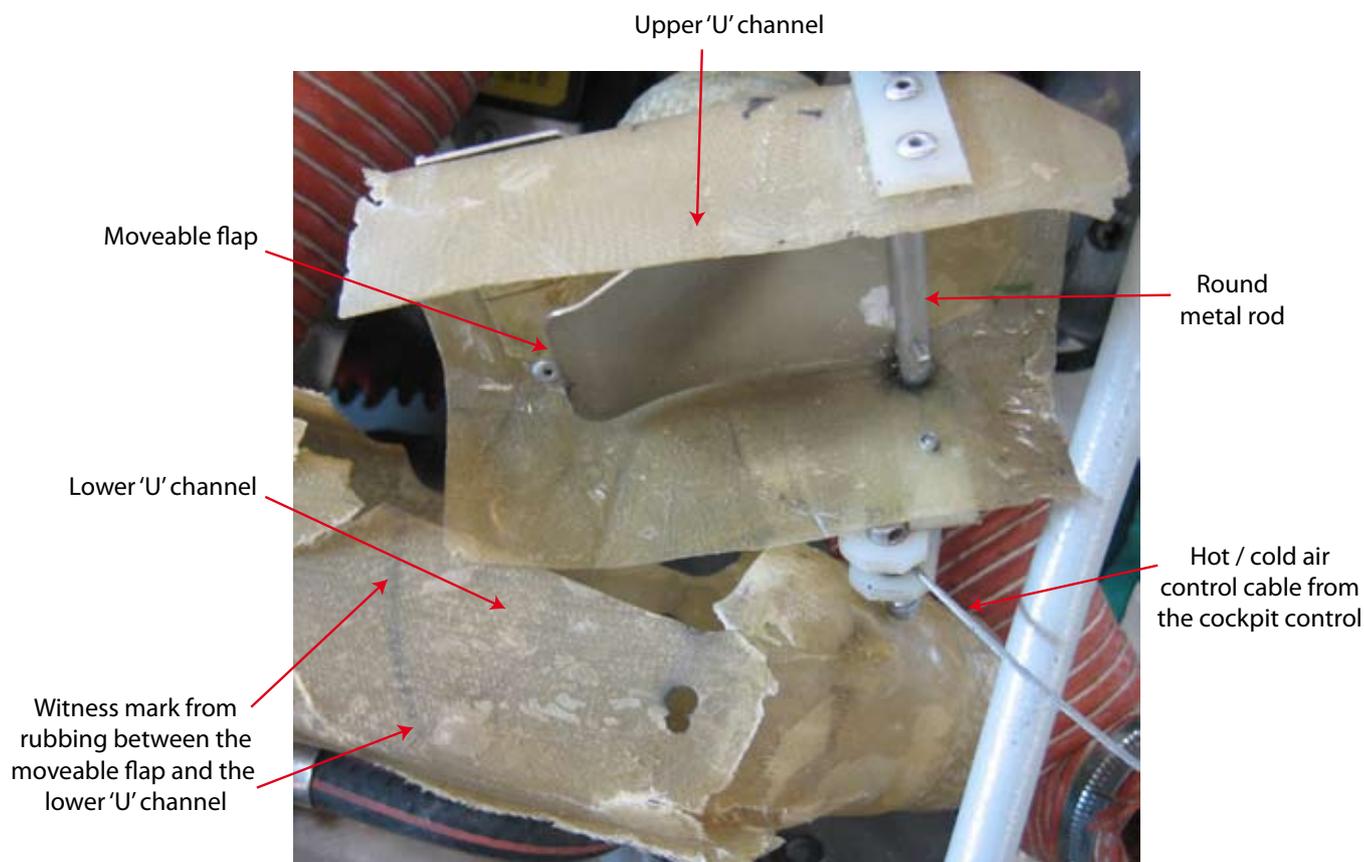
Figure 3

Examination of the system showed that, although all the components were connected, the lever arm was loose on the flap pivot rod. When the two 'U' shaped channels were separated it was seen that the movable flap was in the cold air position and was catching against one side of the lower 'U' channel, tending to cause the flap to stick in the cold air position. There was good evidence that the movable flap had been rubbing against the inside of the lower 'U' channel over its full range of travel for a considerable period of time. Detailed examination of the lever arm to metal rod connection showed that the arm had become loose as a result of the flap interference with lower 'U' channel, Figure 3.

Inside the hot/cold air box

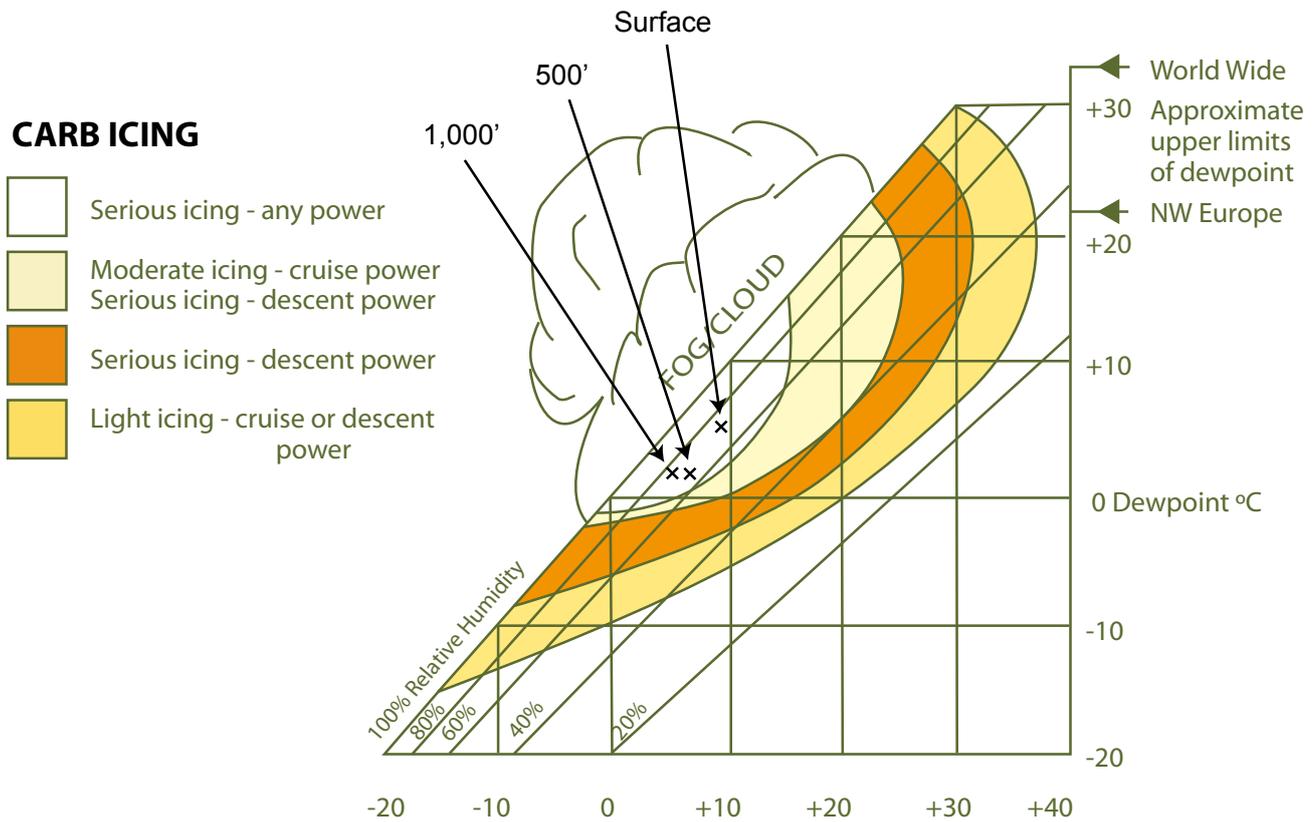
Figure 4

A weather aftercast was obtained from the Met Office for the Fenland Airfield area for the mid-to-late morning of 21 February which specifically gave air temperature, dew point and humidity from the surface to 1,000 ft. When these figures were plotted on the Civil Aviation Authority's Carburettor Icing Prediction Chart, Figure 4, they gave a prognosis that serious carburettor icing could occur at any power setting between the surface and 1,000 ft above sea level.
