**No: 5/92**

**Ref: EW/C92/02/04**

**Aircraft Type and Registration:** Robinson R22 Mariner, G-BPPC

**Information Source:** AAIB Field Investigation

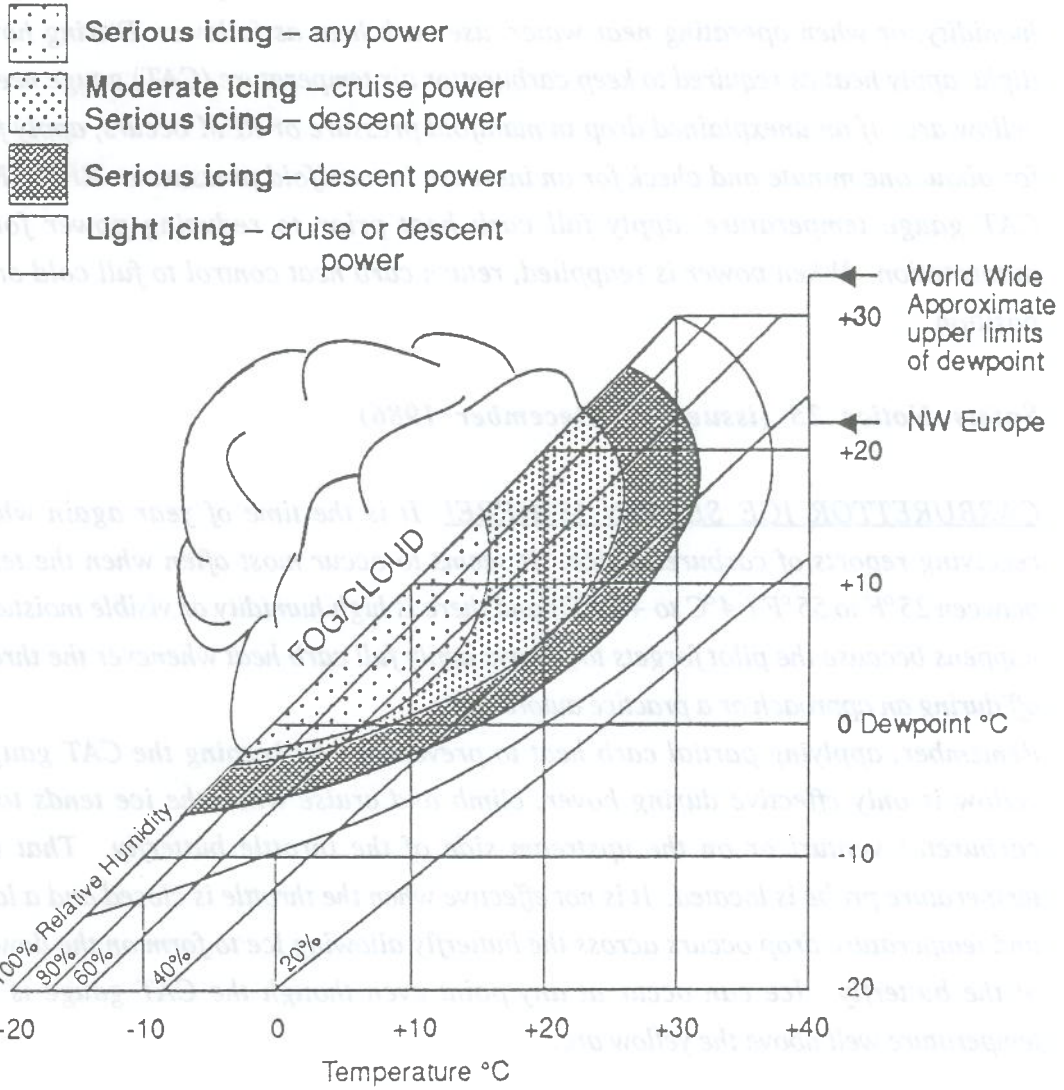
FIGURE 1

The chart reproduced at Figure 1 shows the wide range of ambient conditions conducive to the formation of carburettor icing. Particular note should be taken of the much greater risk of serious icing with descent power. The ambient conditions prevailing on the surface and at 1000 feet in the Olham area at the time of the accident fall within the serious icing range.

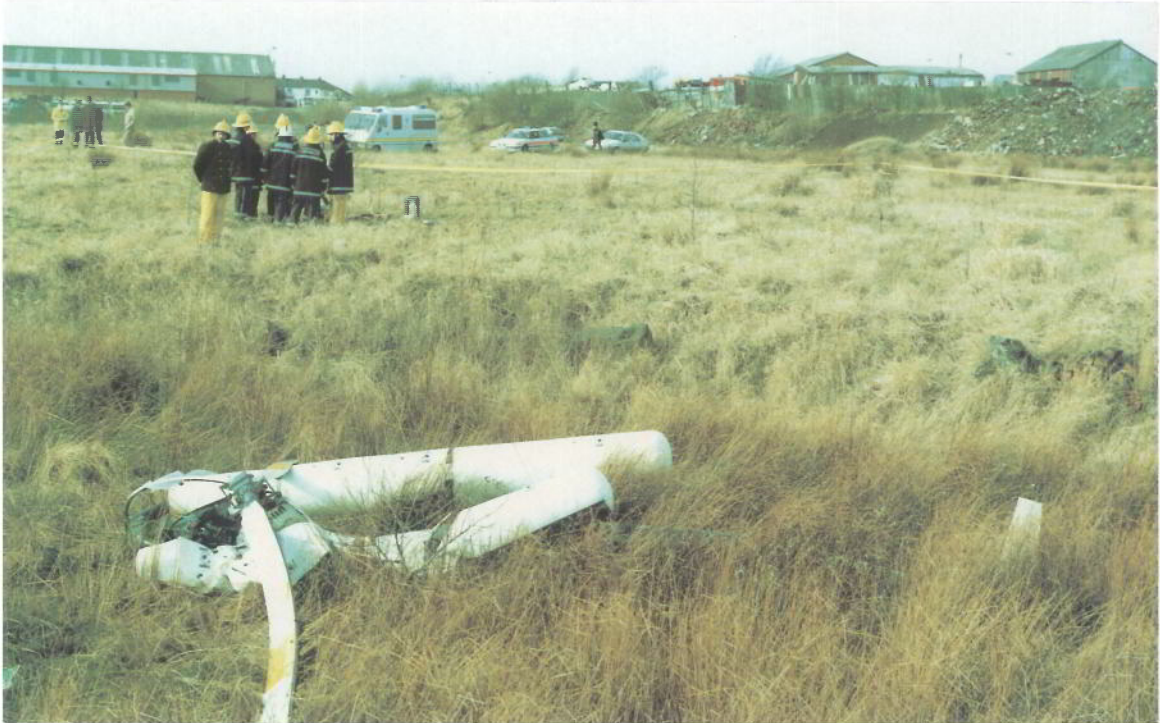
There were no signs of any main rotor blade strikes on the boom nor on the cockpit canopy structure. The main and auxiliary fuel tanks were ruptured and empty but there was a considerable quantity of fuel evident in the ground. The condition of the main and tail rotor blades was consistent with there having been no rotation at all at impact (see Photograph 1).

**G-BPPC: Note lack of rotational damage to main rotor blades**

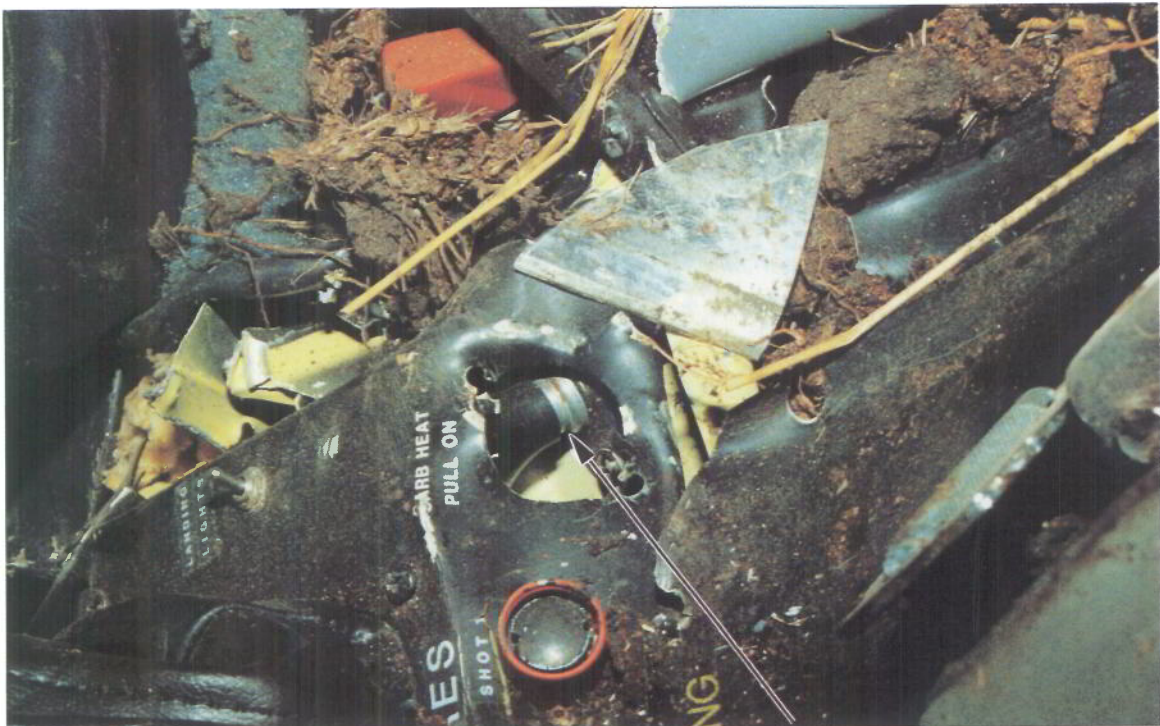
**G-BPPC: View of centre console showing carburettor heat control knob fully down (cold position)**
