Aircraft Type and Registration: Cessna F177RG Cardinal, G-TOTO

Date & Time (UTC): 9 February 2004 at 1205 hrs

Location: Meppershall Airfield, Shefford, Bedfordshire

Synopsis

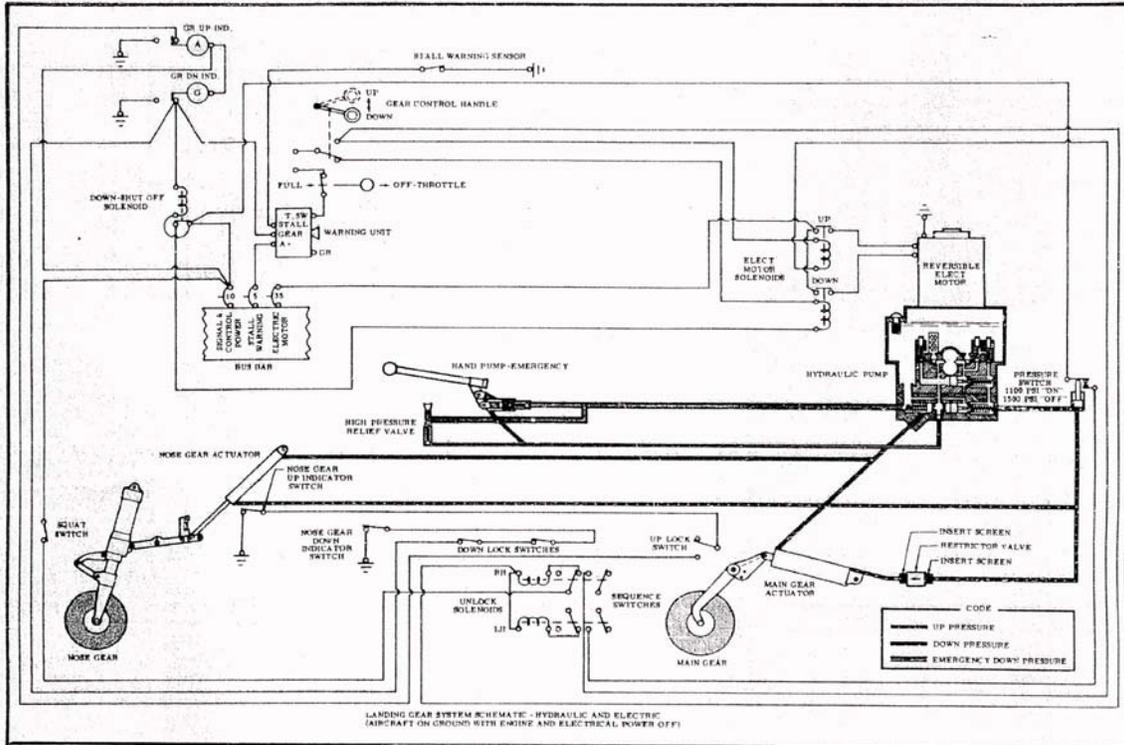
Figure 1
Diagram of the landing gear hydraulic and electrical system

Retraction and extension of the landing gear is accomplished by a hydraulic system integrated with electrical control and indication circuits. There is one hydraulic actuator for the nose landing gear and one actuator that drives a gear system for both main landing gears. Hydraulic fluid is supplied to the actuators by an electrically-powered reversible pump. The hydraulic reservoir is an integral part of the pump. The electrical pump is controlled by the landing gear selector mounted in the cockpit instrument panel. As the landing gear selector is moved to either the up or down position, the pump directs hydraulic fluid through a power pack control valve assembly to the landing gear actuators. As the hydraulic fluid pressure increases at one side of the actuator pistons, the fluid at the other side of the pistons is directed back through the control valve assembly to the pump. The landing gear extension and retraction pipes serve either as pressure or return lines depending on the rotation of the reversible pump and the position of the landing gear selector in the cockpit. Mechanical overcentre locks provide up and down locks for the nose landing gear. The main landing gears utilise hydraulic pressure for positive uplock and electro-mechanical downlocks. Mounted on the control valve, through which pressurised hydraulic fluid passes during landing gear retraction, is a pressure switch. This pressure switch opens the electrical circuit to the pump solenoid when the main landing gear is fully retracted and the hydraulic pressure has reached approximately 1,500 psi. The pressure switch will hold the electrical circuit open until the hydraulic pressure in the system drops to approximately 1,100 psi at which time the pressure switch closes allowing electrical power to the hydraulic pump. The hydraulic pump will run until the pressure reaches approximately 1,500 psi and the pressure switch opens the electrical circuit. This cycling of the hydraulic pressure maintains the main landing gears in their UP AND LOCKED positions whenever the landing gear selector in the cockpit is in the up position. With the landing gear selector in the down position the pressure switch has no effect on the operation of the hydraulic system. Other valves in the hydraulic system channel fluid to the correct outlets during landing gear extension and retraction, allow return fluid into the reservoir without producing any back pressure and allow for thermal relief. An emergency hand pump, located between the two front seats, is used to extend the landing gear manually in the event of electrical or hydraulic failure.

Mounted in the instrument panel are two landing gear position indicator lights. A single amber light illuminates when the landing gear is up and locked; a single green light illuminates when it is down

and locked. Each of the three landing gears has a downlock microswitch and all three microswitches have to be made to complete the electrical circuit to illuminate the green down and locked light in the cockpit. In addition to illuminating the green indicator light, the making of all three downlock microswitches opens the electrical circuit to the hydraulic pump. Mechanically connected to the main landing gear downlock mechanisms are two unlock solenoids on the back of which are mounted sequence switches. These solenoids are mounted on pivots which allow them to pivot through approximately 7°. One of the functions of the sequence switches is to open the electrical circuit to the hydraulic pump when the main landing gears are in their downlock positions. All three downlock microswitches and the two sequence switches have to be operated before electrical power to the hydraulic pump is switched off during the landing gear extension sequence. When the hydraulic pump switches off, the pressure in the down lines slowly dissipates over a period of time which is dependant upon the seal leak rates in the landing gear actuators. The hydraulic pump will switch on when any of the downlock microswitches or sequence switches break, which, providing the landing gear selector is in the DOWN position, will pressurise the down lines. When a correctly adjusted landing gear is in the DOWN AND LOCKED position no hydraulic pressure is required to maintain it in that condition. During the landing gear retraction sequence, only the sequence switches, the pressure switch and the landing gear selector in the cockpit have a controlling function of the electrical power to the hydraulic pump.

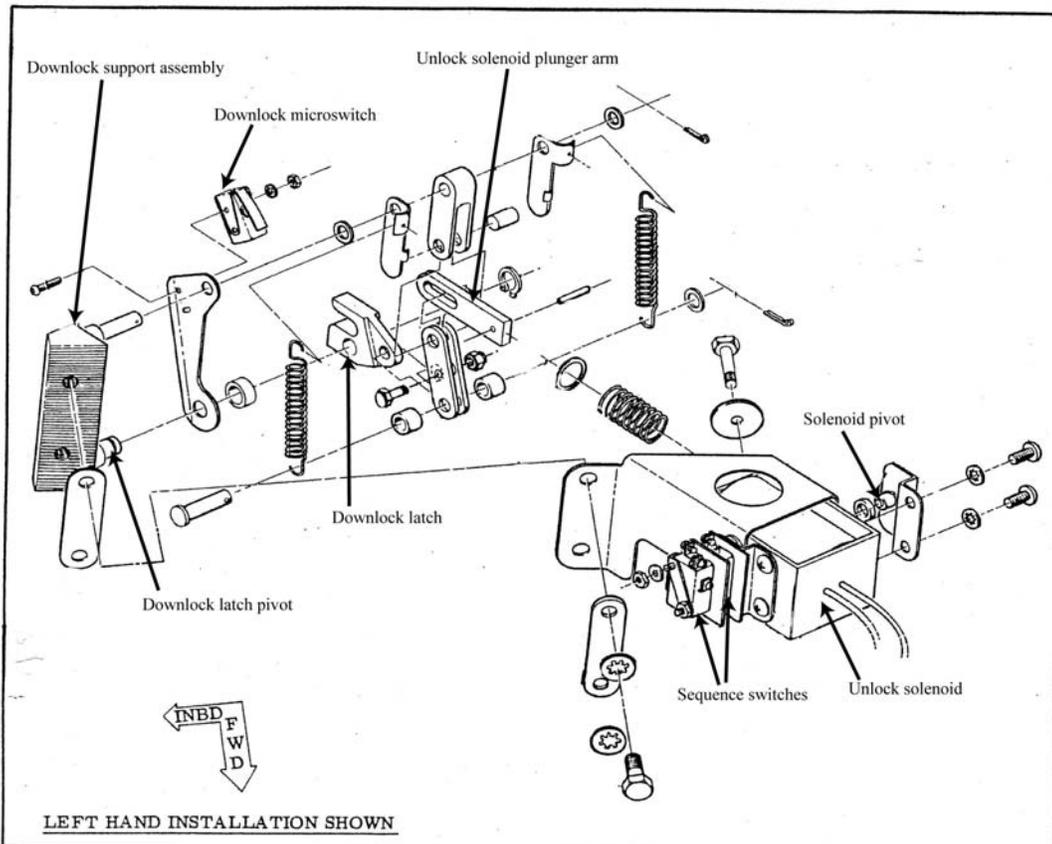
Figure 2
Diagram of the left main landing gear downlock mechanism

The downlock latch (part number 2041017-8) pivot pin mounted on the left main landing gear downlock support assembly (2041017-3) was found to have failed due to a double fatigue mechanism which had occurred over a considerable number of cycles. This failure would have disrupted the operation of either or both of the left main landing gear downlock microswitch and its sequence switch. Examination of the right main landing gear downlock mechanism found that its downlock latch pivot pin was at the point of final failure due to an almost identical double fatigue mechanism.

It is probable that the initial problem that G-TOTO encountered when the landing gear would only partially retract was the result of the left main landing gear downlock latch pivot pin failure not allowing the unlock solenoid to pivot correctly. This in turn did not allow the sequence switch to close the electrical circuit to the electric hydraulic pump and consequently, it did not allow the hydraulic part of the retraction sequence to function. The main landing gears became mechanically unlocked which allowed them to move partially rearwards towards their retracted positions due to their weight and aerodynamic drag. In the landing gear partially retracted position, the downlock microswitches would have been broken allowing the landing gear extension sequence to function normally. When the landing gear was extended it was possible that the geometry of the main landing gear mechanical downlock mechanism, with the left main landing gear downlock latch pivot pin having failed, allowed the downlock microswitch to close and, providing that the other two downlock microswitches were also closed, would give a landing gear down and locked indication in the cockpit.

The fatigue of the downlock latch pivot pins had occurred over a period of time. It is likely that this fatigue had been the result of either incorrect rigging of the main landing gears or the rigging having gone out of adjustment in-service, by for example a heavy landing, allowing excessive loads to be placed on the pivot pins.

It was recommended to the Cessna Aircraft Company that the Cessna 177RG Maintenance/Service documentation should specify to owners, operators and maintainers that whenever a mechanical failure is found in any part of a main landing gear assembly, the corresponding main landing gear assembly should be examined for a potential similar failure.

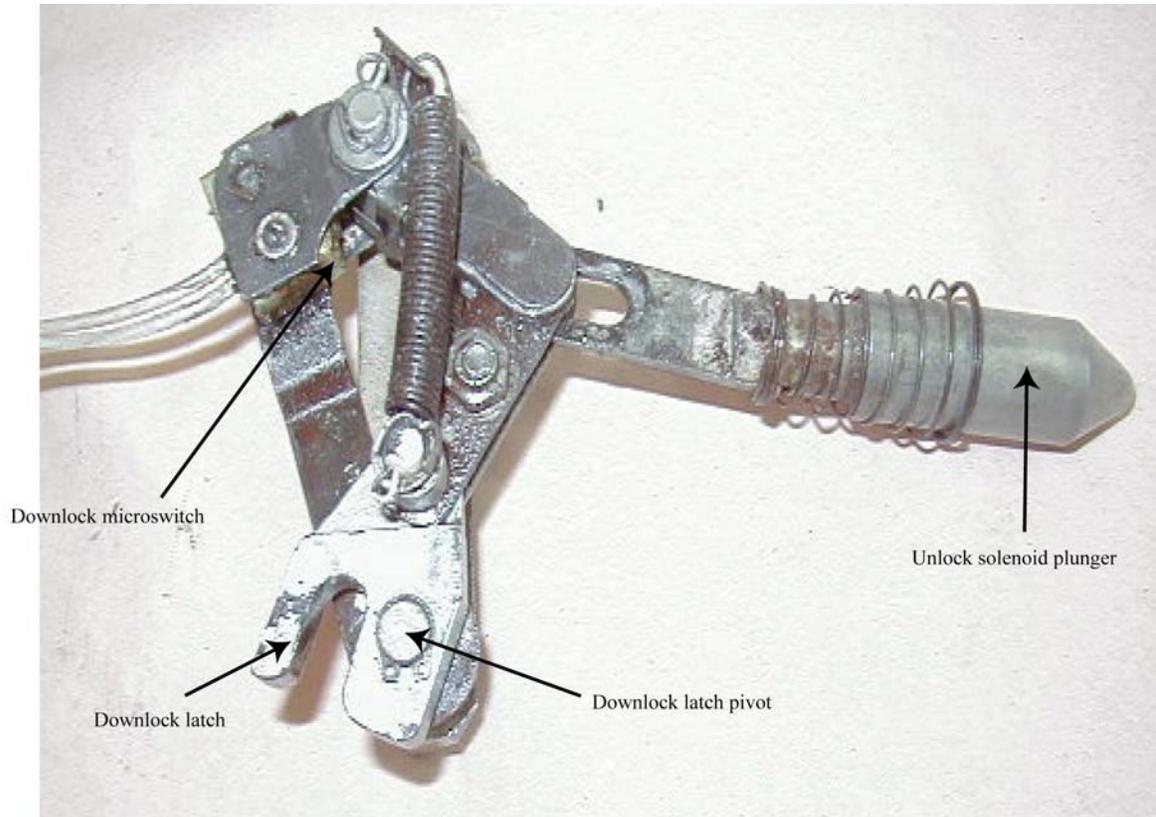
Figure 3

Photograph of part of the main landing gear downlock mechanism
