No: 3/91

Ref: EW/G90/12/12

Pitts Special S-1C, G-BRVL

Extensive damage to cowlings, tail surfaces and fuselage

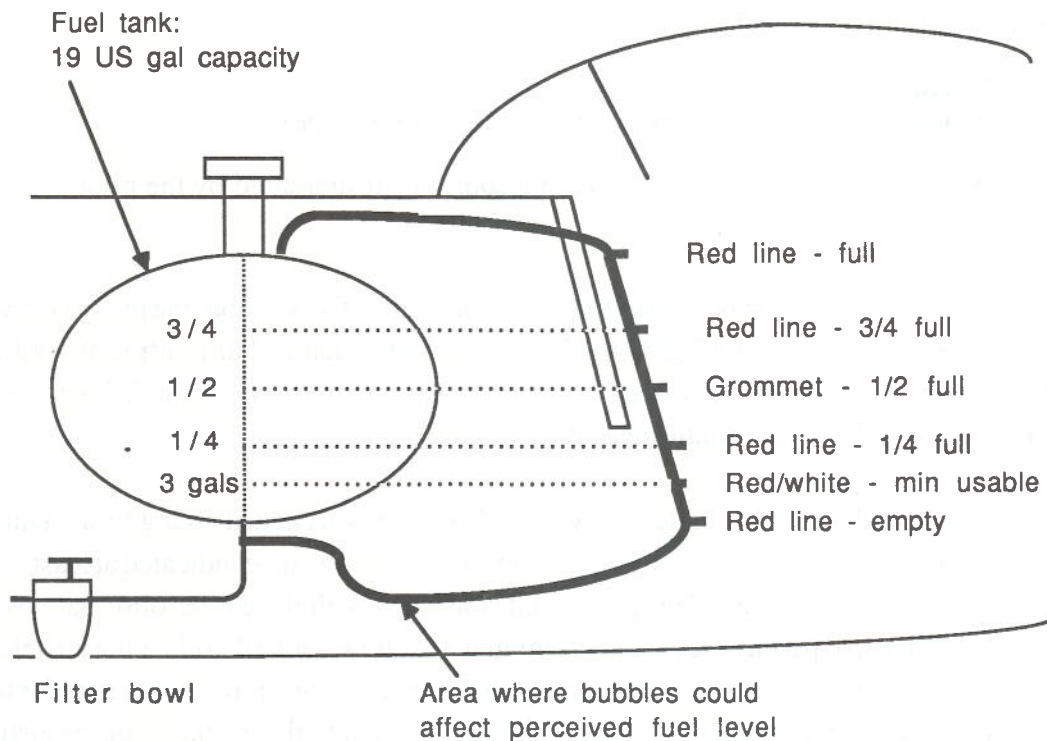
Following the accident, the pilot and another of the aircraft's co-owners have speculated that there may have been bubbles trapped in the lower loop of the fuel sight glass (see accompanying sketch) which could have affected the perceived fuel state. Bubbles had in fact been observed on previous occasions and were thought to have resulted from aerobatics. On the day of the accident however, the pilot did not get right down into the cockpit to check the lower loop of the sight-tube. The pilot has since talked with another Pitts owner who also believes that bubbles can affect the sight-tube (the narrower the bore of the tube, the greater the probability of such an occurrence) and who accordingly checks the fuel level prior to flight by means of a calibrated dip stick.

**G-BRVL Fuel Contents Indication System Schematic**  
(Calibration is for aircraft in level flight attitude. Appx 4" subtracted from readings taken on the ground.)
