INCIDENT

Aircraft Type and Registration:	BN2A MK III-2 Trislander, G-FTSE
No & Type of Engines:	3 x Lycoming O-540-E4C5
Year of Manufacture:	1977
Date & Time (UTC):	17 January 2011 at 0956 hrs
Location:	Alderney Aerodrome, Alderney, Channel Islands
Type of Flight:	Commercial Air Transport (Passenger)
Persons on Board:	Crew - 1 Passengers - 5
Injuries:	Crew - None Passengers - None
Nature of Damage:	Damage to the right navigation light
Commander's Licence:	Commercial Pilot's Licence
Commander's Age:	51 years
Commander's Flying Experience:	5,850 hours (of which 1,450 were on type) Last 90 days - 128 hours Last 28 days - 34 hours
Information Source:	AAIB Field Investigation

Following a non-precision approach, the aircraft manoeuvred to land on the runway and its wingtip touched the ground. During a go-around after touchdown, the aircraft departed the runway prior to getting airborne. This report discusses the use of instrument approach minima following a visual cruise segment, and the availability of GPS as an alternative to conventional non-precision approaches.

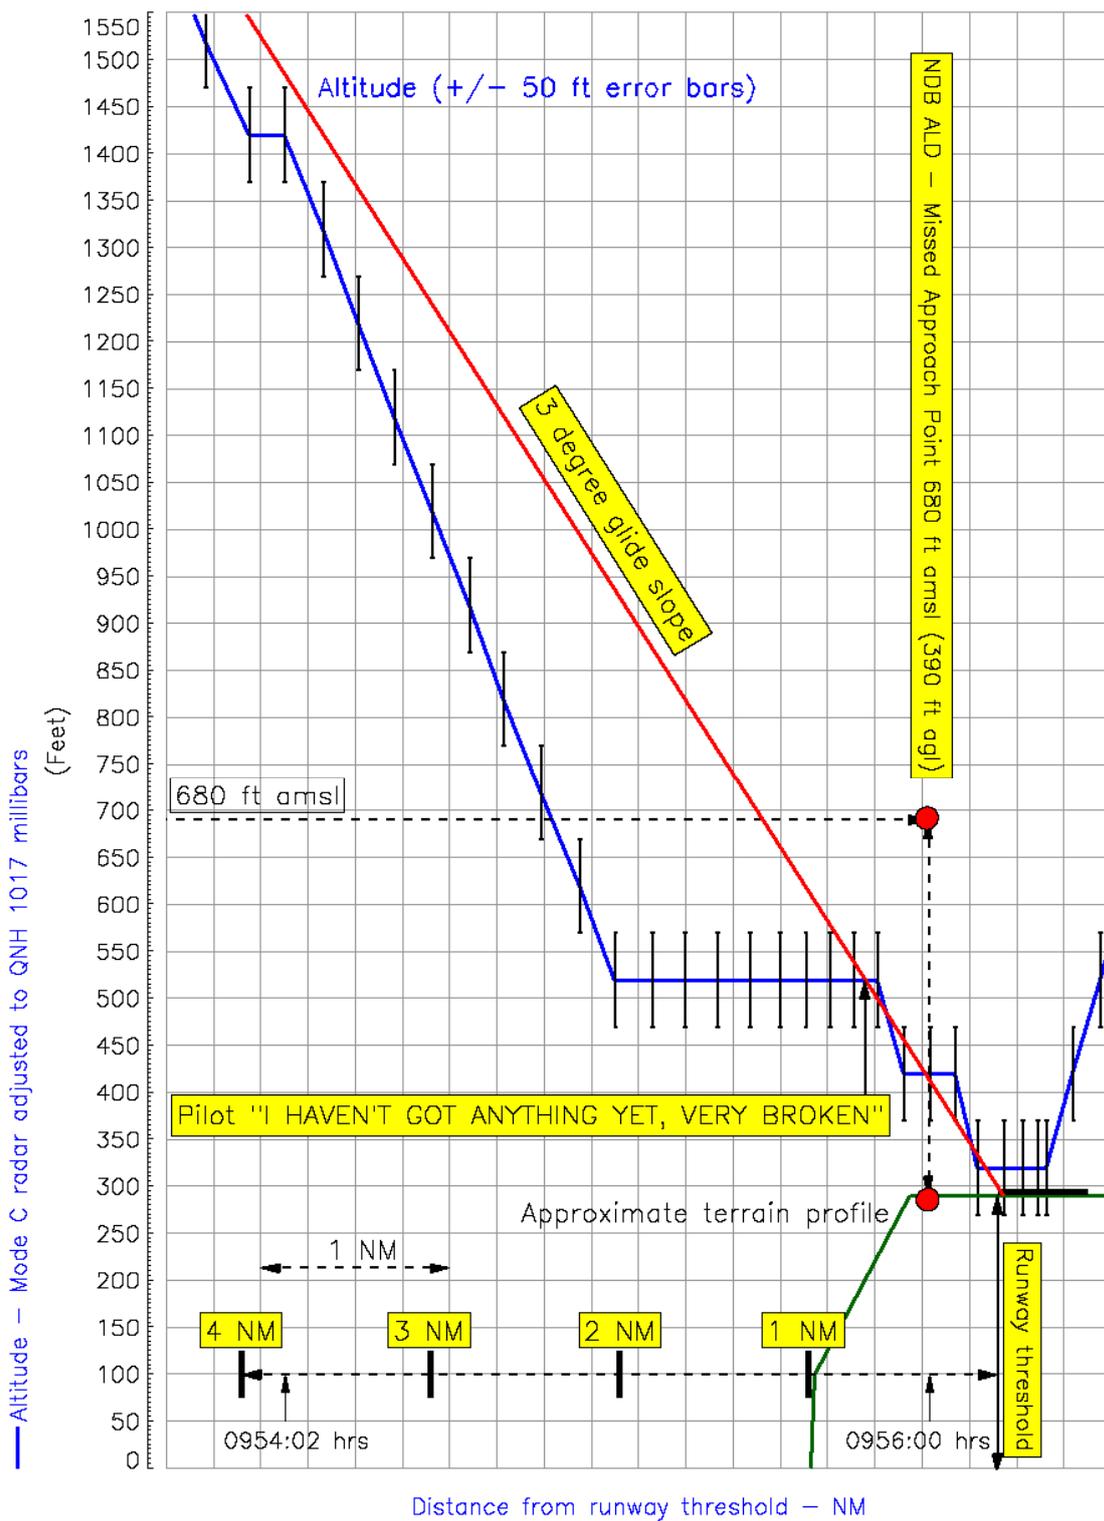
Figure 1

As the aircraft positioned onto the approach, it was cleared to descend to 1,500 ft and approximately 4.5 nm from the runway, cleared to “DESCEND WITH THE PROCEDURE” and contact Alderney Tower, which the commander acknowledged. The pilot turned “late” to intercept the inbound course, so re-intercepted it from the north and commenced a descent using the AP to maintain the aircraft attitude. Approximately 4 nm from the ALD NDB, the aircraft was on the correct vertical profile for the NDB approach at 1,420 ft. The aircraft then started to descend at an average rate of approximately 900 ft/min (see Figure 1).

Shortly over one minute from touchdown and approximately 2 nm from the runway, the aircraft levelled off at 520 ft amsl. Approximately 35 seconds from touchdown, and approximately 1,300 m from the runway, Alderney Tower advised that the visibility had reduced to about 1,200 m. The pilot responded “I HAVEN’T GOT ANYTHING YET, VERY BROKEN”. The aircraft remained at an altitude of 520 ft, approximately 230 ft agl. Several seconds later, the aircraft started to descend and with the aircraft almost abeam the ALD NDB, 680 m from the threshold of Runway 26, the pilot advised Alderney Tower “GOT THE LIGHTS”. The track indicated by radar was then approximately 160 m north of the runway centre line.

Data from approach and rejected landing at Alderney Airport Runway 26

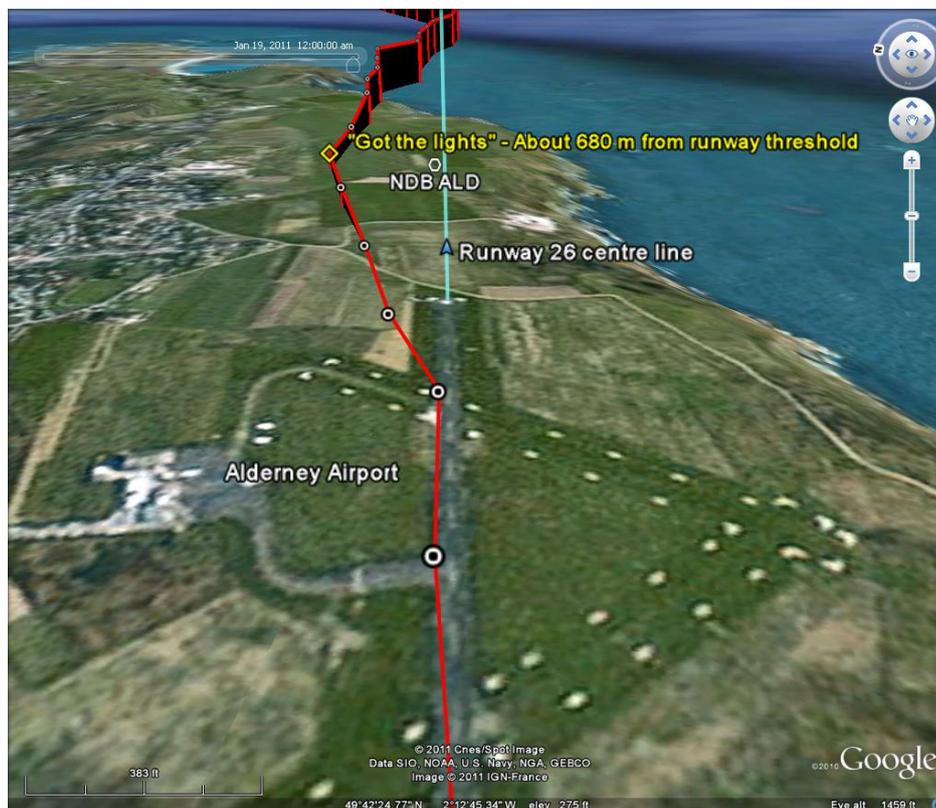
Figure 2

No accident protected data or voice recorder was required or fitted. Primary and secondary¹ radar information available from Jersey was recorded approximately once every six seconds and provided a complete record of the approach and go-around on Runway 26 (Figure 2). Radio transmissions during the flight were also recorded.

Radar track of final approach to Runway 26

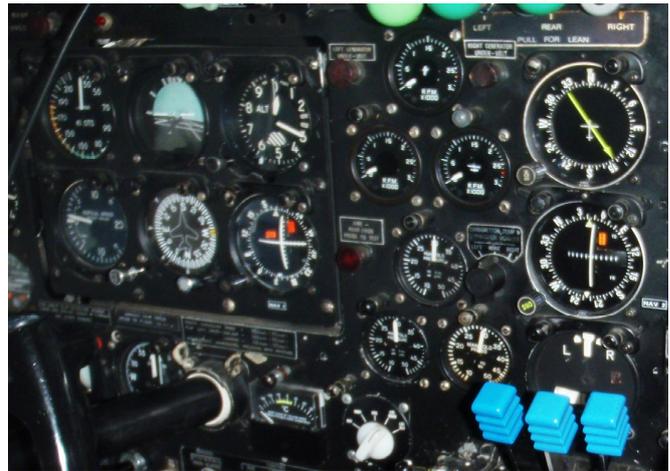
Figure 3
Instruments

The Britten-Norman Trislander is an 18-seat three-engined piston-powered utility aircraft produced in the 1970s and early 1980s, normally flown by a single pilot. G-FTSE was equipped with basic navigation equipment, including a Relative Bearing Indicator (RBI) positioned in the centre of the aircraft instrument panel, separate from the pilot’s primary flight instruments (Figure 3).

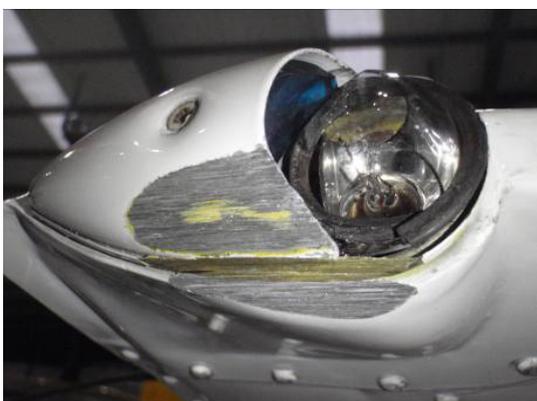
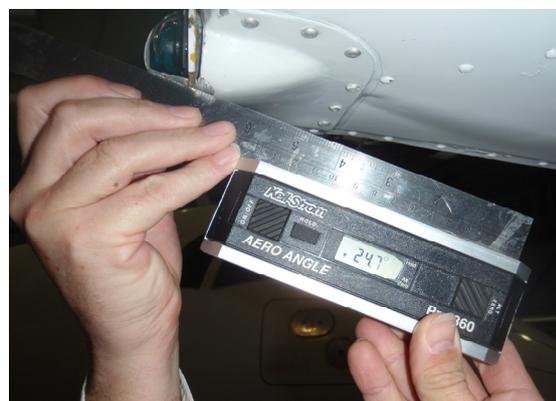
Figure 4
Aircraft damage

An inspection of the runway revealed broken glass from the navigation light and tyre marks which indicated that

after its brief touchdown the aircraft had departed the right edge of the runway before becoming airborne.

The aircraft exhibited damage to the right wingtip and navigation light. An inclinometer was used to measure the angle of the scrape marks, which implied the aircraft was rolled 24° right when it made contact with the runway (Figure 4).

The operator has issued a Flying Staff Instruction, which will become an amendment to its Operations Manual, such that significant manoeuvres below 300 ft agl will not constitute a stabilised final approach.

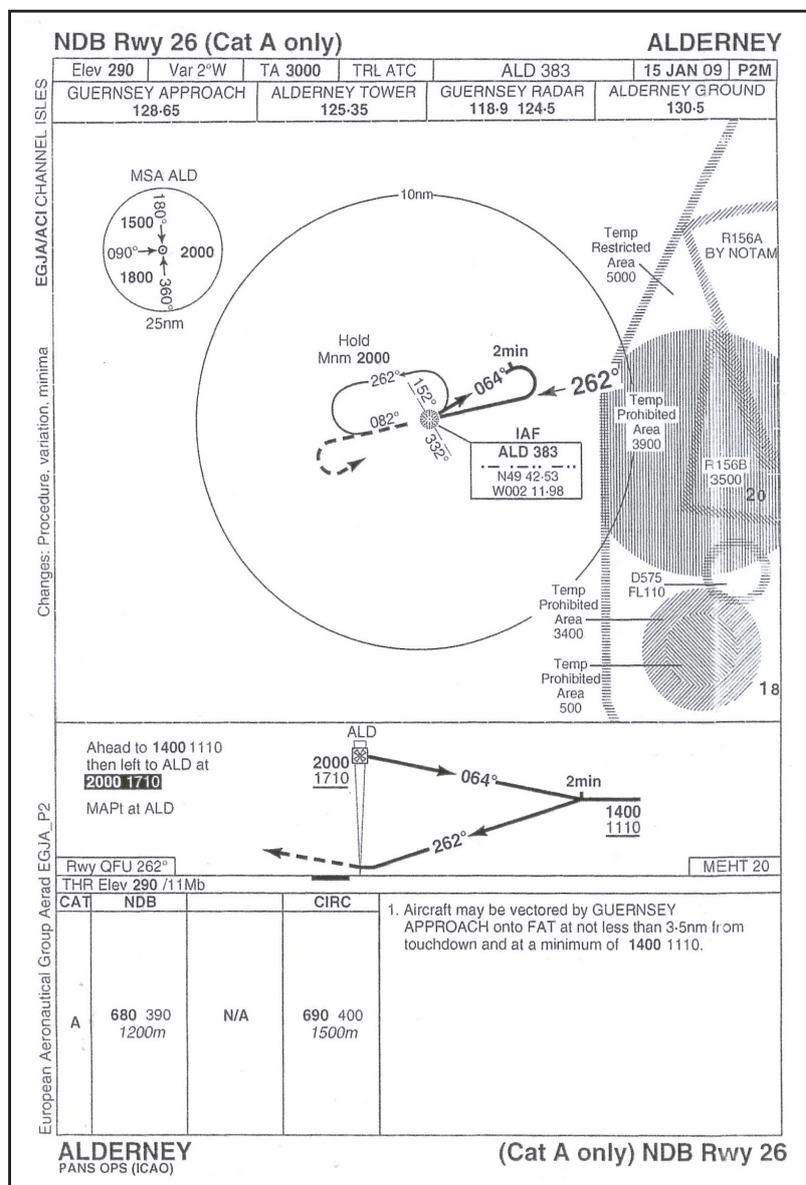
Figure 5
NDB procedure Alderney

An NDB is subject to several sources of error including: night effect, where radio waves reflected back by the ionosphere can cause signal strength fluctuations 30 to 60 nm from the transmitter, especially just before sunrise and just after sunset; terrain effect, where, for example, mountains and cliffs can reflect radio waves, giving

erroneous readings; electrical effect, where electrical storms or electrical interference (from a ground-based source or from a source within the aircraft) can cause the ADF needle to deflect towards the electrical source; coastal effect, where low-frequency radio waves will refract or bend near a shoreline, especially if they are nearly parallel to it; and bank effect, by which the needle is deflected when the aircraft is banked. The effects of these errors reduce the accuracy of an NDB, and increase pilot workload.
