ACCIDENT

Aircraft Type and Registration:	Piper PA-28-140 Cherokee, G-ATRR	
No & Type of Engines:	1 Lycoming O-320-E3D piston engine	
Year of Manufacture:	1966 (Serial no: 28-21892)	
Date & Time (UTC):	19 May 2013 at 1018 hrs	
Location:	Caernarfon Airport, Gwynedd	
Type of Flight:	Private	
Persons on Board:	Crew - 1	Passengers - 2
Injuries:	Crew - 1 (Serious)	Passengers - 1 (Fatal) 1 (Serious)
Nature of Damage:	Aircraft destroyed	
Commander's Licence:	Private Pilot's Licence	
Commander's Age:	61 years	
Commander's Flying Experience:	90 hours (of which 72 were on type) Last 90 days - 9 hours Last 28 days - 2 hours	
Information Source:	AAIB Field Investigation

Synopsis

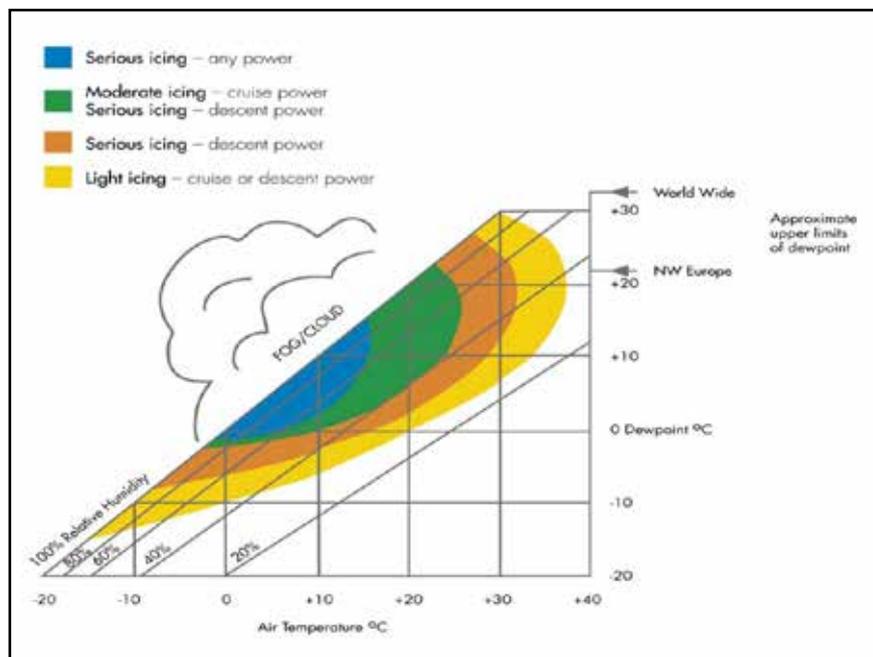
Carburettor icing probability chart

Figure 2 illustrates the probability of carburettor icing for values of air temperature and dewpoint. Assuming a reducing temperature and similar dewpoint above the surface, this would indicate that the latter part of the flight was operating in the blue sector: 'serious icing at any power'.

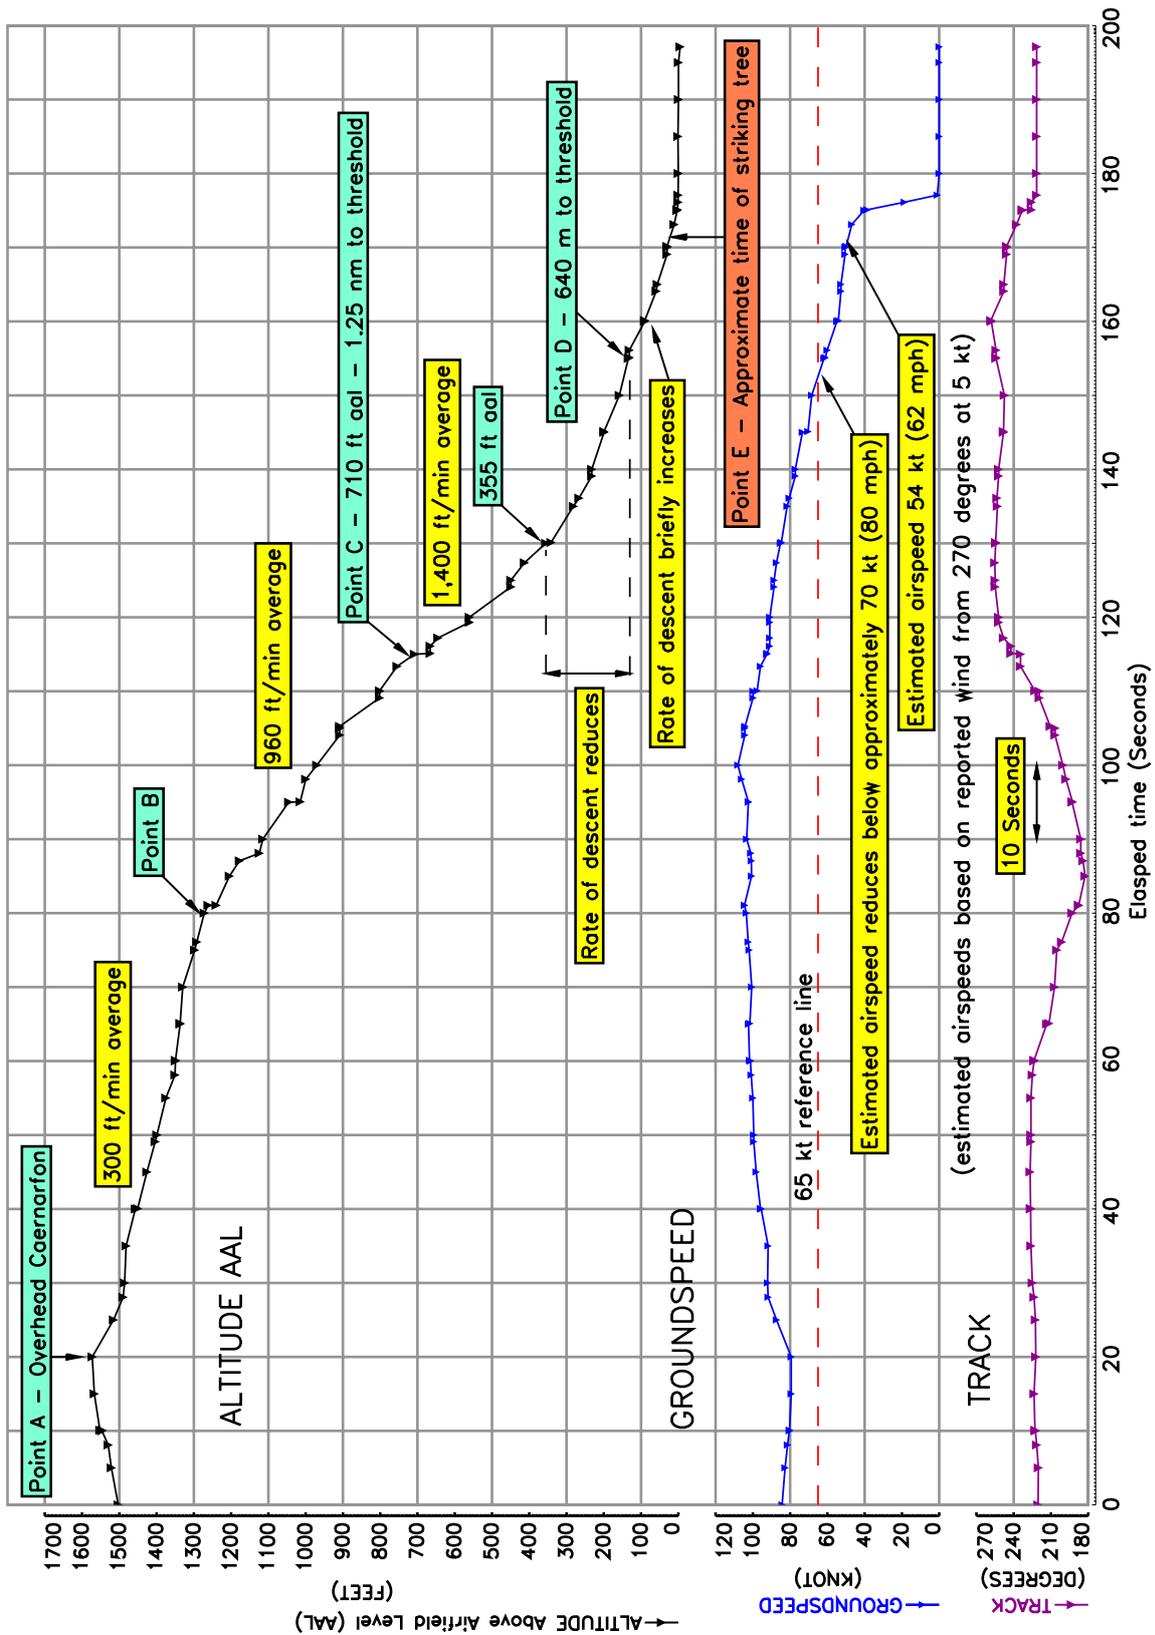
Figure 4
Time history plot of approach

At 1.25 nm from the runway threshold and 710 ft aal, the aircraft was on the final approach track, and the rate of descent increased to about 1,400 ft/min (Point C). As the aircraft approached 350 ft aal the rate of descent reduced; the aircraft was 0.87 nm from the threshold with its groundspeed 85 kt and reducing. As the approach continued, the groundspeed continued to reduce.

At about 500 m from the start of the paved surface of the runway, the aircraft was at 130 ft aal (Point D), its groundspeed was about 60 kt and the rate of descent 250 ft/min. Based on a wind from 270° at 5 kt, the airspeed would have been near 65 kt (75 mph). The descent rate then momentarily increased, whilst the groundspeed continued to reduce gradually. Shortly after, at about 80 m to the east of the paved surface of the runway, the aircraft struck the top of a tree at a groundspeed of about 49 kt (Point E - estimated airspeed 54 kt) before impacting the ground.

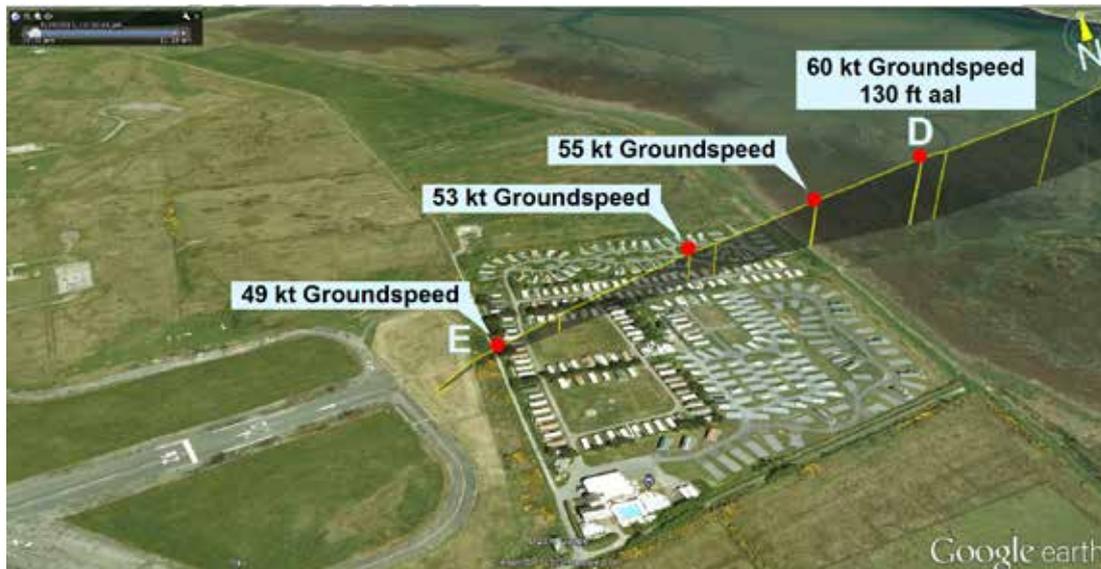
Figure 5
GPS track of final approach

To the east of Runway 26 (Figure 5), adjacent to the airfield boundary, there was a leisure park, with a number of mobile homes and caravans. At the time of the accident the park extended for 300 metres to the east of the airfield boundary.

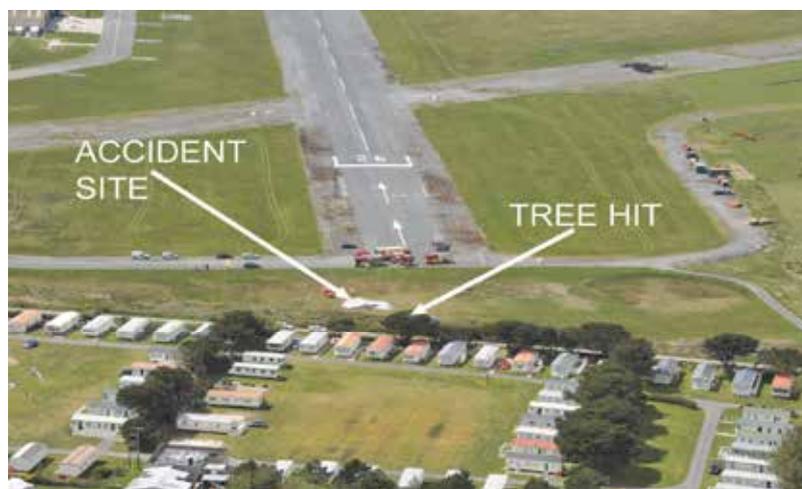
Figure 6
Accident site overview

The aircraft had struck the ground 40 m short of the start of the paved surface of Runway 26 and displaced 15 m left of the extended runway centreline (Figure 6). The ground impact attitude was about 50° nose-down with a slight left bank. Following initial impact the aircraft flipped onto its back and came to rest 2 m further forward (Figure 7). Prior to ground impact the aircraft had struck a tree located slightly south of the extended runway centreline, 80 m from the start of the paved surface of Runway 26. Only the crown of the tree had been damaged with a level cut, indicating that the aircraft had struck the tree in a near-level attitude. The tree was later surveyed to have a height above runway threshold of 9.21 m – this was after the airport had arranged for about 0.4 m to be trimmed from the top. Therefore, immediately following the accident the tree height was about 9.6 m above the runway threshold.

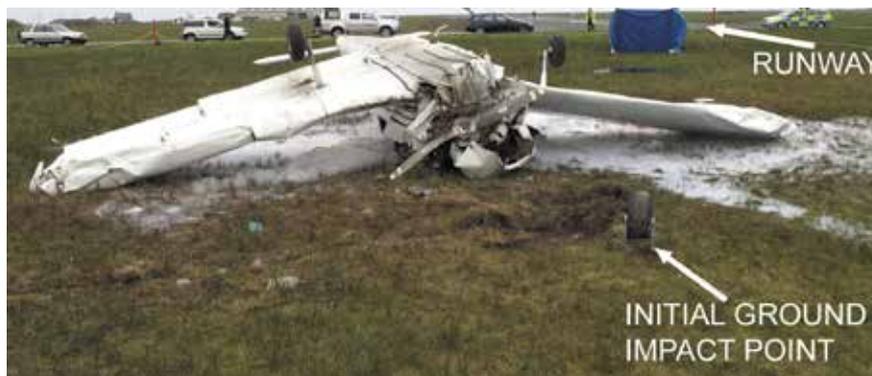
Figure 7

The aircraft suffered significant structural damage to its forward fuselage and wing leading edges and the right wing spar had failed. The propeller blades were slightly bent rearward but did not have any leading edge or tip damage. There were two clear propeller strike marks in the ground at the initial impact point, spaced about 70 cm apart. Based on an estimated impact groundspeed of 40 kt the propeller would have been rotating at about 900 rpm. If the groundspeed had been 50 kt the propeller rpm would have been about 1,100 rpm.

Accident site

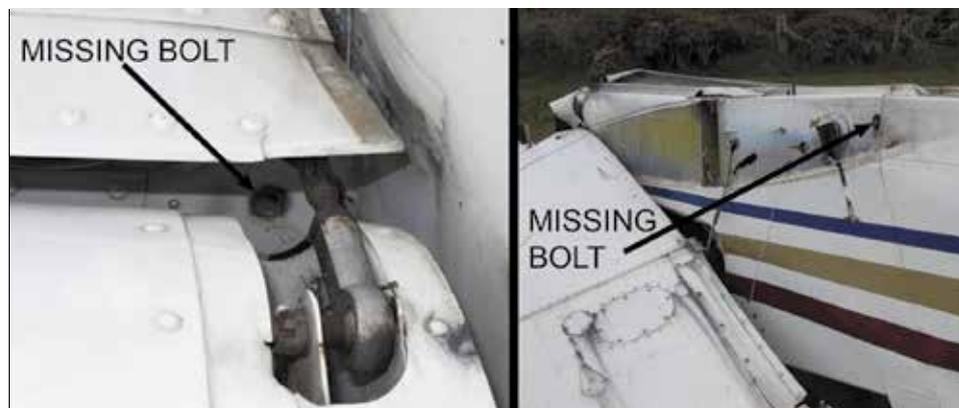
Figure 8

The right wing had failed in overload at the main spar attachment and its rear spar attachment bolt was missing (Figure 8). The bolt could not be found at the accident site and there was no damage to the holes of the attachment fittings, indicating that the bolt had probably not been present at impact. The left wing had remained attached to the fuselage but its rear spar bolt was also missing. There was no damage to the attachment fitting holes and, if the bolt had failed at impact, the forward section of bolt would probably have been trapped in the area between the wing and the lower gap strip, but it was not found there.

Missing rear spar bolts from left wing (left image) and right wing (right image)

The rear spar bolts were found to be missing and the lack of damage to the holes indicated that they had probably not fractured at impact and, at some point, had probably been

removed and not replaced. However, according to the pilot, the flight had proceeded uneventfully and he had not had any concerns about the aircraft's handling. The aircraft struck the tree following a loss of power and there was no evidence that missing rear spar bolts would have been a factor in this.
