**ACCIDENT**

<b>Aircraft Type and Registration:</b>	CAP 222 (Modified), G-GZOZ	
<b>No &amp; Type of Engines:</b>	1 Lycoming AEIO-360-A1E piston engine	
<b>Year of Manufacture:</b>	1998	
<b>Date &amp; Time (UTC):</b>	8 July 2005 at 1415 hrs	
<b>Location:</b>	White Waltham Airfield, near Maidenhead, Berkshire	
<b>Type of Flight:</b>	Private	
<b>Persons on Board:</b>	Crew - 1	Passengers - None
<b>Injuries:</b>	Crew - 1 (Fatal)	Passengers - N/A
<b>Nature of Damage:</b>	Aircraft destroyed	
<b>Commander's Licence:</b>	Airline Transport Pilot's Licence with Flying Instructor Rating	
<b>Commander's Age:</b>	43 years	
<b>Commander's Flying Experience:</b>	10,149 hours (of which 115 were on type) Last 90 days - 221 hours Last 28 days - 49 hours	
<b>Information Source:</b>	AAIB Field Investigation

**Synopsis**

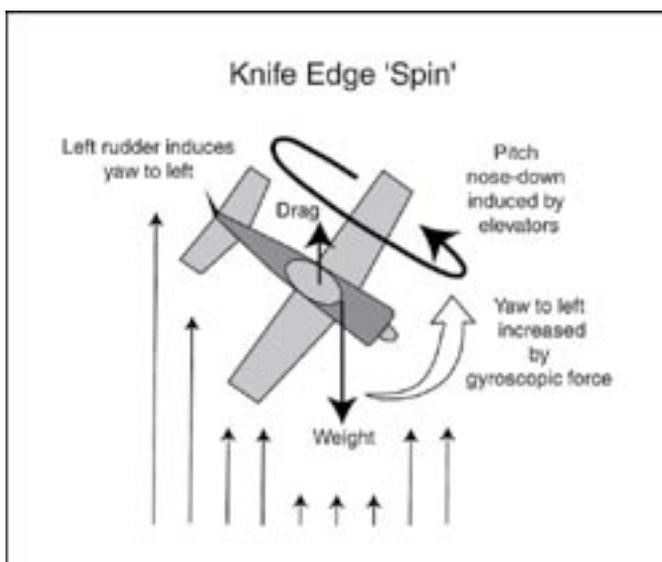
**Figure 1**

In an aircraft with a clockwise turning propeller, a knife-edge spin is usually entered from a stall turn to the left. Initially, a stall turn is flown until, when entering the descent, the moment arises when the pilot should apply opposite rudder to stop the yaw. Instead, left rudder is maintained. This makes the aircraft's nose swing through the vertical to about 45° past the vertical. With the nose in this 45° nose-up attitude, full forward control column is then smoothly applied to start the pitching motion. With high engine rpm, this pitch-down generates a large gyroscopic force which will assist the applied left rudder in holding the nose up against gravity. The forces involved are illustrated at Figure 1.

Knife Edge Spin illustration

It is possible to enter an inverted spin from a knife-edge spin if right rudder is applied while full forward elevator is maintained.

The recovery procedure is always the same; apply opposite rudder and move the control column centrally back. It is possible to reduce the power initially, to reduce the gyroscopic effects, before applying the recovery controls but this will also reduce the effectiveness of the rudder in cancelling the yaw.

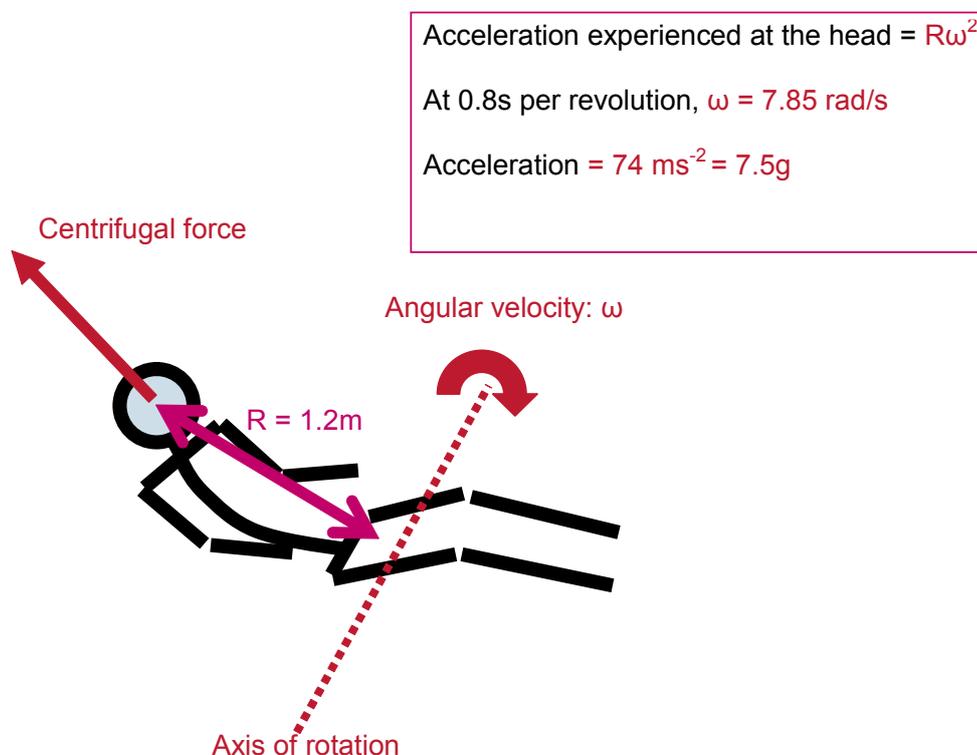
**Figure 3**

After his previous attempt, the pilot had been advised to increase the rate of rotation in the knife-edge spin. The rotation rate he achieved on his third attempt is estimated at about one turn in less than a second. The pilot's head was about 1.2 m from the axis of rotation, which passed through or close to his body. At 1 second per rotation, the acceleration at his head would have been minus 4.8g.

At 0.8 seconds per rotation, his head would have been subjected to a negative acceleration of 7.5g whilst his feet would have been close to the axis of rotation; see Figure 3 below:

Forces acting on pilot's head

Positive g sends a pilot's blood towards the lower body; negative g sends the blood upwards towards the head. The equations above illustrate that a small increase in the speed of rotation would have brought about a significant increase in the acceleration experienced.

As an experienced aerobatic pilot, the accident pilot might have been expected to tolerate minus 4g relatively well, at least for a few seconds. If he was unused to higher levels of negative acceleration, a sudden and unexpected exposure to minus 7.5g could have been very disturbing and painful, delaying his attempt to recover, making that attempt inaccurate and, perhaps, provoking an unthinking retardation of the throttle.
