ACCIDENT

Aircraft Type and Registration:	Gulfstream American GA-7, G-TANI	
No & Type of Engines:	2 Lycoming O-320-D1D piston engines	
Year of Manufacture:	1979	
Date & Time (UTC):	14 January 2007 at 1600 hrs	
Location:	Stapleford Airfield, Essex	
Type of Flight:	Private	
Persons on Board:	Crew - 1	Passengers - 1
Injuries:	Crew - None	Passengers - None
Nature of Damage:	Damage to fin and rudder	
Commander's Licence:	Private Pilot's Licence	
Commander's Age:	70 years	
Commander's Flying Experience:	1,667 hours (of which 1,095 were on type) Last 90 days - 20 hours Last 28 days - 5 hours	
Information Source:	Aircraft Accident Report Form submitted by the pilot

Synopsis

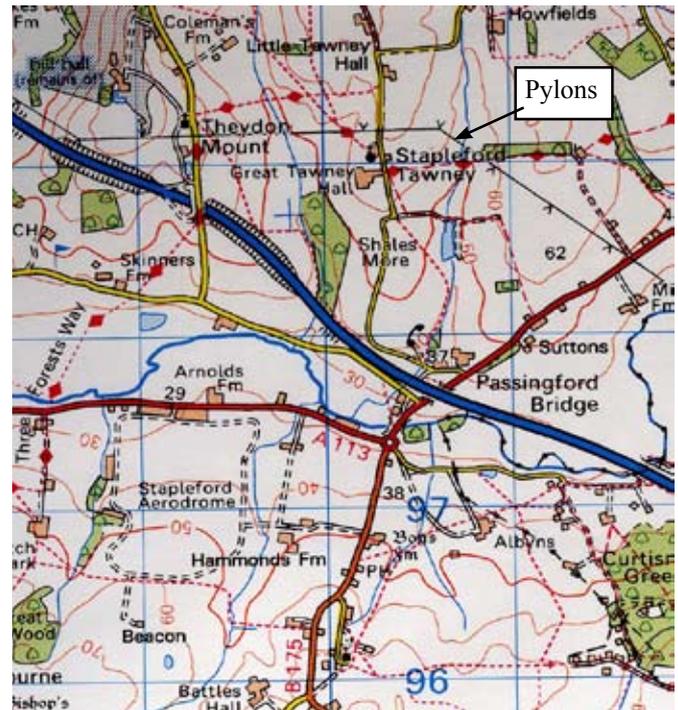
Figure 1

An external inspection of the rear of the aircraft showed extensive damage to the fin and rudder. The aircraft had passed between the earth wire and the electrical power cables suspended between the pylons. The top of the fin had contacted the earth wire.
