**GROUND MARKS AND FINAL POSITIONS OF G-AYWB AND EI-BTZ
AT GATWICK AIRPORT, 12 APRIL 1988**

HUMAN FACTORS REPORT

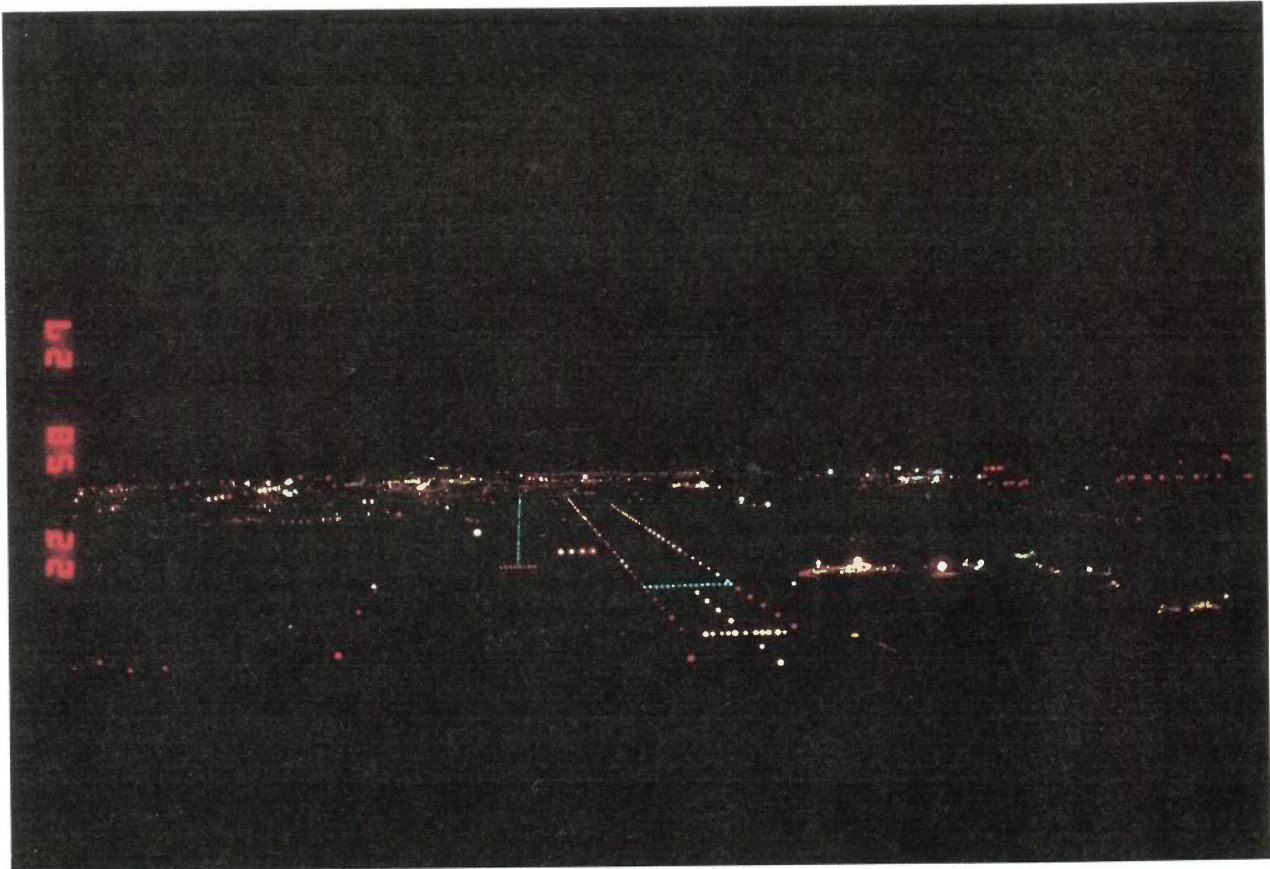
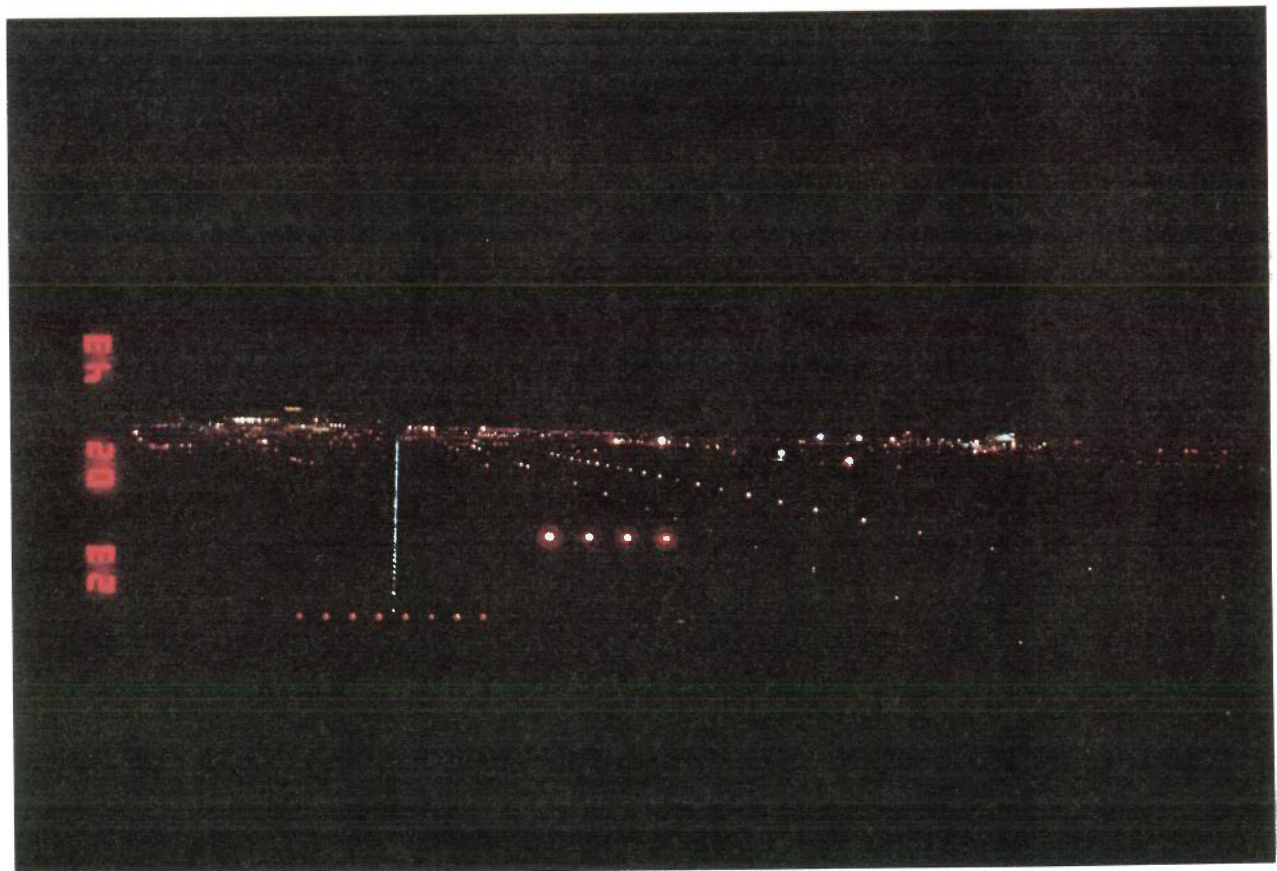
PHOTOGRAPHS OF GATWICK RUNWAY 08L AND TAXIWAY 2 LIGHTING

Runway 08L at Gatwick - the emergency runway - is also a taxiway when 08R is in use; 08R and 08L cannot be used at the same time. When 08L is configured as a runway it is marked by edge, threshold, and approach lighting, but not by centreline lighting, and appears very similar to the main runway. When it is in use as a taxiway, it is also marked by green centreline lighting - as is taxiway 2. When Gatwick is viewed from the west, at night, with the main runway in use, the dominant visual impression is of an obvious runway with taxiways to its left. Similarly, when 08L is in use, the dominant visual impression is of an obvious runway with a taxiway to its left.

The similarity between these two visual scenes is striking, and it is quite understandable that one who is familiar with Gatwick, and who knows that the emergency runway is the taxiway to the left of the main runway, could land on taxiway 2 when 08L is in operation. There can be little doubt that it is the duality of function of 08L (as both a taxiway and runway), combined with the striking visual similarity of operations with 08L and 08R that enabled this incident to occur.

There are, however, some unfortunate visual properties of taxiway 2. The first is that the centreline lighting is both bright and bi-directional making it unnecessarily conspicuous when viewed from the air. The second is that the centreline lighting on this taxiway is in the form of a terminated perfect straight line. The lights do not curve round to join the runway, and no subsidiary taxiways can be seen so the centreline lighting on this taxiway gives a clear indication of a straight, terminated surface (ie a runway). More important, and probably crucially important in the present context, is the set of red lights, the stop bar, at the western end of this taxiway. This red bar not only provides a definite end (ie a threshold) to the centreline lights, but it also confers width to the surface. If a photograph of the approach is viewed with this stop bar obliterated, all similarity between taxiway 2 and a runway disappears. The capacity for a stimulus containing only partial information about a familiar object to elicit a percept or mental model of the complete object was well known to the Gestalt school of

psychologists, and the way in which the centreline lights and stop bar of taxiway 2 are able to provide length, width, and orientational information on the implied rectangular surface is a good example of this. It is emphasised that the presence of the red stop bar normal to the centreline lights is seen as crucial in this incident.

The last point of lighting ambiguity concerns the location of the 08L PAPI. This runway has only one PAPI, situated to its left. Clearly, this would normally be entirely adequate, but it is unfortunate that this location also enables the PAPI to be interpreted as an approach aid sited to the right of taxiway 2. Thus, if a pilot had already misidentified taxiway 2 as 08L, he would be likely to be reassured by the existence of an apparently appropriate PAPI, and would, furthermore, be able to use the PAPI indications as an aid to his approach to this taxiway. It could even be argued that the apparent provision of this PAPI for taxiway 2 added to the set of cues which enabled the commander to regard it as a runway in the first instance. Such a mistake would be less likely if PAPIs were provided on each side of 08L, since their symmetry would indicate more clearly to which set of lights they belonged.
