AIB Bulletin

No: 5/86

Aircraft type and registration: BAC 1—11, type 510 G-AVMY

Location: Kastrup Airport, Copenhagen, Denmark

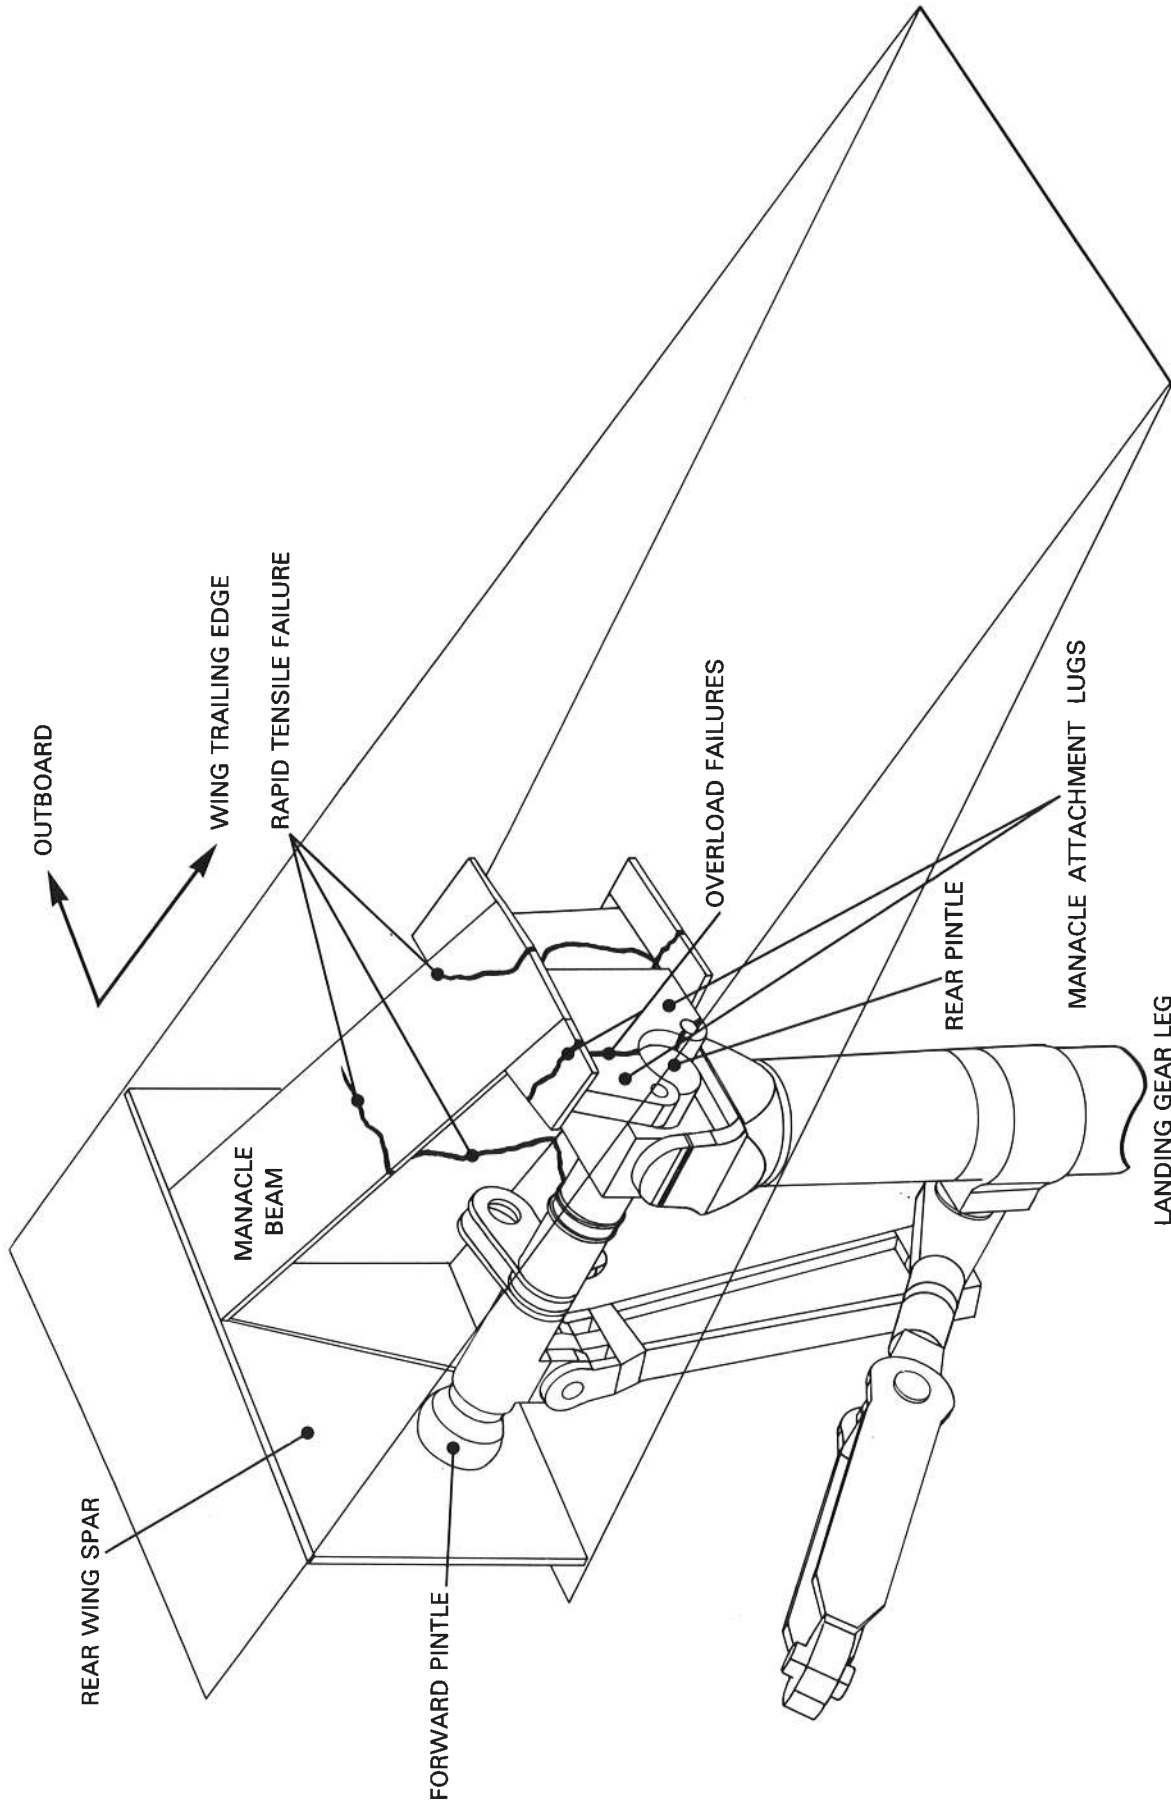
BAC 1-11 RIGHT MAIN LANDING GEAR
 (Rear Pintle Manacle Clamp not shown)

Nature of damage: Right main landing gear, right wing structure in the landing gear bay area, and superficial damage to the underside of the right wing

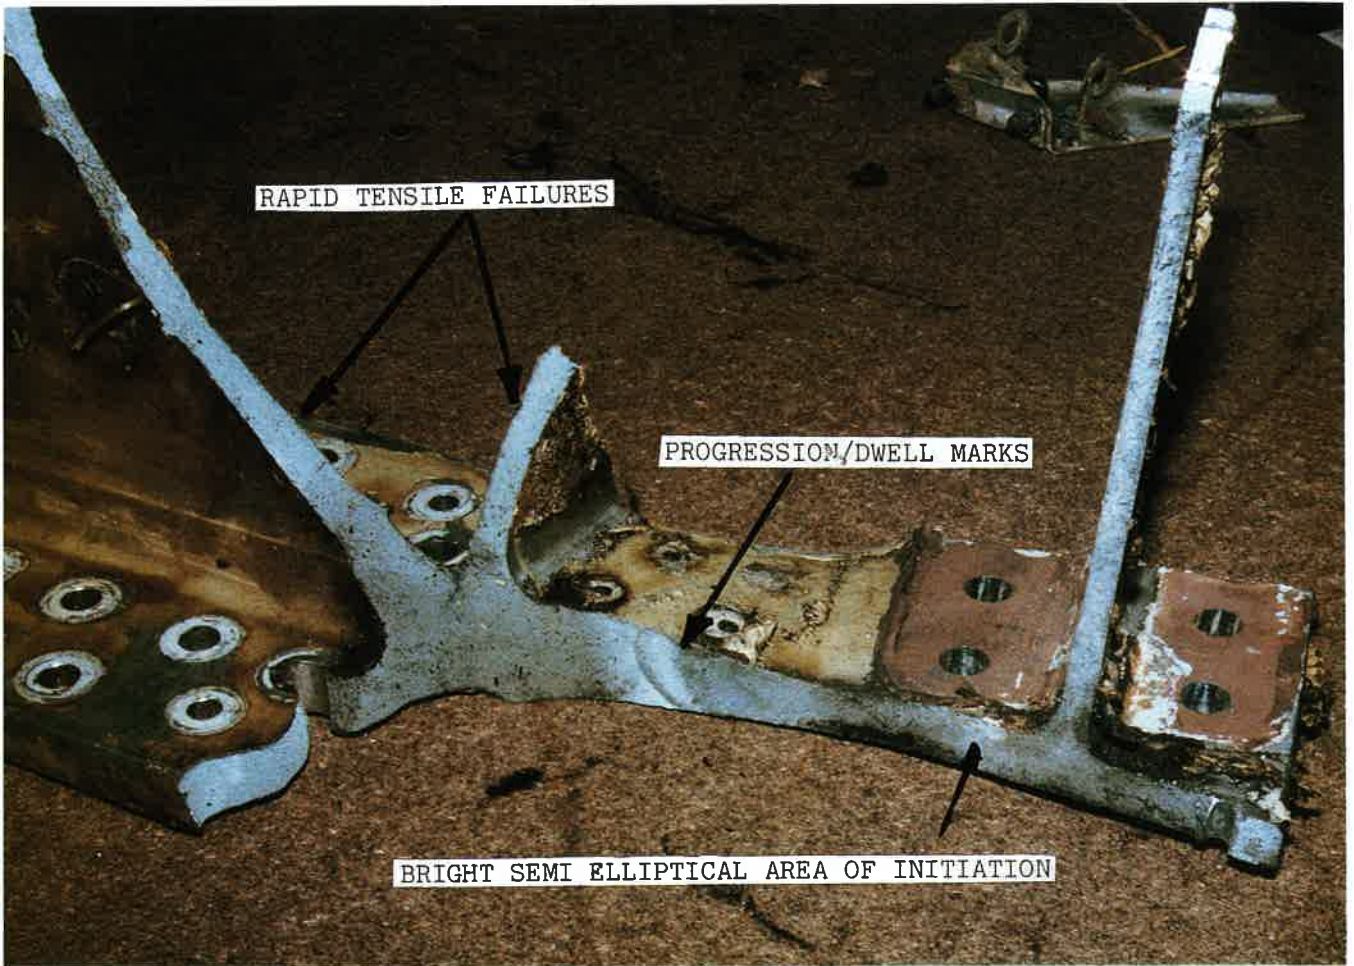
BAC 1-11 FAILED MANACLE BEAM

Detailed examination showed that the landing gear support beam (manacle beam) had failed due to stress corrosion. The failure of the manacle beam allowed forces to be applied on the manacle cap attachment lugs which were in excess of that for which they had been designed. The attachment lugs failed in overload allowing the rear landing gear pintle to move upwards. This upwards movement caused the landing gear to collapse rearwards which damaged the forward pintle bearing housing, but did not damage the integral wing fuel tanks. The failure of the manacle beam had been initiated at a small area of corrosion located approximately one inch aft of the forward edge of the bottom flange of the spanwise section of the beam, immediately inboard of the joint angles. The fracture area showed evidence of a slow crack growth mode originating at a bright flat area of fracture, roughly semi-elliptical in shape, which was typical of stress corrosion cracking. Although the fracture extending from the ellipse exhibited

progression/dwell marks, they had occurred in a predominantly tensile cracking mode. Unfortunately metallurgical examination of the failure could not determine the time taken for the crack to grow to a critical depth or the propagation time over the area of the progression/dwell marks. Evidence from the build-up of dirt along the crack line on the landing gear wing torsion box bottom stress plate indicated that an area of the manacle beam had had a crack present for some considerable time, 9 to 12 months or more.

At the time of manufacture of this manacle beam, Alocrom 1200 was used as a surface protection treatment. The area of the beam where the initial crack formed from surface corrosion pitting had no protective paint (primer, finish and lacquer) present although there was evidence of the characteristic iridescent sheen typical of the expected thin Alocrom layer. It was possible that the continual presence of hydraulic fluid over the aircraft's life removed the protective paint in that area.

The manufacturers issued a Campaign Wire, classified as mandatory by the United Kingdom Civil Aviation Authority, requiring ultrasonic and eddy current non-destructive testing to be carried out on all aircraft fitted with the same type of manacle beam. To date no other cracked beams have been found.
