Skyranger 912(1), G-CBWL

AAIB Bulletin No: 11/2004	Ref: EW/C2003/07/01	Category: 1.4
Aircraft Type and Registration:	Skyranger 912(1), G-CBWL	
No & Type of Engines:	Rotax 912 - UL DCDI piston engine	
Year of Manufacture:	2002	
Date & Time (UTC):	8 July 2003 at 1140 hrs	
Location:	Barton Airfield, Manchester	
Type of Flight:	Private	
Persons on Board:	Crew - 1	Passengers - None
Injuries:	Crew - 1 (Serious)	Passengers - N/A
Nature of Damage:	Left wing damaged. Forward fuselage disrupted. Engine shock loaded	
Commander's Licence:	Private Pilot's Licence (Aeroplanes) (Microlight only)	
Commander's Age:	60 years	
Commander's Flying Experience:	75 hours (of which 15 were on type)	
	Last 90 days - 11 hours	
	Last 28 days - 4 hours	
Information Source:	AAIB Field Investigation

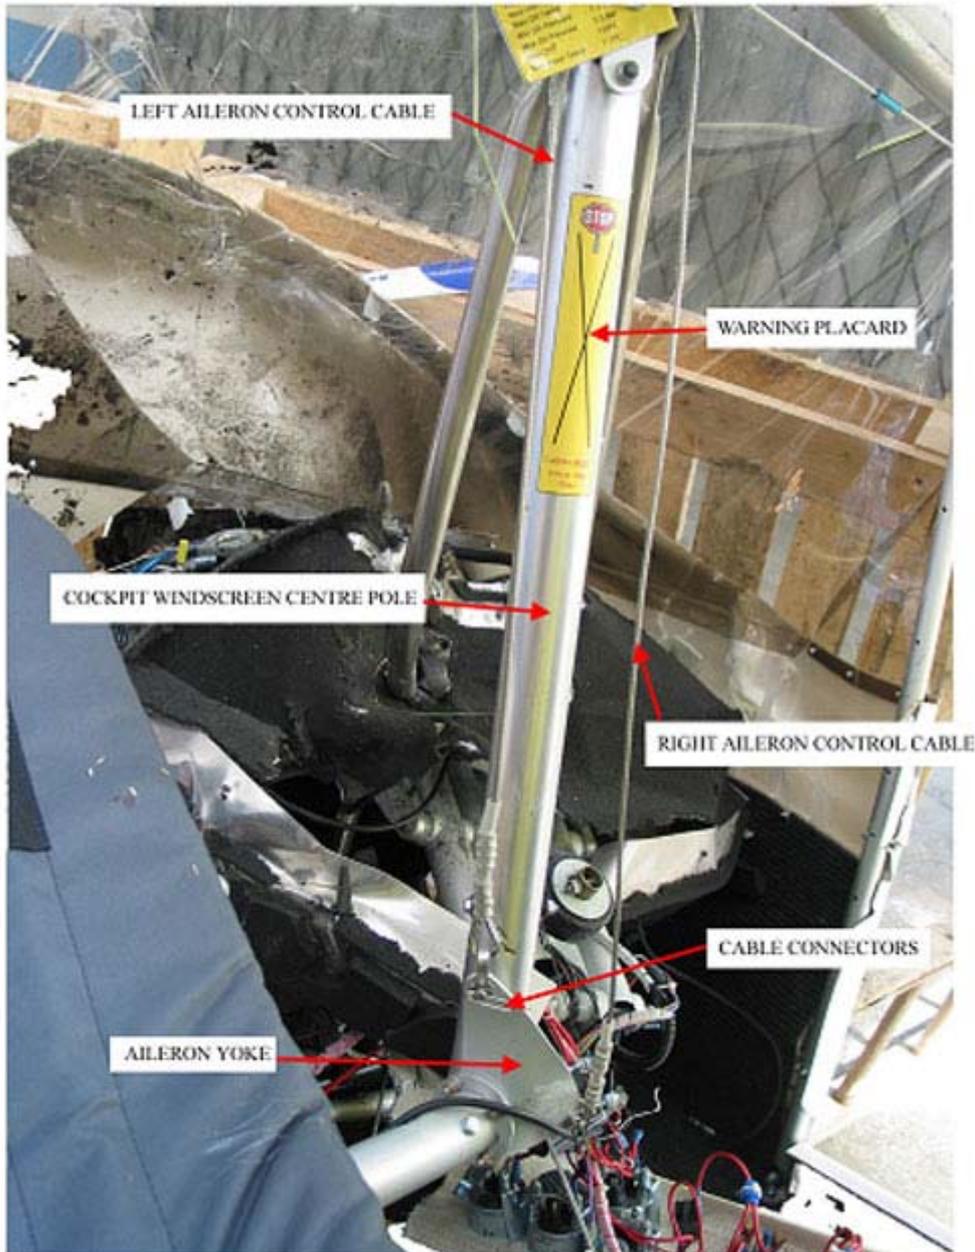
Examination of the microlight's wreckage found no evidence of pre-impact damage or failure that could have contributed to the accident. However, during the examination it was found that the aileron control cables had been incorrectly connected to the aileron yoke on the control stick, Figure 2.

Figure 2 Photograph showing incorrect connection of aileron cables to the yoke

Aileron control cables cross connected to the aileron yoke on the accident aircraft

It is recommended that the PFA and the BMAA ensure that as aircraft, which are certificated to the requirements of BCAR Section S, continue in service, no degradation of any distinctive markings applied to flight control systems connections intended to minimise the possibility of cross connection of flight controls during the aircraft rigging process, occurs.

It is recommended that the Civil Aviation Authority, in conjunction with the to British Civil Airworthiness Requirements (BCAR) Section S steering group, amend the requirements so that all elements of the flight control systems of new aircraft types certified to BCAR Section S rely solely upon design features in order to prevent flying control cables or rods being cross connected during the aircraft rigging process.

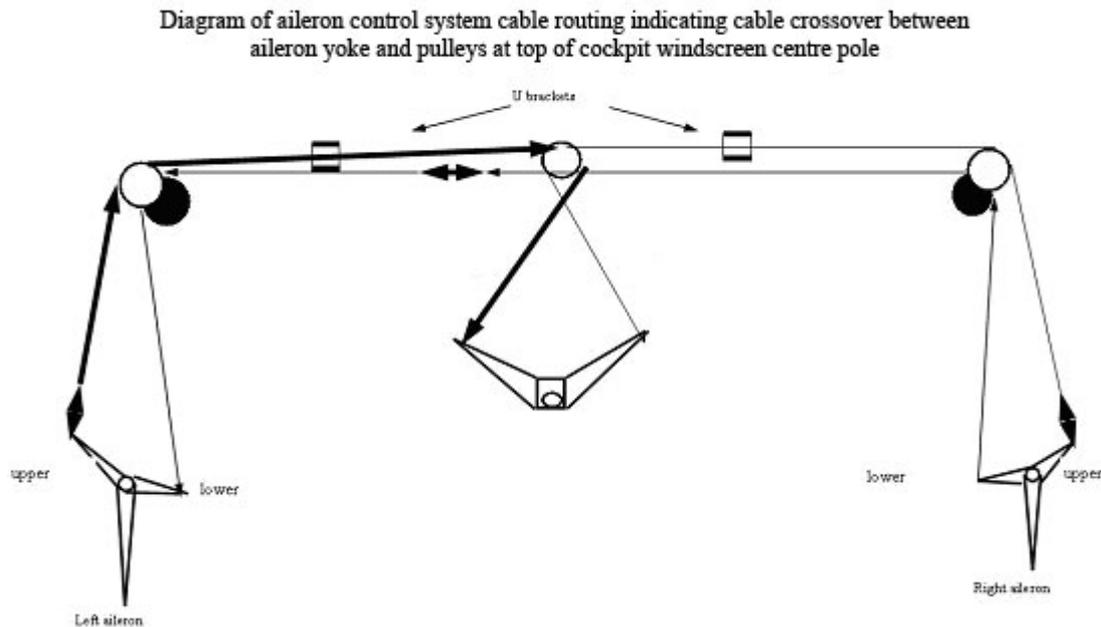
When the aileron cables are correctly fitted they cross over each other so that the left aileron cable is connected to the right-hand side of the aileron yoke and the right cable to the left-hand side of the aileron yoke, Figure 3. This area is hidden from view by the instrument panel.

Figure 3 Diagram of aileron control system cable
