**ACCIDENT**

<b>Aircraft Type and Registration:</b>	Reims Cessna F172N, G-BHDZ	
<b>No &amp; Type of Engines:</b>	1 Lycoming O-320-H2AD piston engine	
<b>Year of Manufacture:</b>	1979	
<b>Date &amp; Time (UTC):</b>	28 October 2006 at 1112 hrs	
<b>Location:</b>	900 ft above Snetterton, Norfolk	
<b>Type of Flight:</b>	Private	
<b>Persons on Board:</b>	Crew - 1	Passengers - 1
<b>Injuries:</b>	Crew - None	Passengers - None
<b>Nature of Damage:</b>	No damage incurred during forced landing, but fire damage behind instrument panel	
<b>Commander's Licence:</b>	Private Pilot's Licence	
<b>Commander's Age:</b>	45 years	
<b>Commander's Flying Experience:</b>	411 hours (of which 334 were on type) Last 90 days - 18 hours Last 28 days - 5 hours	
<b>Information Source:</b>	Aircraft Accident Report Form submitted by the pilot and additional AAIB inquiries

**Synopsis**

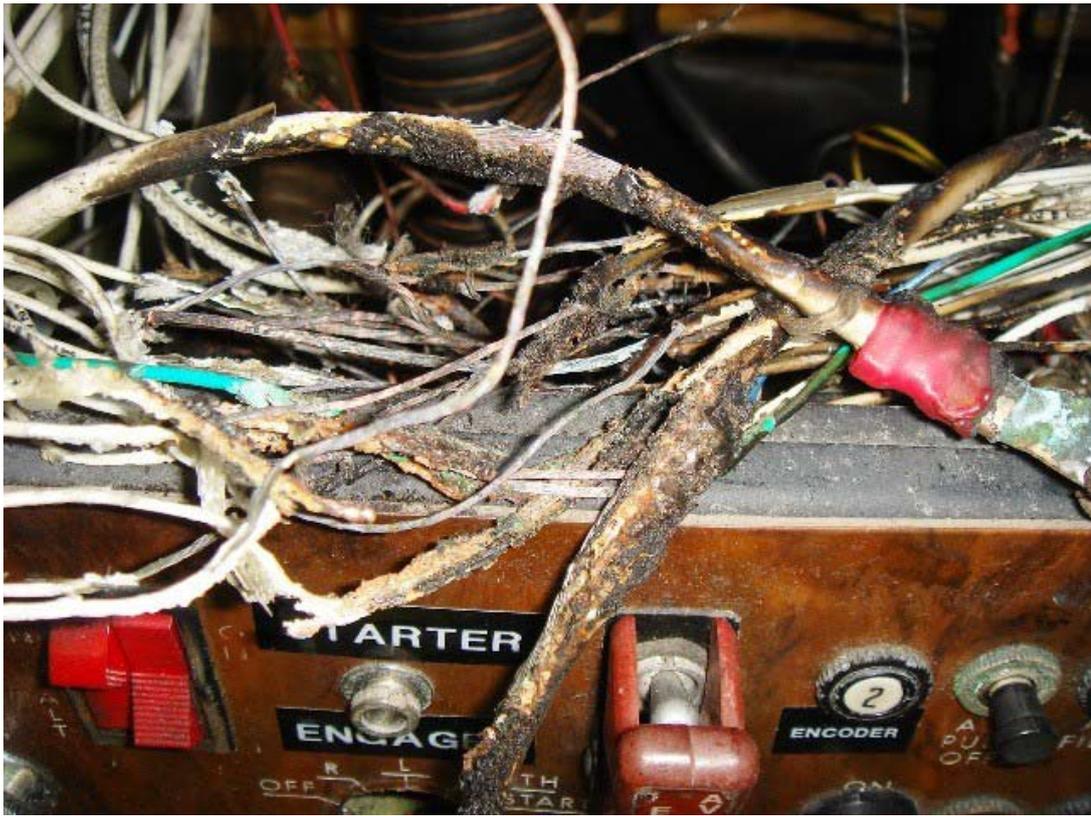
Damage to the wiring behind the instrument panel was extensive and centred on the area around the magneto/start switch and the immediately adjacent combined battery master and alternator switch. In addition, many of the instruments had been affected by heat and/or smoke, and some of the surrounding plastic trim had melted. It was established that the correct type of battery and alternator ganged switch was fitted, in that a battery OFF selection also switched off the alternator. Photographs of some of the components, including the alternator circuit breaker, are shown at Figure 1, where it can be seen that the circuit breaker casing has suffered an explosive event, with melting of the brass and copper terminal fittings on the associated feed wire.

View of wiring damage

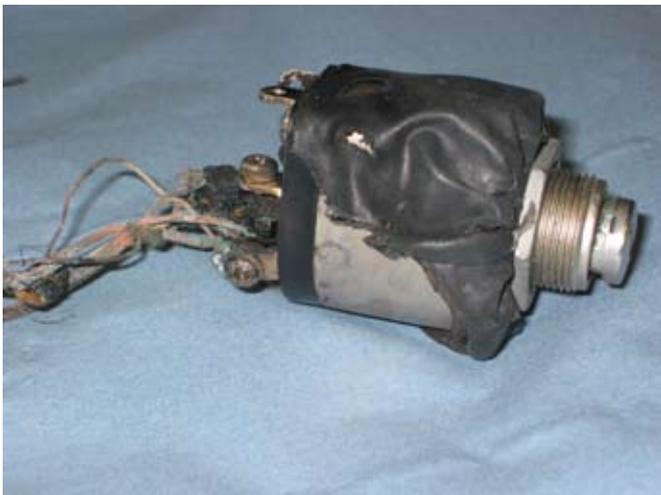
Ignition switch

The evidence suggests that the alternator circuit breaker probably tripped shortly after the engine was started, with this not being noticed by the pilot at the time. It is also likely that the poor condition of the temporary replacement battery accounted for the relatively short time period before the voltage deteriorated to the point where the fuel gauges and radio did not operate correctly. The probable failure mode of the regulator resulted in a high current being applied to the alternator field coil, and in consequence, a high alternator power output. Resetting the circuit breaker thus caused this output to be applied through the circuit breaker to the aircraft wiring, which melted the insulation and led directly to the smoke and flames. It is likely that a cascade of short-circuit conditions ensued within the wiring loom, to the extent that the pilot's action of switching off the battery master was likely to have been ineffective. Almost certainly, the cause of the engine failure was due to the grounding of the magnetos as a result of wiring damage around the magneto switch.

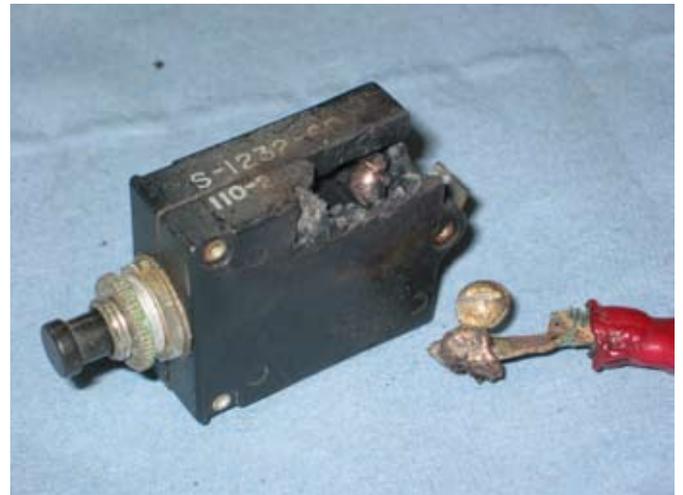
Figure 1

Alternator circuit breaker and feed wire

The action of the pilot of G-BHDZ, in resetting the circuit breaker, subjected the aircraft wiring to a high-power surge from an unregulated alternator, which in turn challenges the wisdom of attempting a once-only re-setting operation of 'heavy duty' circuit breakers whilst airborne. In single engine aircraft, the battery, assuming it is in good condition, can sustain operation of the radio, other avionic systems and lighting for more than 30 minutes from the point at which it ceases to be charged. This would normally allow sufficient time for a safe landing to be made. Accordingly, the following Safety Recommendations are made:

It is recommended that the European Aviation Safety Agency, in conjunction with the Civil Aviation Authority, publish specific information aimed at discouraging the resetting of high power circuit breakers on light aircraft, such as those that control alternators, whilst in flight unless considered essential for the safe continuation of the flight.
