**ACCIDENT**

<b>Aircraft Type and Registration:</b>	Czaw SportCruiser, G-CFPA	
<b>No &amp; Type of Engines:</b>	1 Rotax 912 ULS piston engine	
<b>Year of Manufacture:</b>	2008	
<b>Date &amp; Time (UTC):</b>	2 October 2010 at 1115 hrs	
<b>Location:</b>	East Fortune Airfield, Scotland	
<b>Type of Flight:</b>	Private	
<b>Persons on Board:</b>	Crew - 1	Passengers - None
<b>Injuries:</b>	Crew - None	Passengers - N/A
<b>Nature of Damage:</b>	Damage to leading edge of right wing, aileron and flap, propeller and wheel spat	
<b>Commander's Licence:</b>	Private Pilot's Licence	
<b>Commander's Age:</b>	33 years	
<b>Commander's Flying Experience:</b>	245 hours (of which 86 were on type) Last 90 days - 22 hours Last 28 days - 9 hours	
<b>Information Source:</b>	Aircraft Accident Report Form submitted by the pilot

**Synopsis**

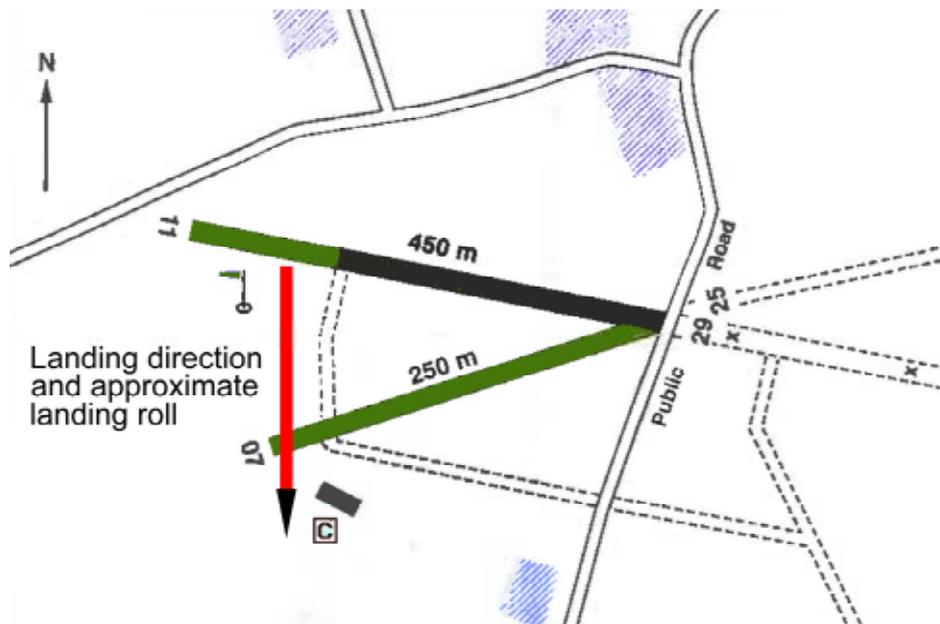
**Figure 1**

G-CFPA Landing direction and approximate landing roll

of concrete construction and the remaining 100 m grass. Near to the threshold of Runway 07 and 11 is a concrete taxiway running almost north-south, adjacent to which is a mown grass area of approximately 20 m in width and 190 m in length. At the southern end of the grass area, near the threshold of Runway 07, was an area of light vegetation bounded by a wire fence. The pilot had previously flown flex-wing microlights at the airfield and, when operating with strong northerly or southerly winds, he and other flex-wing microlights had occasionally used the grass area for landing. He had also previously landed G-CFPA at East Fortune, but not on the north-south grass area. The airfield operator advised that it was aware that the area was occasionally used for landing, but had not published information on it.

decided to land in a southerly direction on the grass area. The final approach appeared normal, flown at about 50 kt with full flap selected, but shortly before touchdown, he noticed that the wind speed had reduced. The pilot stated that his groundspeed was higher than expected and upon touchdown he had applied heavier than normal braking. Both mainwheels subsequently locked and the aircraft skidded. The aircraft is equipped with a castering nosewheel, with main directional control on the ground accomplished by differential mainwheel braking. As the aircraft neared the end of the grass area, he attempted to turn the aircraft, but it continued straight ahead before striking the wire fence, which caused the engine to stop and the aircraft to come to a halt. The pilot was uninjured and exited unaided through the canopy door. The propeller, right wheel spat, right wing leading edge, aileron and flap were damaged.

The pilot considered that he should have aborted the landing and, having established that the winds were within crosswind limits, landed on Runway 29. To assist pilots in determining the suitability of the grass areas for landing, the airfield operator advised that it would review the publication of additional airfield information.
