DH82A Tiger Moth, G-ANHK

AAIB Bulletin No: 11/2003	Ref: EW/G2003/04/12	Category: 1.3
Aircraft Type and Registration:	DH82A Tiger Moth, G-ANHK	
No & Type of Engines:	1 De Havilland Gipsy Major 1 piston engine	
Year of Manufacture:	1939	
Date & Time (UTC):	17 April 2003 at 1115 hrs	
Location:	Bromsgrove Farm, Pewsey, Wiltshire	
Type of Flight:	Private	
Persons on Board:	Crew - 1	Passengers - None
Injuries:	Crew - None	Passengers - N/A
Nature of Damage:	Propeller, engine cowling, cockpit floor and left wing tips	
Commander's Licence:	Private Pilot's License	
Commander's Age:	55 years	
Commander's Flying Experience:	1,078 hours (of which 263 were on type)	
	Last 90 days - 6 hours	
	Last 28 days - 1 hour	
Information Source:	Aircraft Accident Report Form submitted by the pilot, telephone enquiries by the AAIB and metallurgical examination of failed component

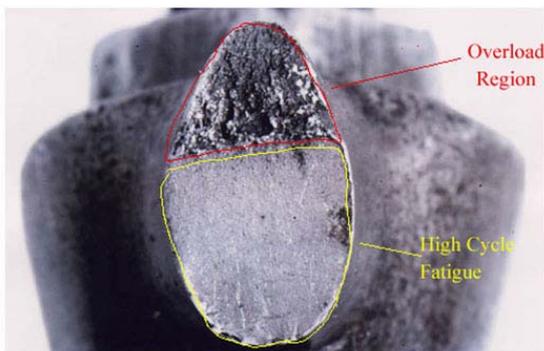
Figure 1

Examination of the engine by a maintenance organisation revealed that the No 2 cylinder inlet rocker arm had failed close to the exhaust valve, with the separated portion having become jammed in the exhaust guide. The broken pieces of the rocker arm, which were returned to the AAIB for metallurgical examination, revealed a high cycle fatigue failure (see Figure 1), which had initiated in a region of mechanical damage (see Figure 2).

Fracture surface indicating high cycle fatigue failure

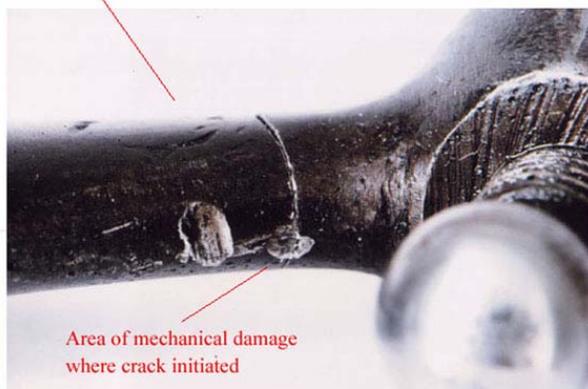
Figure 2

Plane of separation of Rocker Arm coincident with area of mechanical damage

The aircraft, fitted with this engine, had been operated by the current owner for some 30 years with low utilisation. The engine had completed 670 hours since overhaul, but only 170 hours since 1978. The last entry in the log book for maintenance, which would have entailed removal of the cylinders and thus the rocker arm, was in 1990. It was not possible to determine when or how the damage to the rocker arm occurred.
