<b>Aircraft Type and Registration:</b>	Enstrom 280c, G-BRPO	
<b>No &amp; Type of Engines:</b>	1 Lycoming HIO-360-E1AD piston engine	
<b>Year of Manufacture:</b>	1977	
<b>Date &amp; Time (UTC):</b>	18 July 2004 at 1240 hrs	
<b>Location:</b>	Near Oulton Park Racing Circuit, Cheshire	
<b>Type of Flight:</b>	Private	
<b>Persons on Board:</b>	Crew - 1	Passengers - None
<b>Injuries:</b>	Crew - None	Passengers - N/A
<b>Nature of Damage:</b>	Substantial damage	
<b>Commander's Licence:</b>	Private Pilot's Licence	
<b>Commander's Age:</b>	42 years	
<b>Commander's Flying Experience:</b>	145 hours (of which 137 were on type) Last 90 days - 3 hours Last 28 days - 3 hours	
<b>Information Source:</b>	AAIB Field Investigation

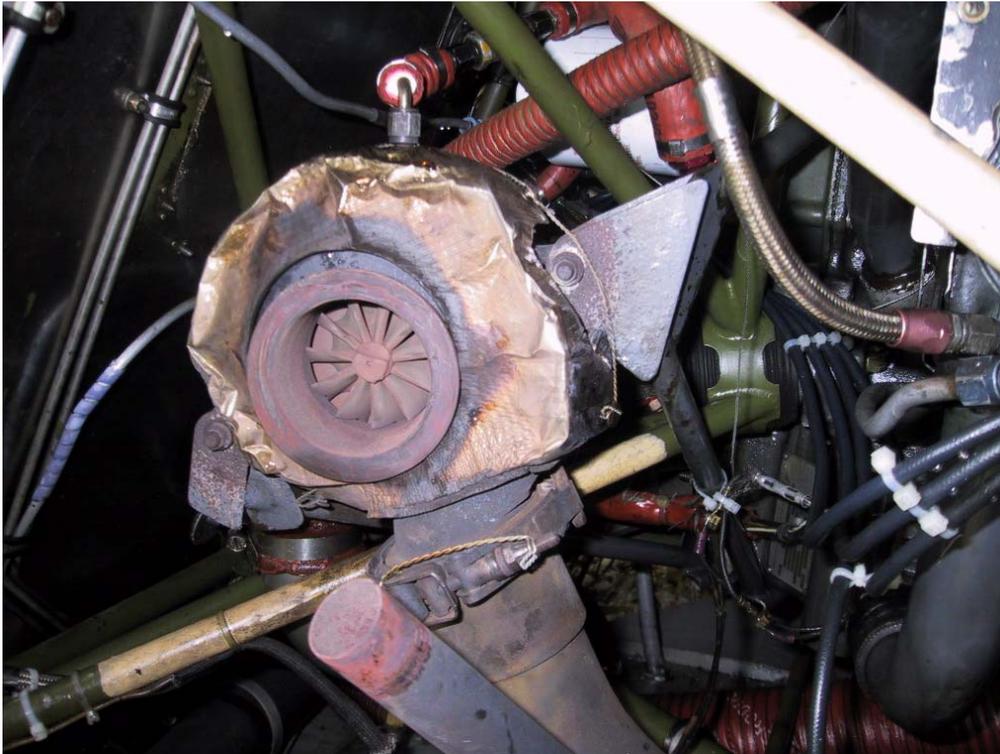
**Figure 1**

The engine was turbo-charged, and the outlet from the turbocharger passes via a short exhaust pipe through an aperture in the skin to dump overboard. This pipe (Figure 1) was detached from the turbocharger, allowing the exhaust to impinge directly on the inside of the skin, resulting in the local overheating previously mentioned. The pilot had assumed that this had been dislodged in the landing, however the clamp securing it (Figure 2) had fractured in fatigue, allowing it to become dislodged in flight. This pipe also connected to a bypass pipe from the engine exhaust system, and once dislodged this allowed exhaust from close to the cylinders to be directed at the bulkhead immediately behind the pilot. The entire engine compartment would have filled with exhaust fumes, accounting for smoke in the cockpit.

Turbocharger outlet and disconnected bypass pipe  
(To the left is the bulkhead behind the left seat)

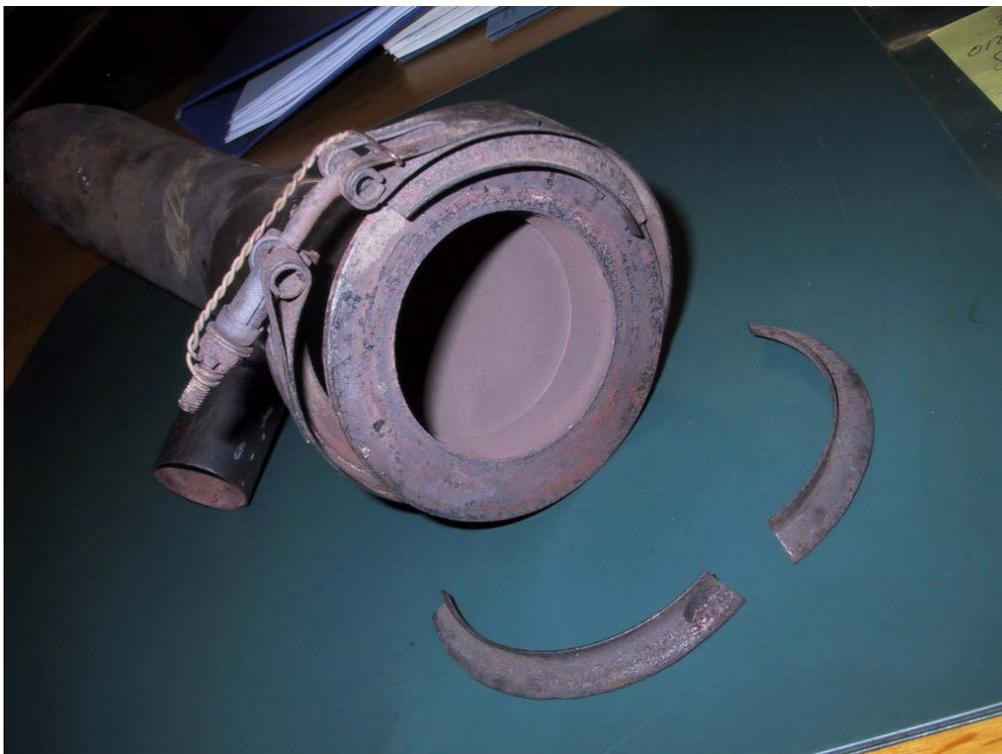
**Figure 2**

The manufacturer's agent advised that fractures of this type of clamp are rare, and that in this particular case the clamp appeared to be quite old. There is, however, no requirement to change it if it appears serviceable.

Fractured clamp and detached exhaust outlet pipe
