AAIB Bulletin No: 12/95

Ref: EW/G95/07/19

Aircraft Type and Registration: Renegade Spirit UK, G-MWNR

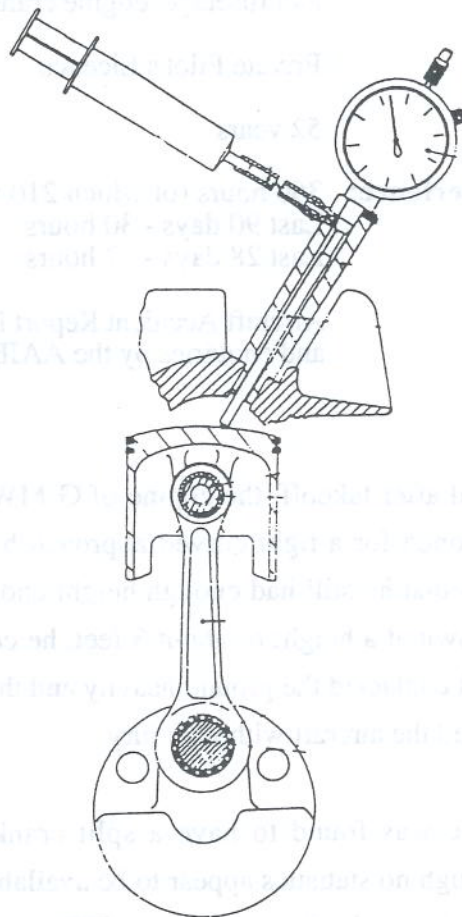
Called the 'Cyclone Conrod Bearing Clearance Tester' the device is illustrated in Figure 1. Essentially it is a dial gauge mounted on an extension tube which screws into the spark-plug holes and bears on the piston crown at top dead centre. A syringe is used to suck/blow the piston up and down and the difference in gauge readings is converted into combined bearing clearance. It is recommended that this check be performed every 12.5 flight hours when the plugs should be removed for inspection in accordance with the Rotax service schedule. Maximum wear figures are given with the instrument but records should also be kept so that any trend can be detected in advance. It is understood that the Popular Flying Association agree that this device has been effective in preventing failures of this nature and intend to publish an article to this effect in their magazine *Popular Flying*.

Figure 1 The Cyclone Conrod Bearing Clearance Tester for Rotax engines
