Sikorsky S76C Spirit, G-JCBJ

AAIB Bulletin No: 5/2004	Ref: EW/C2003/10/02	Category: 2.2
Aircraft Type and Registration:	Sikorsky S76C Spirit, G-JCBJ	
No & Type of Engines:	2 Turbomeca Arriel 2S1 turboshaft engines	
Year of Manufacture:	1999	
Date & Time (UTC):	11 October 2003 at 1200 hrs	
Location:	Cranfield Airfield, Bedfordshire	
Type of Flight:	Training	
Persons on Board:	Crew - 2	Passengers - None
Injuries:	Crew - None	Passengers - N/A
Nature of Damage:	Structural damage to the tail cone	
Commander's Licence:	Airline Transport Pilot's Licence	
Commander's Age:	53 years	
Commander's Flying Experience:	11,800 hours (of which 1,920 were on type)	
	Last 90 days - 101 hours	
	Last 28 days - 28 hours	
Information Source:	AAIB Field Investigation

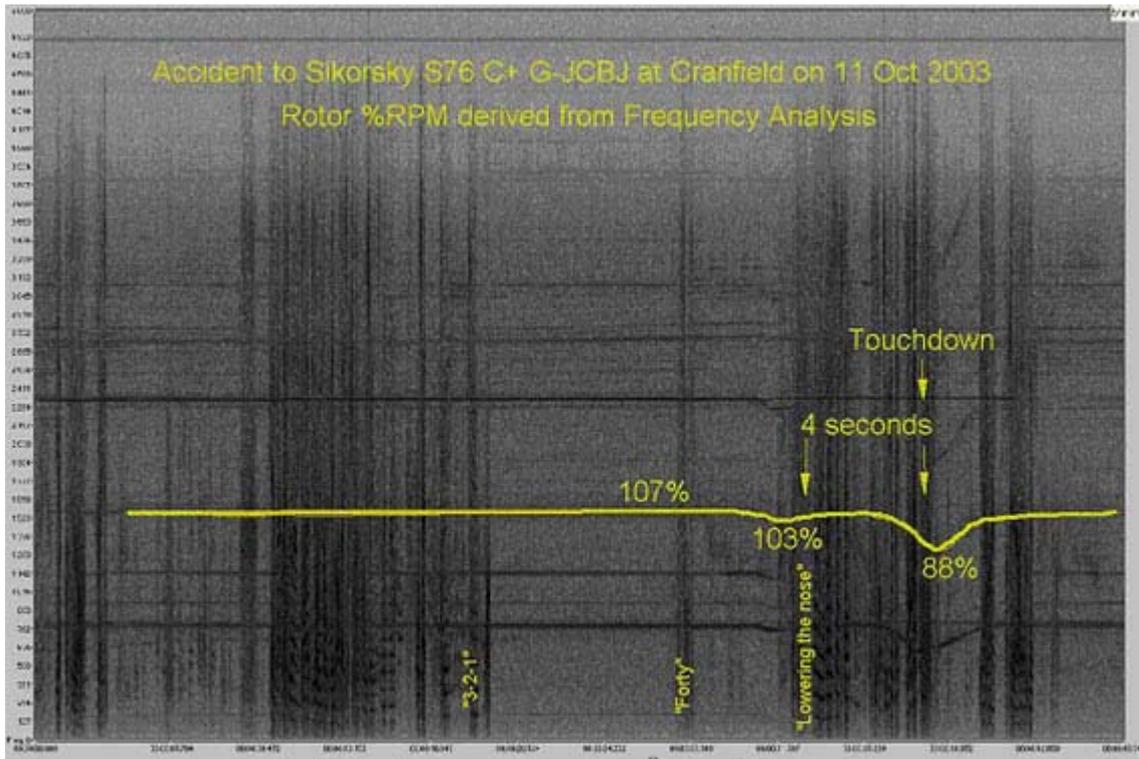
Rotor %RPM derived from frequency analysis

Spectral analysis of the CVR recording (Figure 1) showed the N_r in the climb to be within the normal governed range at 107%. About nine seconds after the beginning of the manoeuvre the N_r reduced to 103% and then recovered to about 107% over the next four seconds before reducing again to 88% during the landing. The handling pilot announced that he was "LOWERING THE NOSE" just after the N_r reached 103% and two seconds later he stated "THIS DOES NOT LOOK PARTICULARLY GOOD". Two seconds later the helicopter could be heard landing heavily. The total elapsed time from the start of the climb to the landing was about 16 seconds. The descent from the estimated apex of the manoeuvre to the ground took about five seconds.
