No: 3/91

Ref: EW/C1185

Lockheed L1011-500 Tristar, C-GAGI

Rupture of gore panel in rear pressure bulkhead

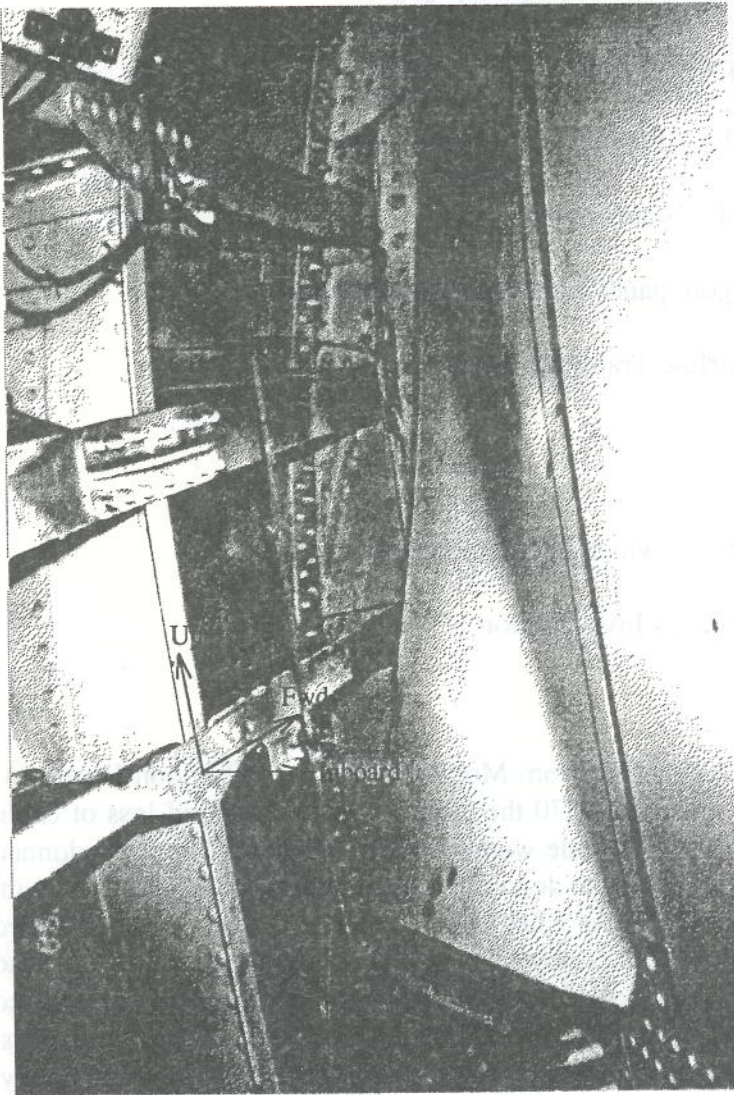
After landing, an inspection of the aft toilet compartments revealed that one of the decorative wall panels had been pushed back towards the rear pressure bulkhead, causing the corners of the panel to split. Fibreglass insulation material was hanging from access panel grills on the fuselage skin beneath the tailplane centre section, and additional insulation could be seen distributed around the interior of the rear fuselage aft of the rear pressure bulkhead. An inspection of the aft side of the rear pressure bulkhead revealed that it had ruptured near the outer edge of the 8-9 o'clock gore panel, allowing a rectangular element approximately 2ft high by 1ft wide to flap outwards, as shown in fig 1.

Fig 1
Bulkhead rupture
(View looking forward onto rear
face of bulkhead, adjacent to
fuselage side)

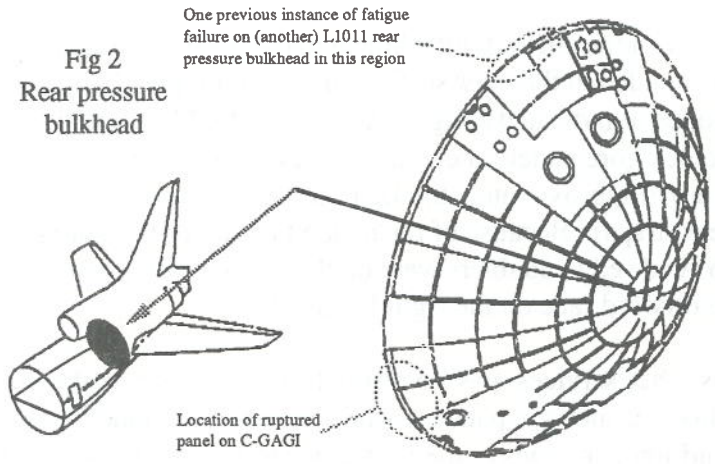
The rear pressure bulkhead was a thin shell structure comprising a series of 0.040" thick gore panels lap-jointed to form a pressure membrane, with additional doublers and anti-tear straps, producing a bulkhead of spherical pro

file as shown in fig 2.

Only one prior instance of rear pressure bulkhead rupture on L1011 aircraft is recorded, in which a slightly smaller "D" shaped rupture was produced adjacent to the 6" wide edge doubler at the top of the bulkhead, in the area indicated in fig 2.

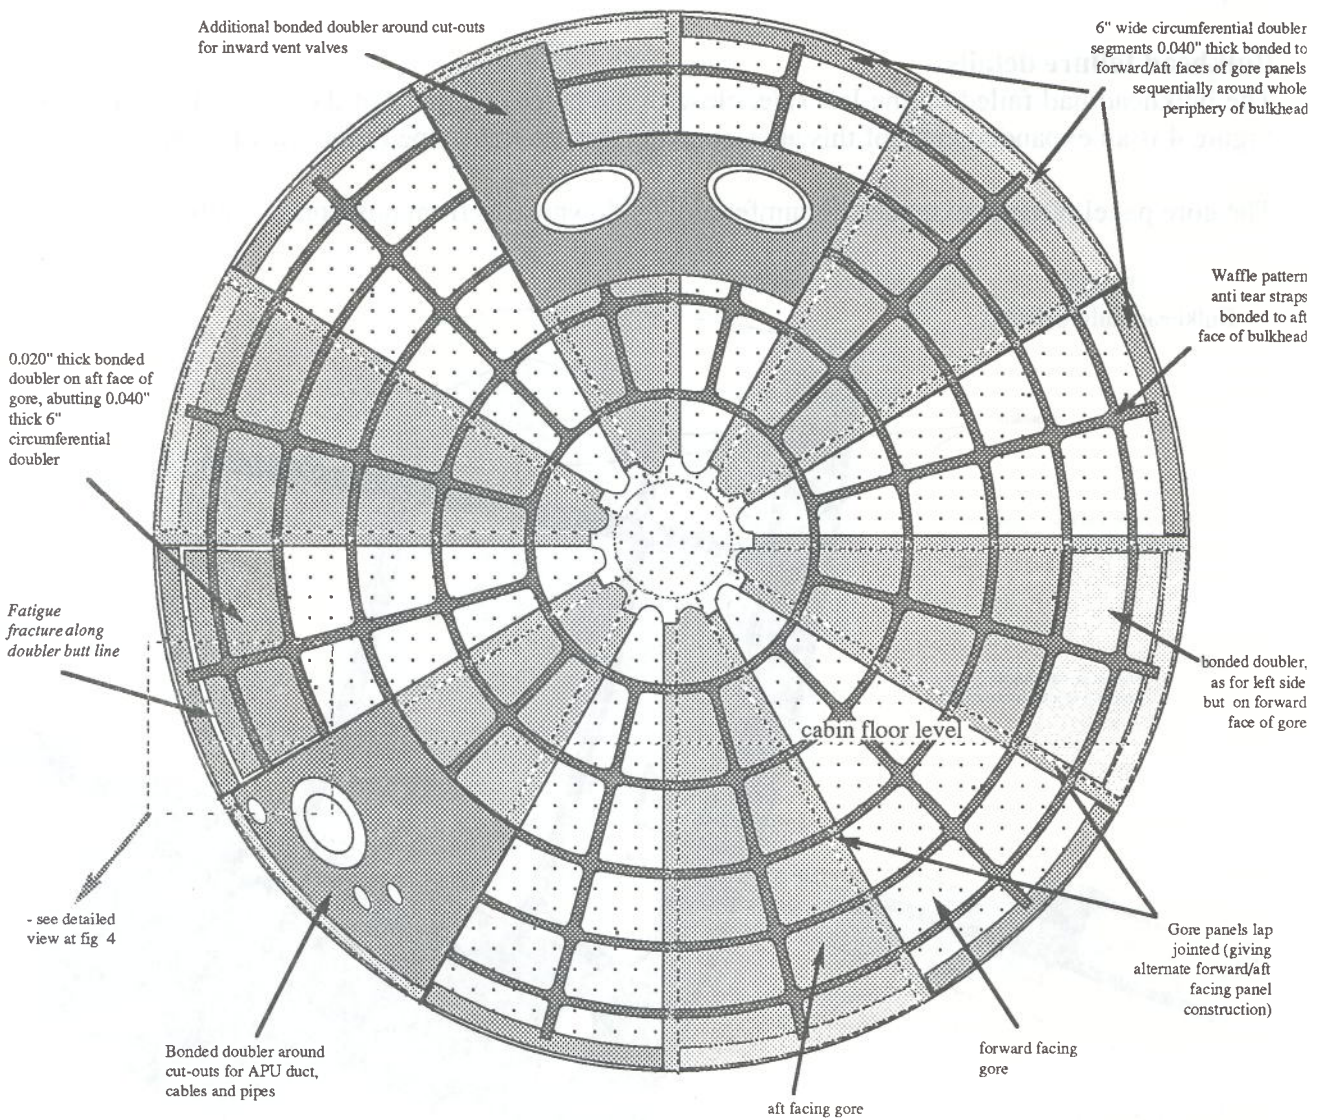
Constructional details are shown in fig 3. The gore panels were lap jointed alternately on the forward and aft sides of the nominal membrane surface, producing a handed form of construction. A series of radial and circumferential anti-tear straps, bonded in a typical *waffle* pattern to the aft face of the bulkhead, subdivided each of the gore panels into ten elements of approximately rectangular shape.

Fig 3
Constructional details of Lockheed L101-500 series rear pressure bulkhead (view looking forward)

Around the outer circumference of the bulkhead, adjacent to its attachment to the fuselage proper, were a series of 6" wide by 0.040" thick doublers bonded to the *back* surface of each gore panel, mirroring the constructional form of the gore panels proper, as indicated in fig 3. Additional doublers 0.020" thick were bonded to the 8-9 o'clock and 3-4 o'clock gore panels at cabin floor level, abutting the 6" wide circumferential doubler, and extending inboard to approximately the 1/3 radius position (ie over the two outermost grid panels formed by the anti-tear straps). Because of the handed nature of the gore panel lap-joints, these doublers and the adjacent 6" wide edge doublers were on the aft face of the gore panel on the left hand side of the aircraft, and the forward face on the right hand side.

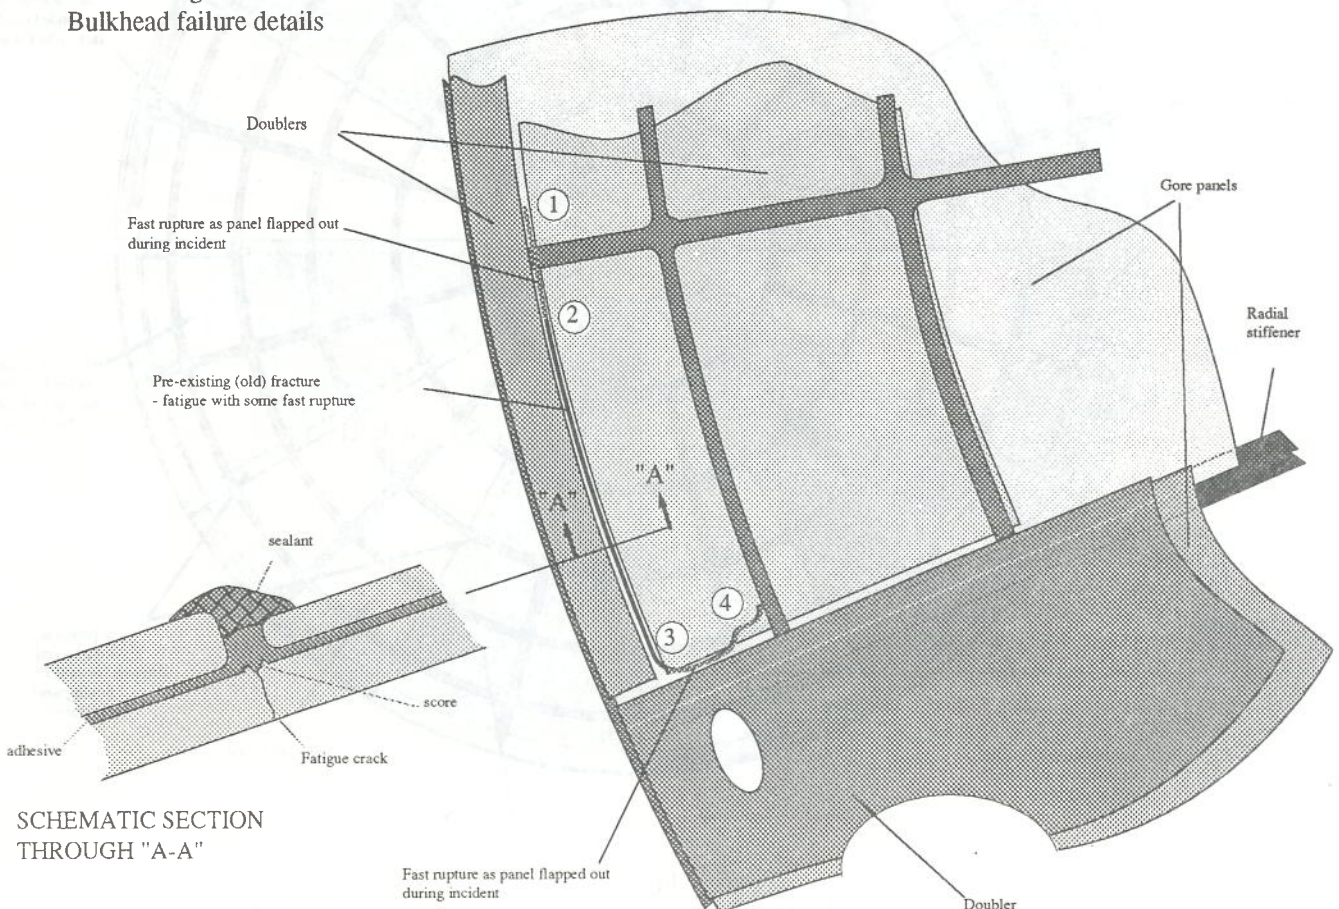
Fig 4
Bulkhead failure details

The bulkhead had failed on the left side, close to the outer periphery of the 8-9 o'clock gore panel. Figure 4 is an expanded view of this area, showing the general shape of the fracture path.

The gore panel fracture extended circumferentially downwards from position "1", along the joint line

between the 6" wide 0.040" thick doubler and the adjacent 0.020" thick bonded doubler panel, to the bottom of the panel at position "3". It then turned inboard and ran along the radial stiffener frame as far as the next circumferential anti-tear strap at position "4", before turning upwards, along the circumferential strap, for a short distance.

Evidence of dirt on the fracture faces suggested that approximately 18" of the circumferential fracture had existed for some time prior to the final rupture. This pre-existing, or *old*, fracture is shown as the solid black line in fig 4, extending from position "2" to position "3". The radial fracture (grey fracture line from "3" to "4") and the uppermost 6" of the circumferential fracture (grey fracture line from "2" up to "1") appeared to be fast rupture immediately preceding, or contemporary with, the *blow-out* event.

Microscopic examination of the fatigue fracture region revealed clear evidence of a score line on the aft face of the gore panel between the doublers, as shown diagrammatically at section "A-A" in fig 4. The score extended over the whole of the fatigue fracture region and slightly beyond, a total distance of approximately 15". Adhesive, of a type visually similar to that used to bond the doublers to the gore panel, could be seen filling the score channel in many areas.

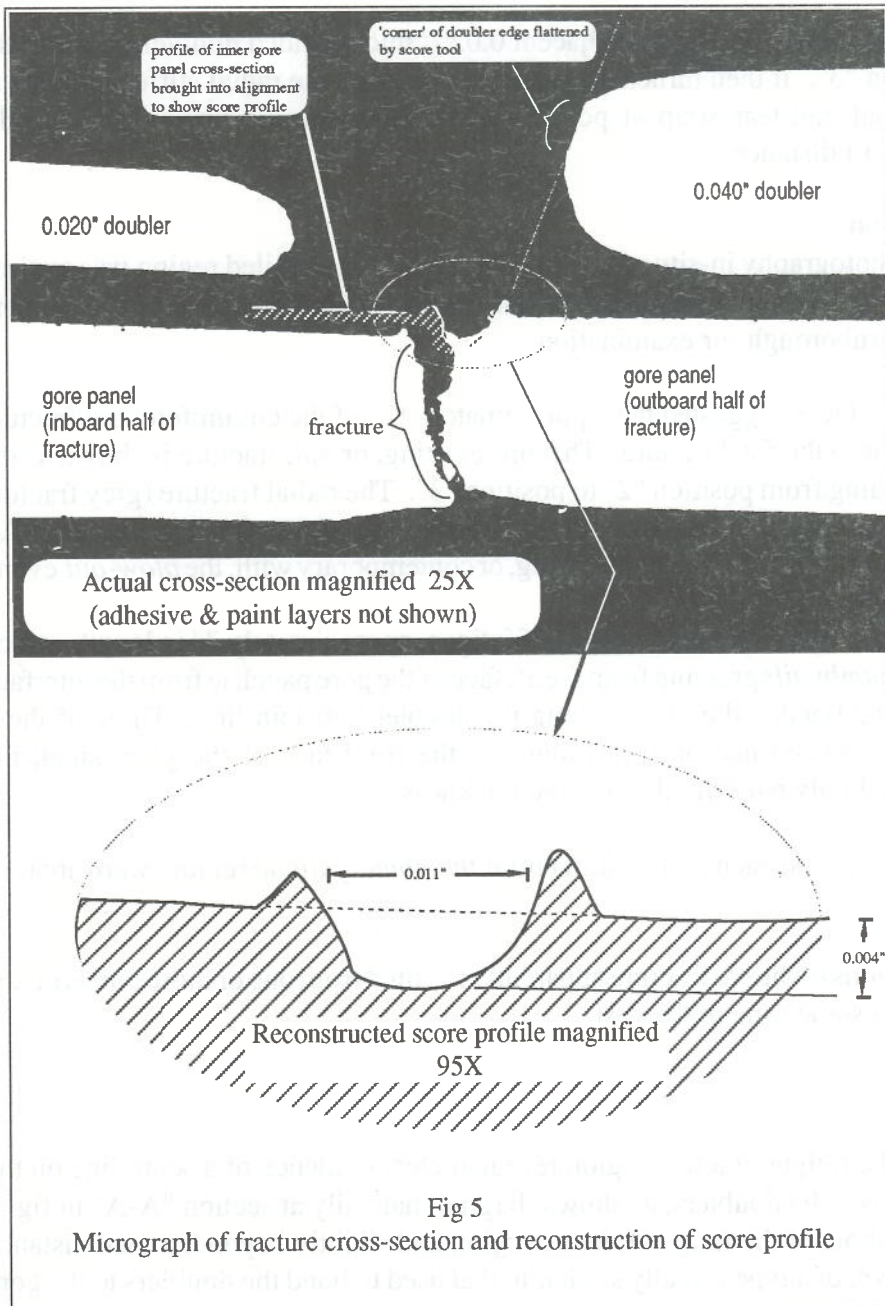
Microscopic examination of sections cut from the fracture/score line area indicated that the score was produced by some form of tool which had been drawn along the edge of the 6" doubler, producing the score channel itself and also throwing up material at the sides of the score channel. The score cross-section is clearly evident in the micrograph reproduced in fig 5, one of three sections taken through the fatigue fracture region.

The sections indicated a score depth of the order of 0.004" to 0.010", and 0.012" to 0.016" wide.

The maintenance and repair documentation for the aircraft did not record any remedial work on the bulkhead during its period in service; however, the paint/adhesive/sealant layers suggested that the score was produced during manufacture.
