AAIB Bulletin S4/2006

ACCIDENT

Aircraft Type and Registration:	Pegasus Quantum 15-912, G-BYNO
No & Type of Engines:	1 Rotax 912 piston engine
Year of Manufacture:	1999
Date & Time (UTC):	5 April 2006 at 1225 hrs
Location:	Clench Common Airfield, near Marlborough, Wiltshire
Type of Flight:	Training
Persons on Board:	Crew - 1 Passengers - 1
Injuries:	Crew - 1 (Serious) Passengers - 1 (Serious)
Nature of Damage:	Aircraft destroyed and barn roof damaged
Commander's Licence:	Private Pilot's Licence with Microlight Flying Instructor rating
Commander's Age:	49 years
Commander's Flying Experience:	14,000 hours approximately Last 28 days - 8 hours
Information Source:	AAIB Field Investigation, with the participation of the British Microlight Aircraft Association

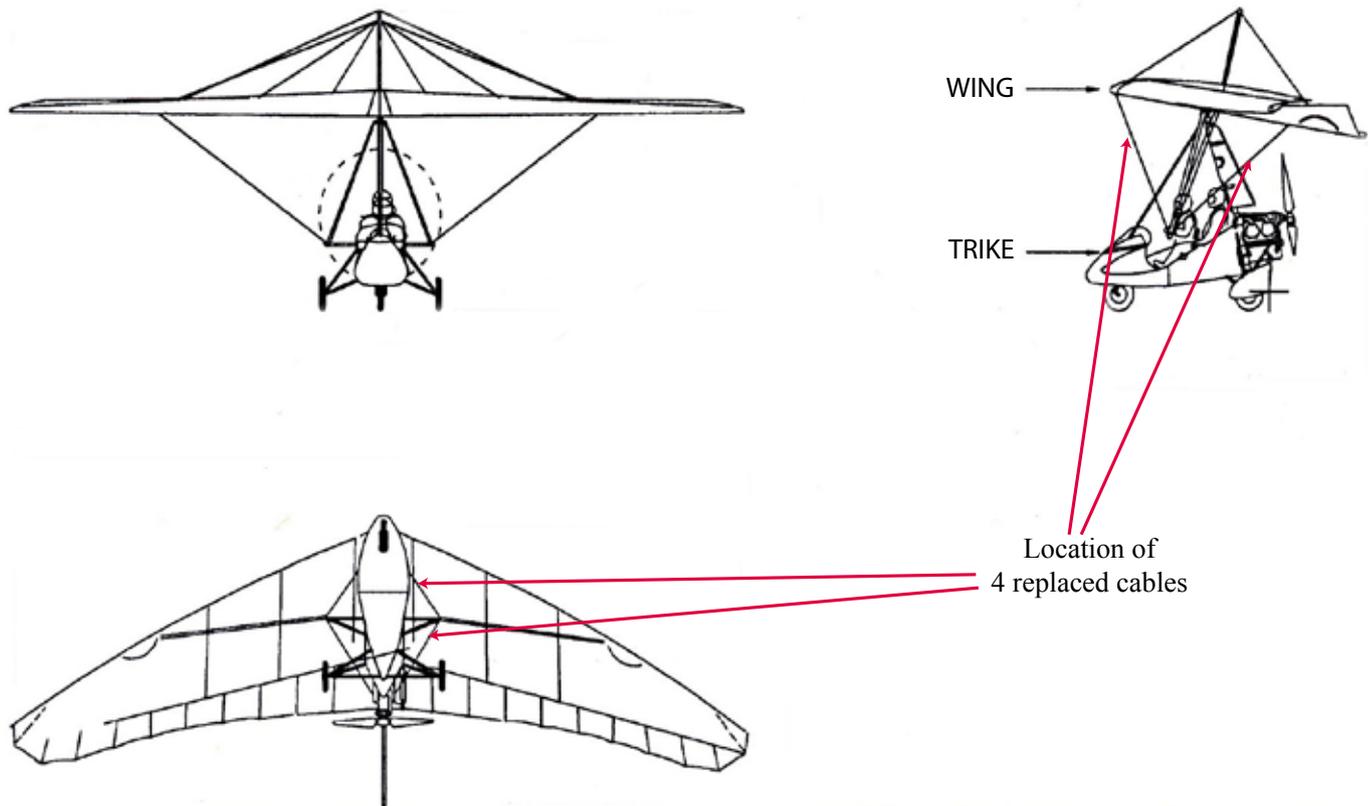
Figure 1

Aircraft layout and location of replaced cables

On 22 March 2006 the four rigging cables had been replaced. The location of these cables is shown in Figure 1. The replacement cables were not supplied or approved by the manufacturer. The aircraft had flown for a total of 1 hour and 50 minutes on three flights (not including the accident flight) since the cables were replaced.

Swages had failed in all four rigging cable assemblies. The four cable assemblies, which transmit the control forces from the base bar, did not conform to either the BMAA's Guide to Airworthiness Procedures or the Operator's Manual, in that they were not made or approved by the manufacturer.
