ACCIDENT

Aircraft Type and Registration:	1) Luscombe 8E Silvaire Deluxe, G-AKUI 2) Pacific Aerospace PAC 750XL, ZK-KAY
No & Type of Engines:	1) 1 Continental Motors Corp O-200-A piston engine 2) 1 Pratt and Whitney PT6A-34 turboprop engine
Year of Manufacture:	1) 1947 2) 2004
Date & Time (UTC):	16 December 2007 at 1158 hrs
Location:	Rectory Farm, near Rugeley, Staffordshire
Type of Flight:	1) Private 2) Private
Persons on Board:	1) Crew - 1 Passengers - 1 2) Crew - 1 Passengers - 2
Injuries:	1) Crew - 1 (Fatal) Passengers - 1 (Fatal) 2) Crew - None Passengers - None
Nature of Damage:	1) Aircraft destroyed 2) Left main landing gear separated, minor damage to nose landing gear and underside of fuselage and left wing
Commander's Licence:	1) Private Pilot's Licence 2) Private Pilot's Licence
Commander's Age:	1) 59 years 2) 39 years
Commander's Flying Experience:	1) 670 hours (of which 130 were on type) Last 90 days - Not known Last 28 days - Not known 2) 2,037 hours (of which 730 were on type) Last 90 days - 50 hours Last 28 days - 3 hours

Information Source:	AAIB Field Investigation

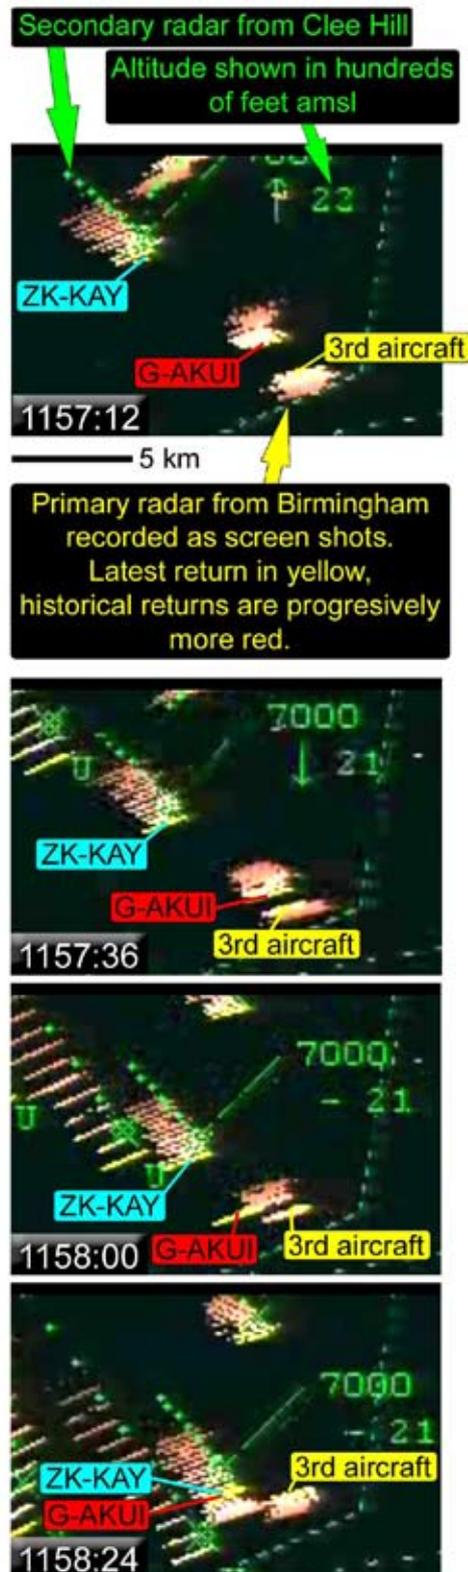
Images of radar recording at 24 second intervals

The Birmingham radar recording showed all three aircraft involved, until the time of the collision. At the moment of collision the radar returns of ZK-KAY and G-AKUI merged, and after this moment only the primary return of ZK-KAY was recorded (the SSR antenna on ZK-KAY was broken off in the collision, and SSR transmissions from the aircraft ceased).

Figure 1 shows images of the radar recording at intervals of 24 seconds, immediately prior to and including the collision; the time is shown in the bottom left corner of each image. Figure 2 shows an overview of the collision and debris field, relative to ground features.

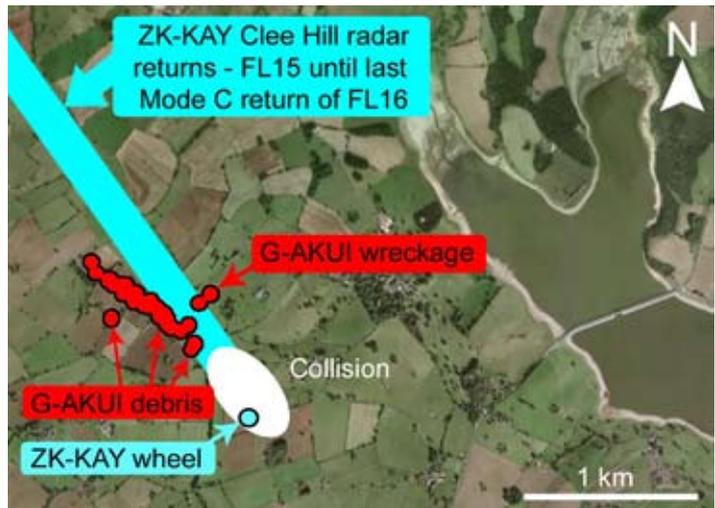
Figure 2

Collision overview

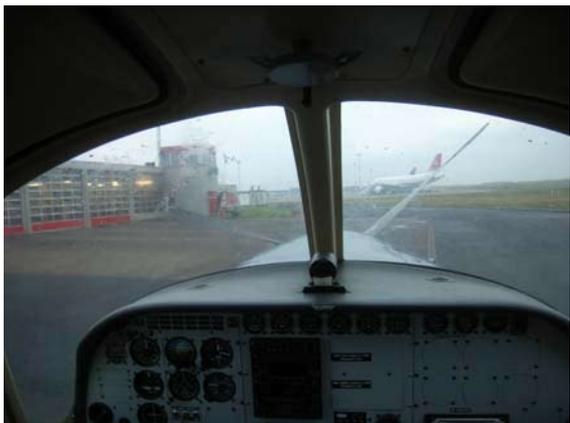
Figure 7

View from cabin of ZK-KAY

Note - view from the pilot's eye position (left and lower) is compromised by the windscreen strut and engine cowling

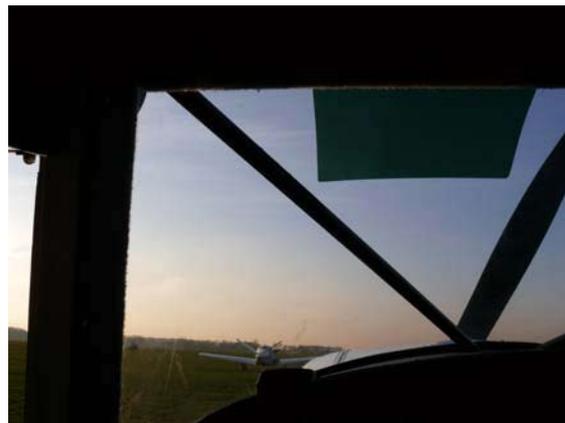
Figure 8

View from pilot's position in an aircraft similar to G-AKUI.

Note - the view left and above is compromised by the aircraft wing, door pillar, and strut. G-AKUI was not fitted with the semi-transparent sun blind
