G-OEMA jammed aileron positions

Broken bolt tail, castellated nut and cotter pin recovered from G-OEMA

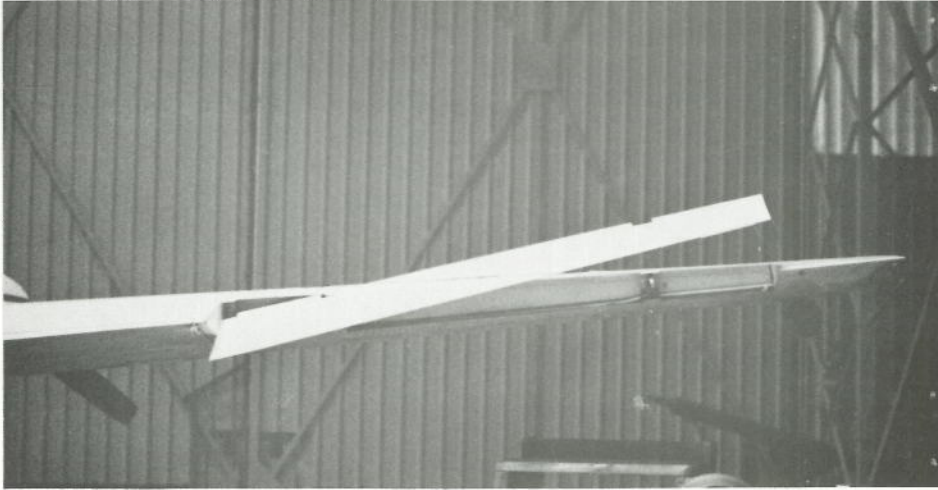
Right aileron in jammed position

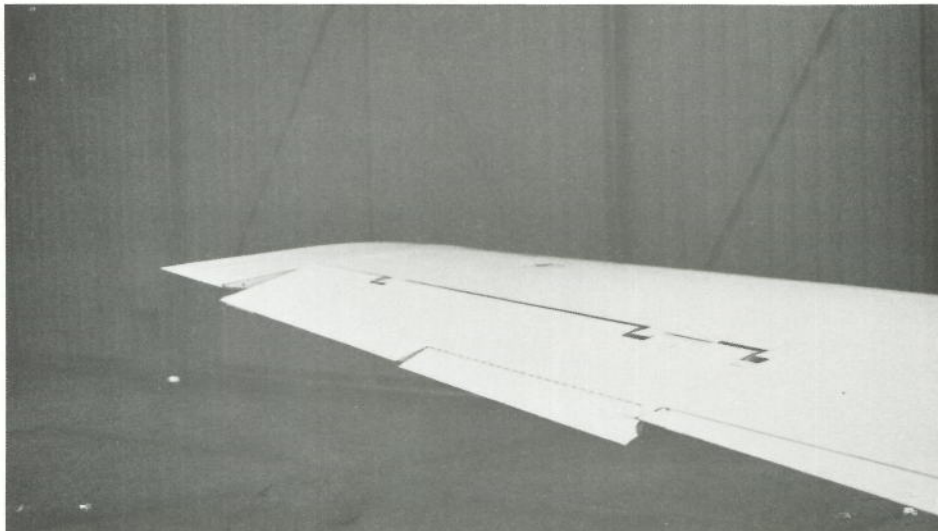
Left aileron in jammed position

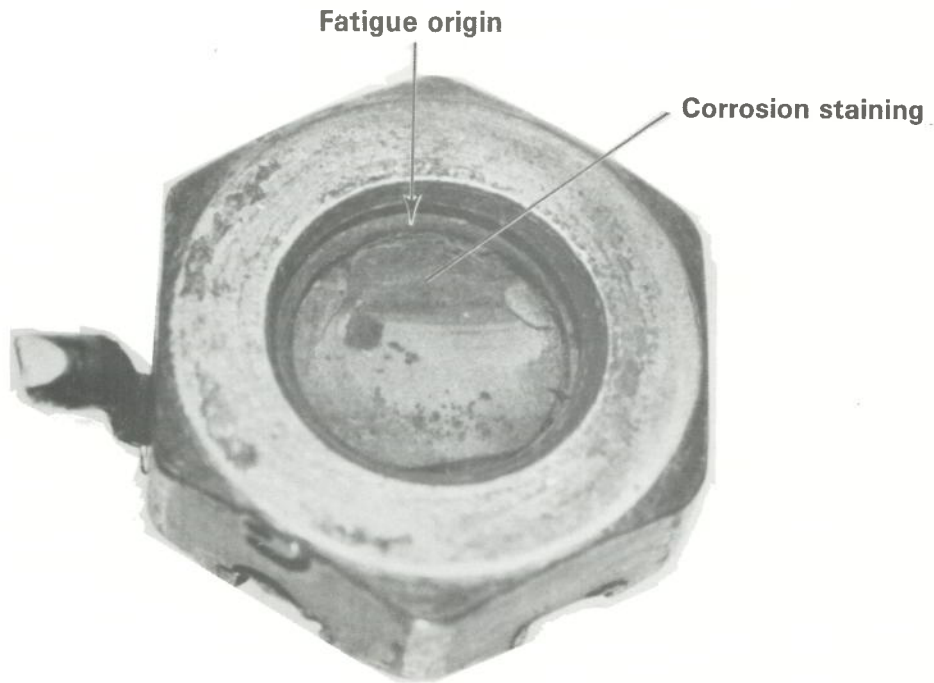
Broken end of bolt contained in nut X6.5

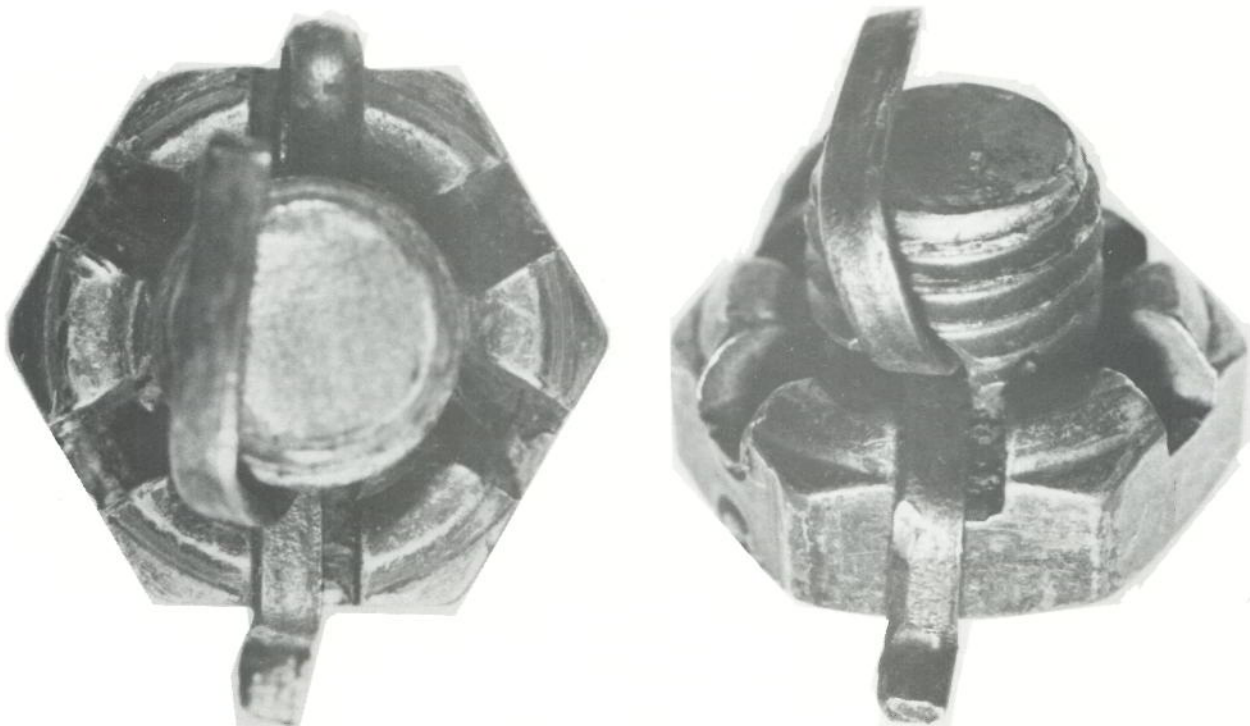
Showing badly aligned cotter pin and castellations X6.5

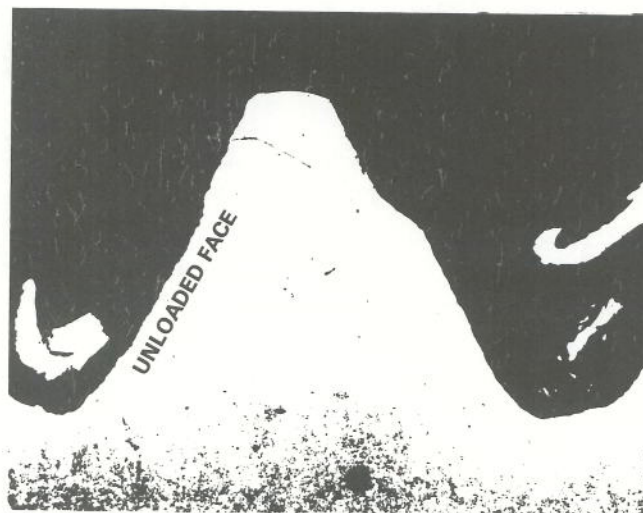
Comparison of thread form damage
