AAIB Bulletin S1/2005

AAIB Bulletin No: S1/2005

Ref: EW/C2005/02/03

Aircraft Type and Registration: Airbus A340-642, G-VATL

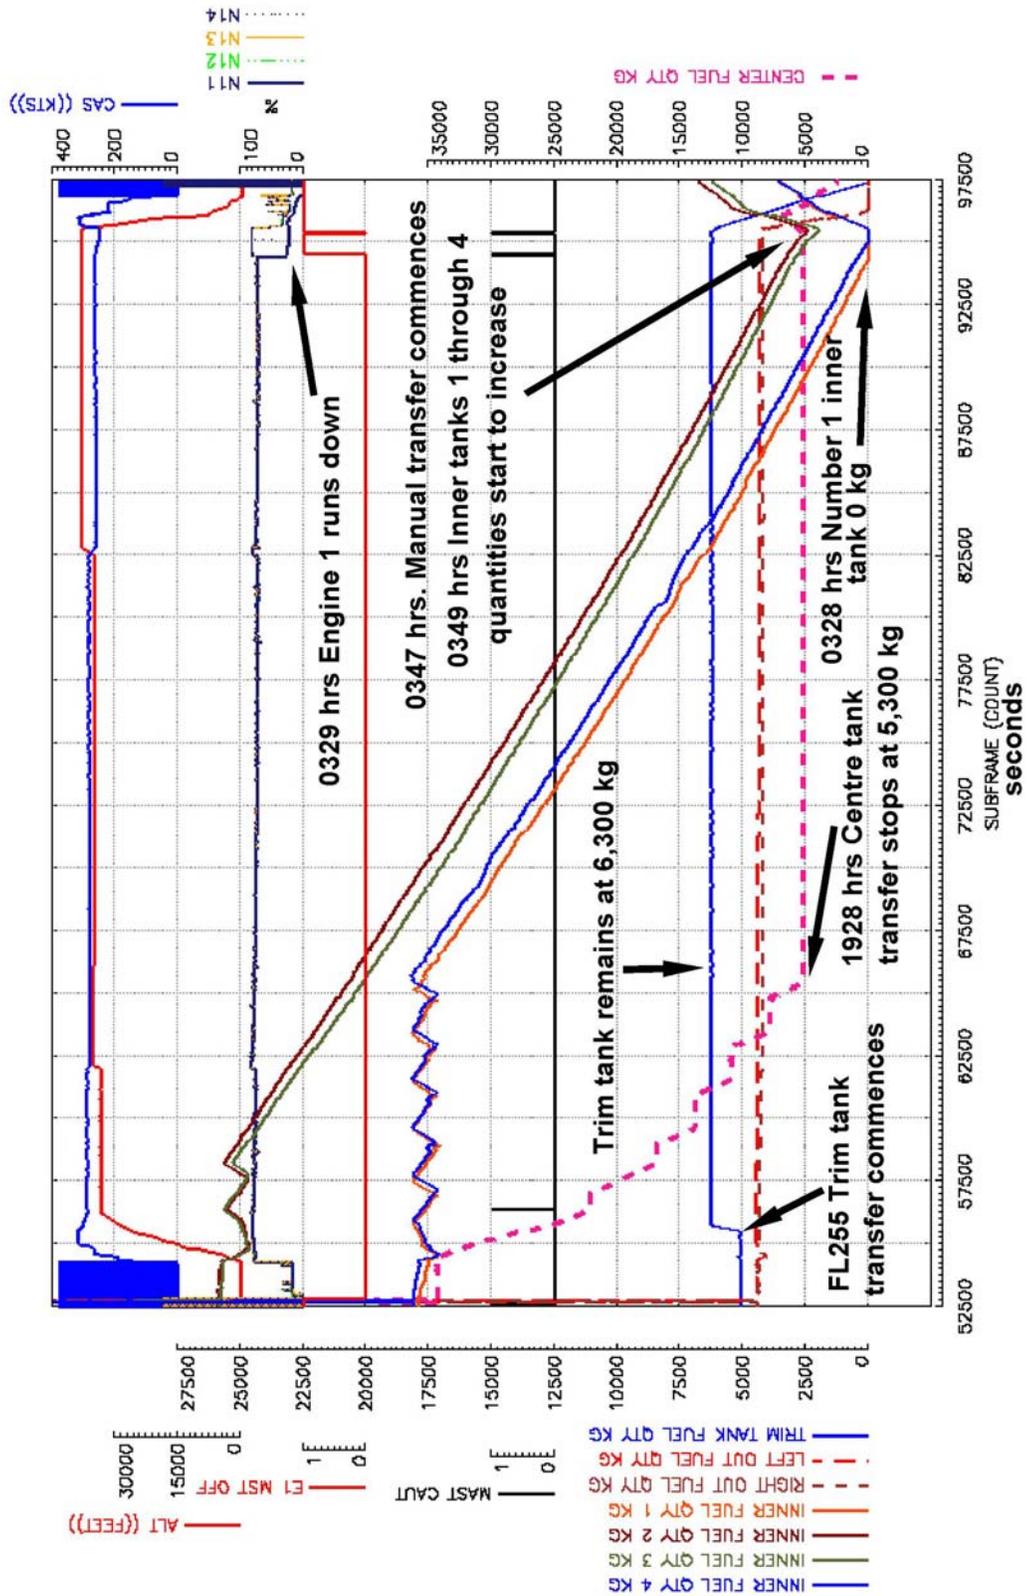
Figure 1 – An Extract of Relevant Flight Data

An extract of the relevant recorded flight data is shown at Figure 1. Takeoff occurred at 1621 hrs with a total recorded fuel of 135,450 kg. As the aircraft climbed, normal fuel transfer occurred. At 1928 hrs, at FL 354, transfer from the centre fuel tank stopped; the tank quantity at that time was 5,300 kg. The aircraft continued en route until at 0328 hrs the inner 1 fuel tank quantity indication reached zero; 40 seconds later the No 1 engine started to run down and the engine was subsequently shutdown. At 0340 hrs the inner 4 fuel tank quantity reduced to zero and the No 4 engine started to run down. At 0345 hrs the flight crew attempted to restart the No 1 engine, but they were unsuccessful. Shortly afterwards at 0347 hrs, the flight crew manually started fuel transfer from the trim, centre and outer tanks to the four inner fuel tanks. At 0349 hrs there was an increase in all four inner fuel tank quantities. The inner fuel tank quantities continued to increase as fuel was transferred from the trim, centre and outer tanks. Touchdown was at 0410 hrs, with a total of 22,960 kg of fuel remaining, with the inner 1 through 4 fuel tank quantities of 2,641 kg, 5,922 kg, 5,370 kg and 2,583 kg respectively. Fuel continued to transfer to the inner tanks until the engines were shut down.
