**No: 5/90**

**Ref: EW/C1148**

Handley Page Dart Herald 209, G-GNSY

**Nature of Damage:** Top section of the rear passenger door buckled

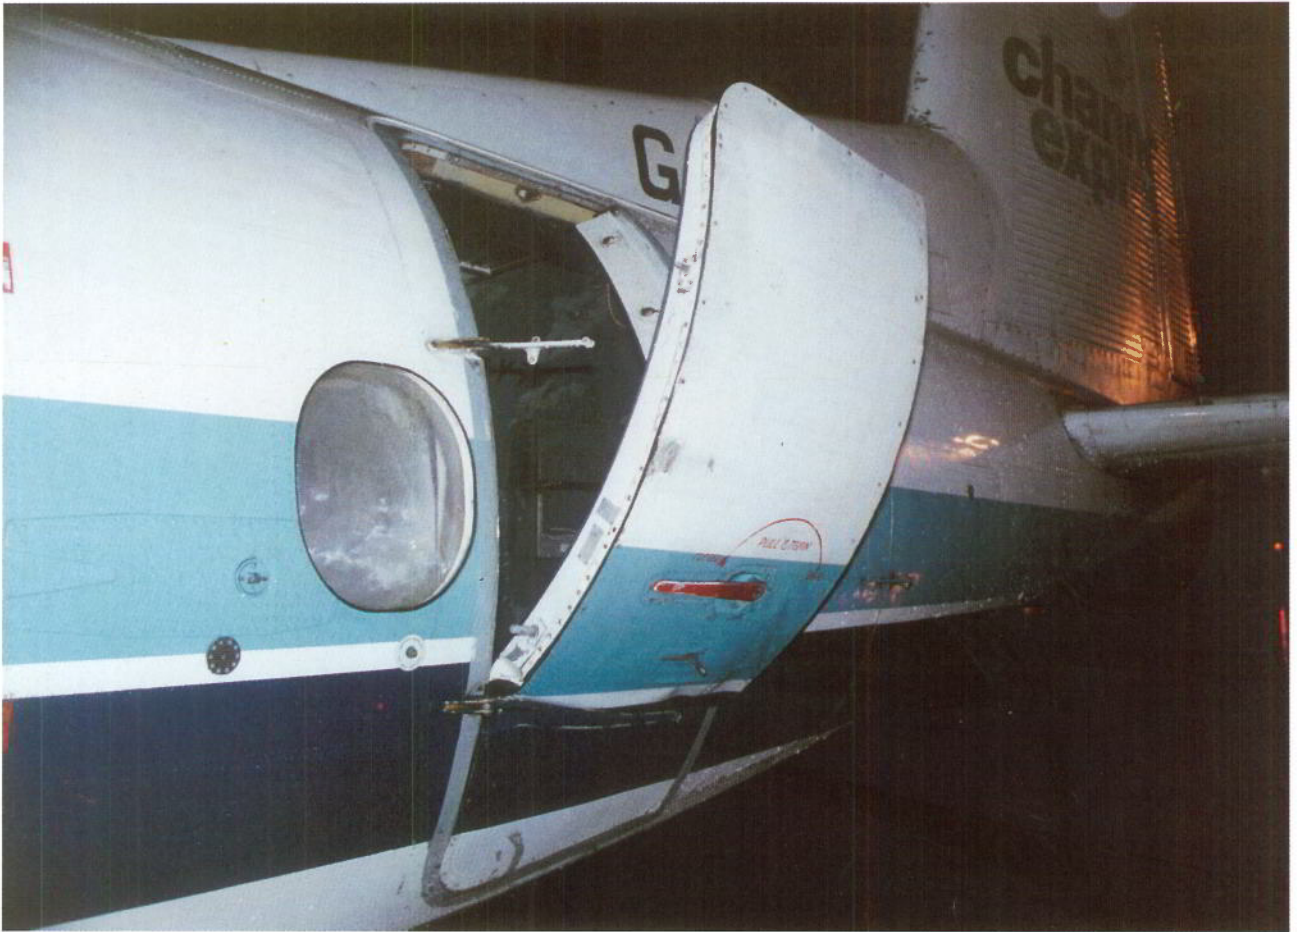
The door had buckled about a horizontal line level with the lower hinge, as can be seen in the accompanying photograph. The upper hinge attachment had been torn from the outer skin of the door. The door operating mechanism is shown on the attached drawing.

When the door was examined, the upper drawbolts were withdrawn and the indicators showed red. It was clear that the lower bolts were still engaged, and these, together with the lower locating pin, had retained the door on the aircraft. It was noted however that the indicator paint on the bolts of this door, and those of a spare, had flaked and become smeared with grease, reducing the clarity of the indicator.

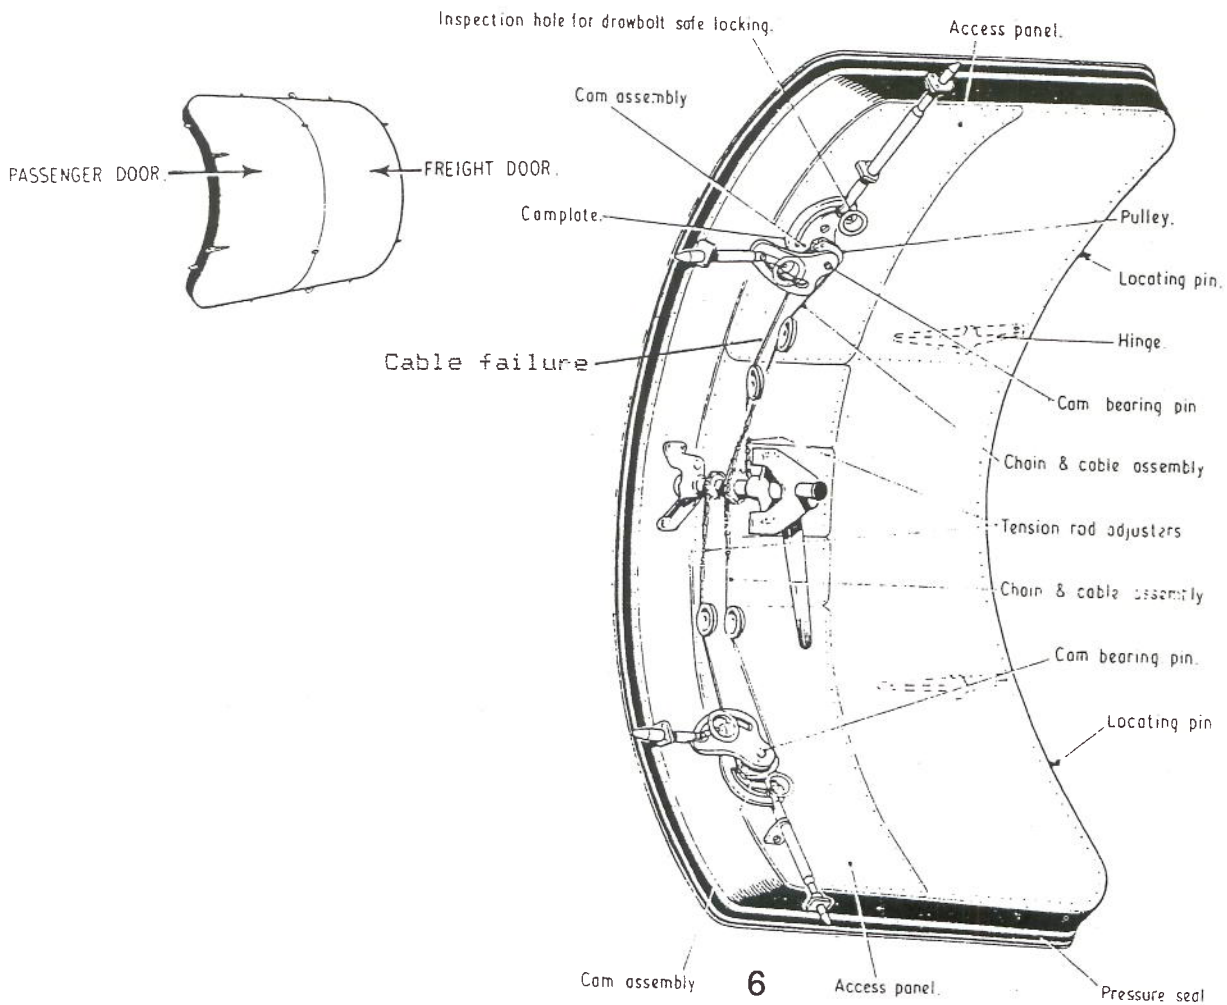
The door, which is located immediately forward of the freight door, is locked by means of four drawbolts, one at each of the top and bottom edges and two at the aft edge. Those at the top and bottom engage with holes in the door aperture structure, whilst the bolts in the aft edge of the door engage with holes in the forward edge of the freight door. In addition, two fixed locating pins on the forward edge of the door engage with holes in the forward edge of the door aperture; these pins disengage due to the hinging movement when the door is opened.

The internal and external handles operate the drawbolt mechanism through two chain and cable systems. The bolts have red and green portions painted on them where they pass behind viewing ports: thus when the bolts are in the closed, *ie* safe position, green paint is visible through the ports; red paint shows if the bolts are partially or totally withdrawn.

It was subsequently found that the operating cables for the upper drawbolt assembly were severely frayed where they passed over the pulleys, with the extending/locking cable completely severed. It was not possible to ascertain how far the bolts had been engaged prior to the decompression. However there was no sign of any tearing on the keep plates of the freight door or door frame. By contrast, it was clear that the upper locating pin had torn out of engagement, leaving the tip of the pin embedded in the side of the hole. It therefore seemed possible that the cable finally failed when the

door was closed at Guernsey, with the upper drawbolts at best partially engaged. There appeared to be some scope for the mechanism to move to the withdrawn position under gravity. The tapered ends of the bolts would also produce a tendency to withdraw under the action of pressurisation forces on the door in the event of partial engagement.

Following the incident, the maintenance organisation proposed to amend the maintenance schedule to increase the frequency of the cable inspection to every Check 1 and to check visual indication of all door locking at Check A periods (72 hours elapsed time). Also, a Check 1 inspection will be raised to ensure clarity of the bolt viewing ports and the condition of the paint marks on the bolts.
