**INCIDENT**

<b>Aircraft Type and Registration:</b>	Avro 146-RJ85, OH-SAI
<b>No &amp; Type of Engines:</b>	4 Honeywell LF507 Turbofan engines
<b>Year of Manufacture:</b>	2001
<b>Date &amp; Time (UTC):</b>	17 June 2007 at 1820 hrs
<b>Location:</b>	Stratford St Andrew, Suffolk
<b>Type of Flight:</b>	Commercial Air Transport (Passenger)
<b>Persons on Board:</b>	Crew - 4                      Passengers - 83
<b>Injuries:</b>	Crew - None                      Passengers - None
<b>Nature of Damage:</b>	Panel from wing/fuselage fairing detached in flight, minor damage to fin
<b>Commander's Licence:</b>	Airline Transport Pilot's Licence
<b>Commander's Age:</b>	32
<b>Commander's Flying Experience:</b>	5,208 hours (of which 2,688 were on type) Last 90 days - 193 hours Last 28 days - 83 hours
<b>Information Source:</b>	AAIB Field Investigation

**Synopsis**

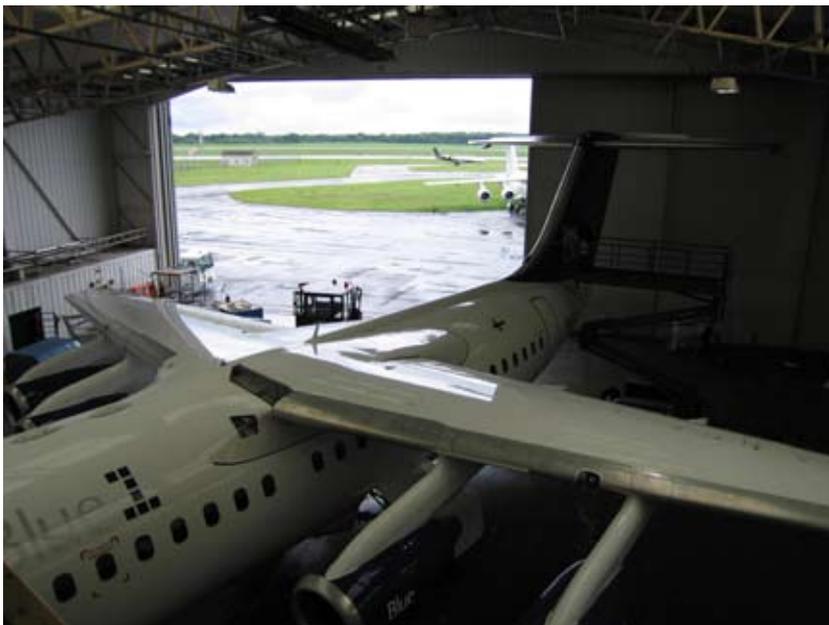
**Figure 1**

After parking the aircraft, the crew noticed that a panel was missing from the wing-to-fuselage fairing and there was minor damage to the fin (Figure 1).

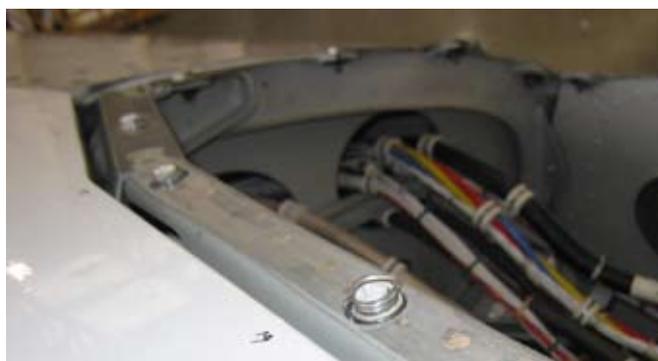
**Figure 2**

The aircraft was inspected at Stansted and the 25 bolts that secure this panel to the aircraft were all still on the aircraft located in their respective grommets (Figure 2 shows an example). The bolts and grommets were then removed and in all cases the grommets were found to have failed (Figure 3 shows several failed grommets). The failure of the grommets differed in detail but the upper flange in all 25 had failed, and there was evidence that the flanges in the region of the failures were of reduced thickness. There was also evidence of paint on the grommet flanges.

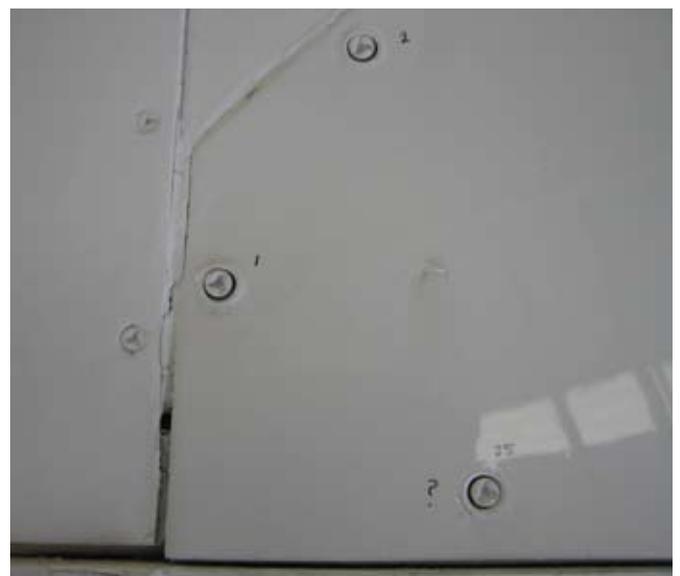
**Figure 4**

The similar panel on the right wing to fuselage joint was inspected. The grommets and bolts on this panel had all been painted and it was therefore very difficult to inspect the grommets (Figure 4). Four areas of the right panel in the region of grommets were then stripped of paint and it was determined that the flange thickness on these four grommets was less than specification and importantly, there were marks on the grommets consistent with the flanges having been abraded.

This incident reinforces the requirement not to paint the grommets so that effective inspection can be performed.
