**SERIOUS INCIDENT**

<b>Aircraft Type and Registration:</b>	Champion 7ECA Citabria Aurora, G-EGWN	
<b>No &amp; Type of Engines:</b>	1 Lycoming O-235-K2C piston engine	
<b>Year of Manufacture:</b>	2007 (Serial no: 1399-2007)	
<b>Date &amp; Time (UTC):</b>	18 July 2013 at 0850 hrs	
<b>Location:</b>	RAF Halton, Buckinghamshire	
<b>Type of Flight:</b>	Training	
<b>Persons on Board:</b>	Crew - 2	Passengers - None
<b>Injuries:</b>	Crew - None	Passengers - N/A
<b>Nature of Damage:</b>	None	
<b>Commander's Licence:</b>	Airline Transport Pilot's Licence	
<b>Commander's Age:</b>	58 years	
<b>Commander's Flying Experience:</b>	9,500 hours (of which 65 were on type) Last 90 days - 123 hours Last 28 days - 41 hours	
<b>Information Source:</b>	Aircraft Accident Report Form submitted by the pilot

**Synopsis**

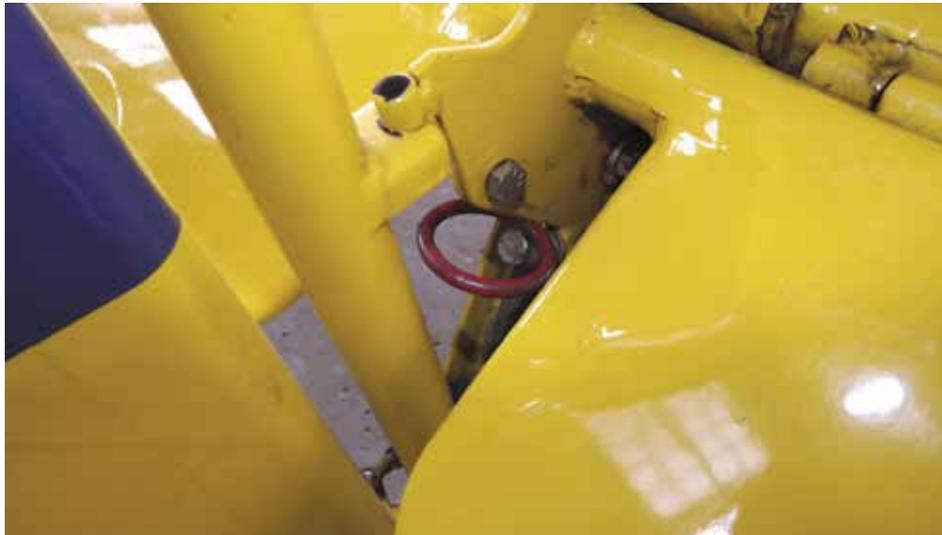
**Figure 1**

After removing the fairing around the stern post, a red painted steel ring approximately 45 mm in diameter was found jammed in the elevator up stop, Figure 1. This limited the maximum upwards travel of the elevator to 1½ degrees below the neutral position. The origin of the ring or how it entered the aircraft could not be determined.

View of loose article as found after landing  
(Photograph courtesy of Nigel Huxtable)

could not be determined. Further investigation by the flying club has identified that the metal ring was from the aircraft's door emergency release pull. The ring has been replaced and an additional lanyard added to restrain it should it become detached again.
