SERIOUS INCIDENT

Aircraft Type and Registration:	Raytheon 390 Premier I, G-FRYL	
No & Type of Engines:	2 Williams International FJ44-2A turbofan engines	
Year of Manufacture:	2004	
Date & Time (UTC):	7 August 2008 at 1800 hrs	
Location:	En route Copenhagen, Denmark to Farnborough, UK	
Type of Flight:	Commercial Air Transport (Non-Revenue)	
Persons on Board:	Crew - 2	Passengers - None
Injuries:	Crew - None	Passengers - N/A
Nature of Damage:	None	
Commander's Licence:	Commercial Pilot's Licence	
Commander's Age:	60 years	
Commander's Flying Experience:	11,830 hours (of which 1,850 were on type) Last 90 days - 140 hours Last 28 days - 30 hours	
Information Source:	AAIB Field Investigation

Synopsis

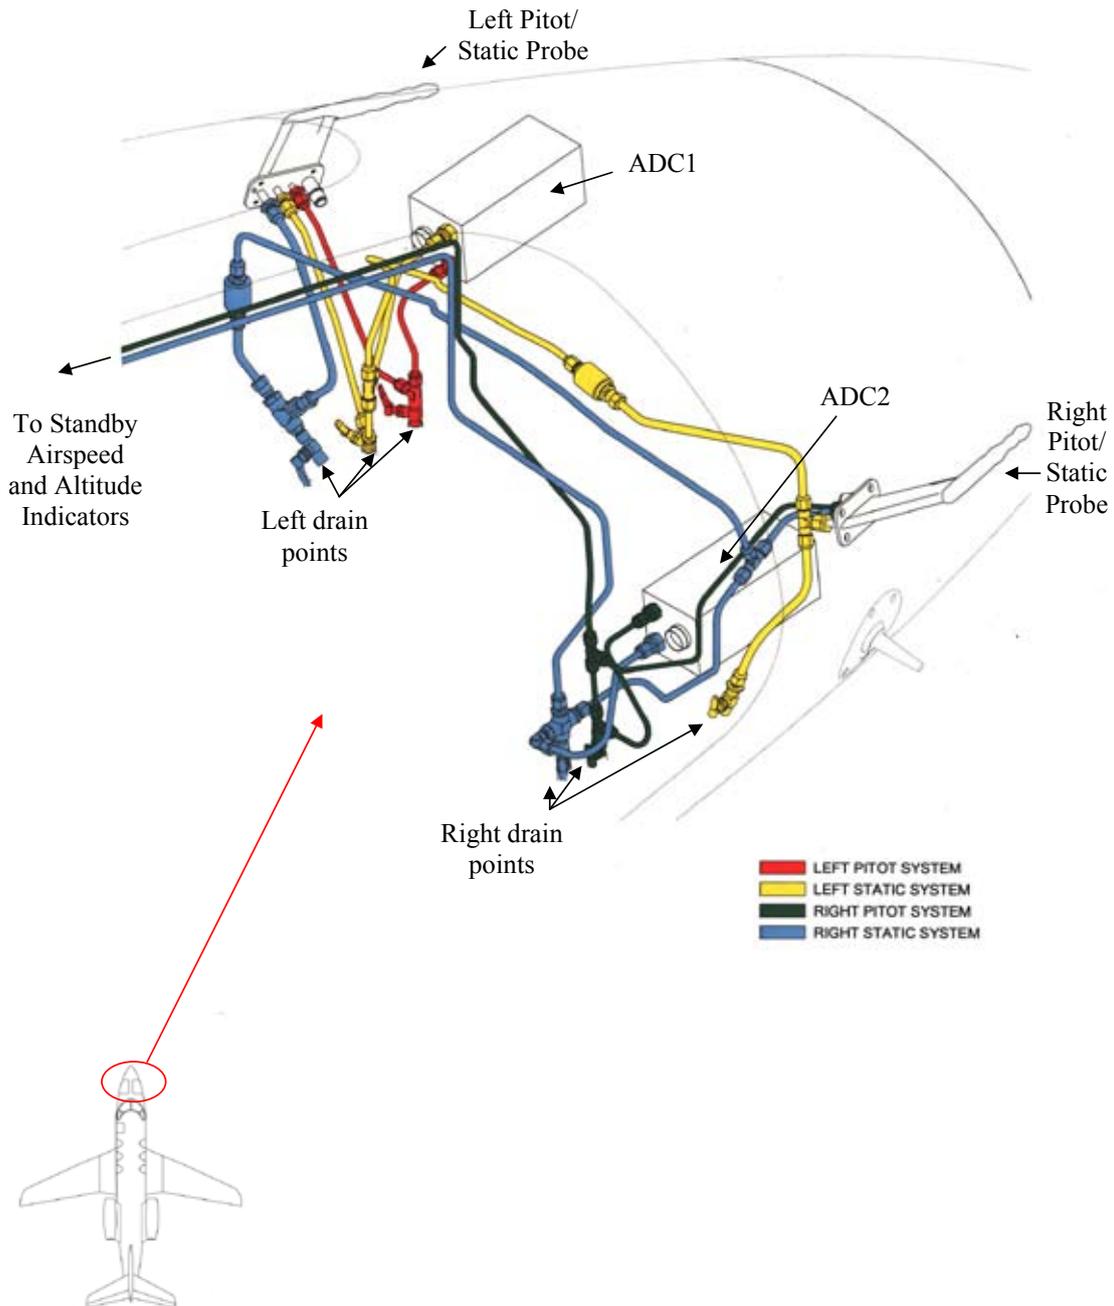
Figure 2
Pitot/static connections

probe pitot connection supplies the left (No 1) ADC only and the right probe pitot connection feeds the right (No 2) ADC and the standby ASI. The left and right probe static lines are cross-connected and supply static pressure to the ADCs. The standby ASI and altimeter use the same static feed as ADC2.

Both left and right pitot/static systems have drain traps, located at the lowest point in the lines to collect any moisture, which can be drained by operating a spring loaded lever on the drain traps. The pitot/static probes are electrically heated.

The return of valid air data information as the aircraft descended supports the theory that the blockage was caused by ice, which then melted as the outside air temperature rose. Subsequent investigations found no faults within either of the ADCs or the right pitot/static probe.

It is recommended that the Federal Aviation Administration should require Hawker Beechcraft Corporation to review and modify, if necessary, the design of the pitot and static drainage on the Premier 1 aircraft in order that its pitot/static systems cannot become blocked as a result of trapped moisture.

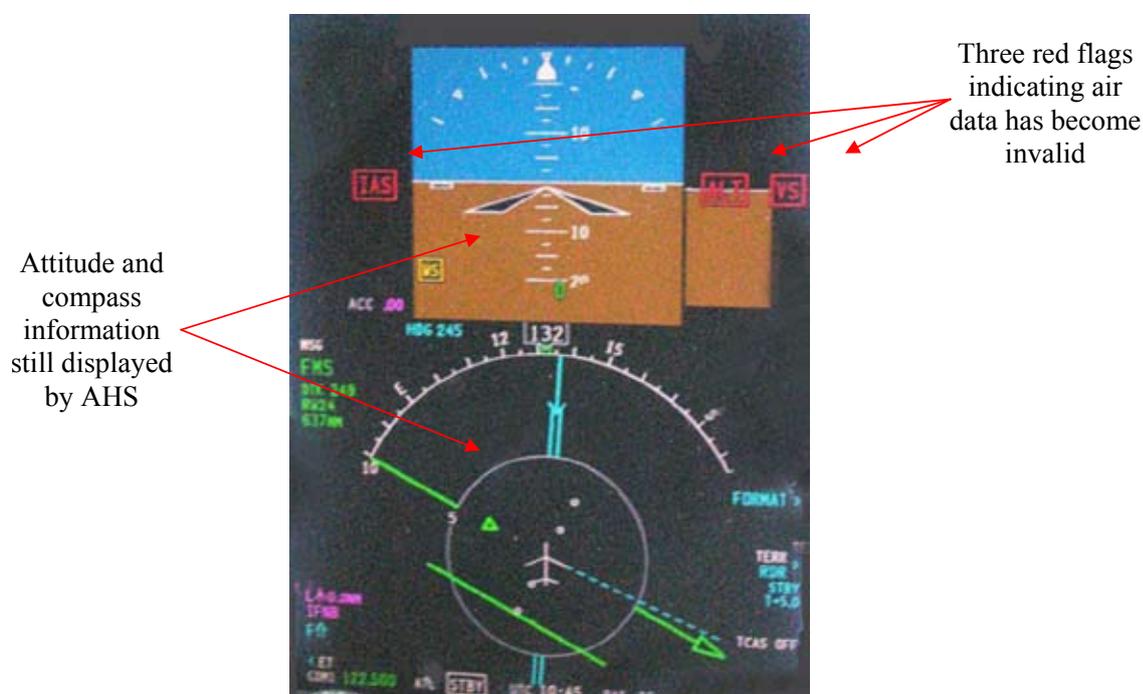
Figure 3

If the air data information becomes invalid, red boxed IAS, ALT and VS captions appear instead of the airspeed, altitude or vertical speed tape on the PFD of the side affected. With these flags in view, all air data information is removed (see Figure 3),

PFD display with air data information invalid

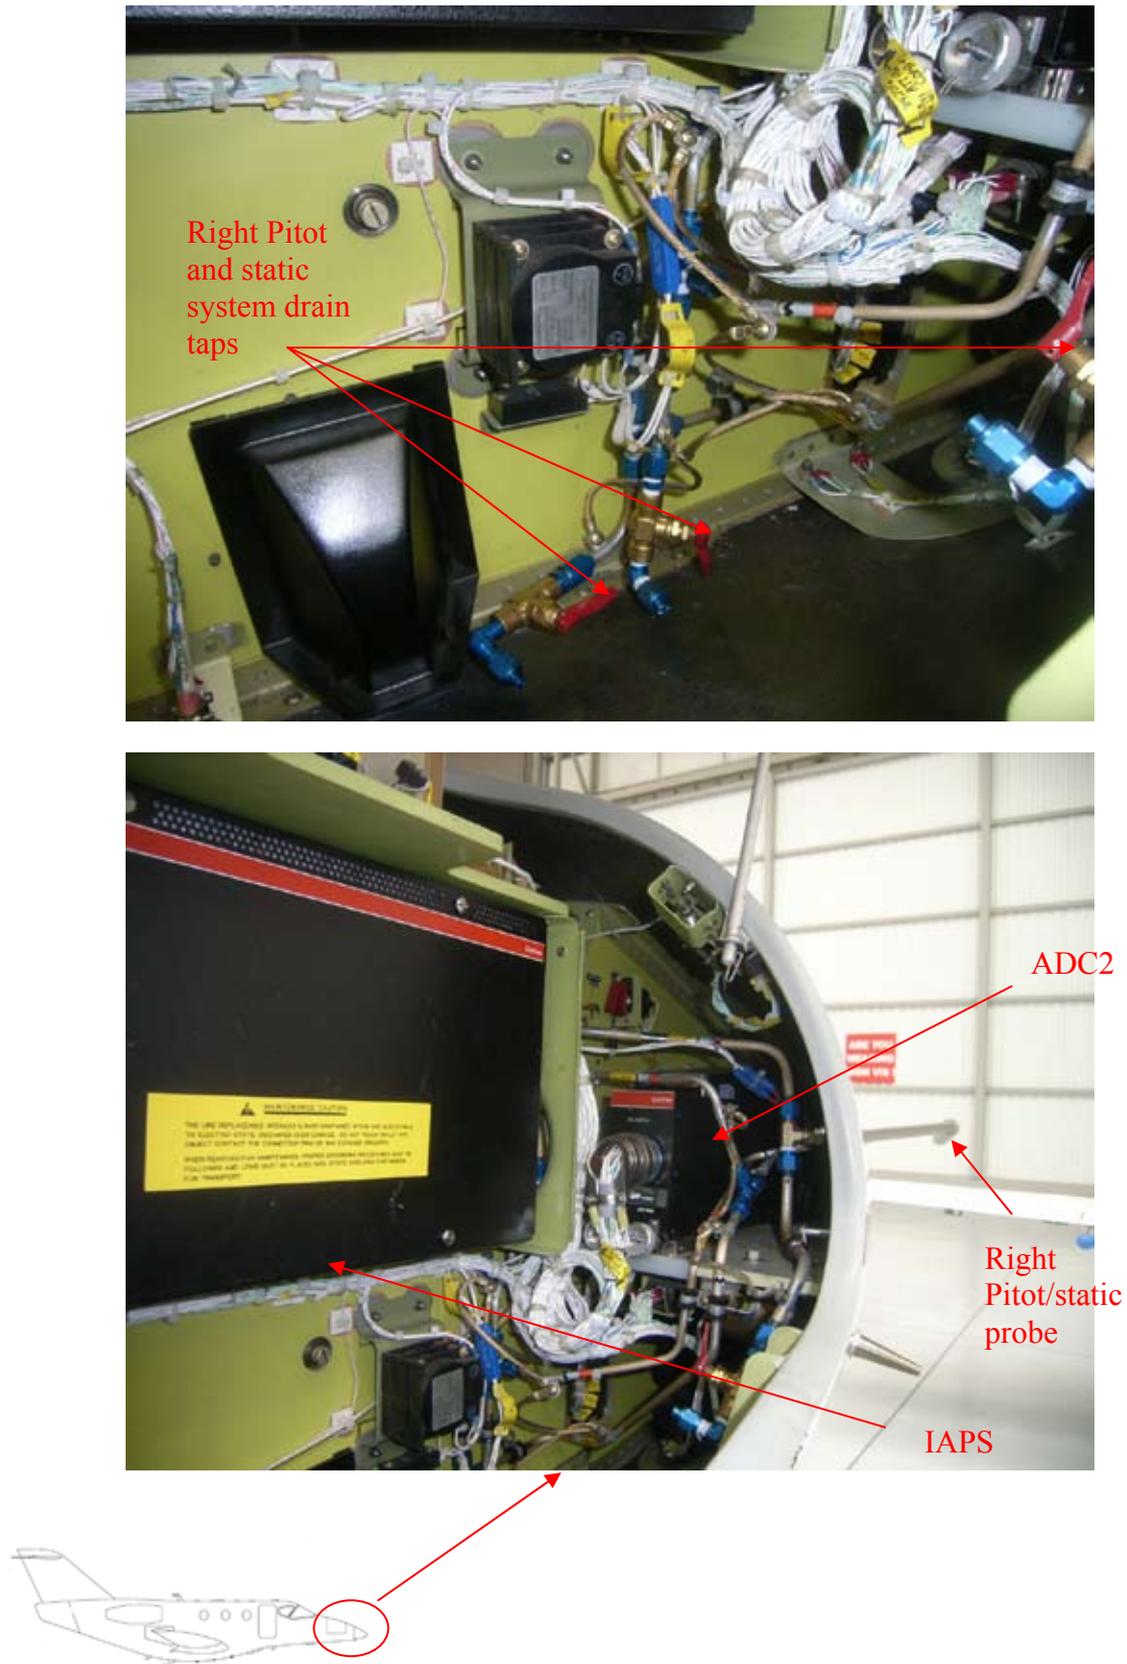
Figure 4
Right Avionics Bay

The aircraft manufacturer reported that from certification test flying experience, temperatures within the forward avionics bay can drop below freezing and any moisture in the pitot/static tubes can freeze at altitude. Some avionics units will remain warm from internal heat generated, but others can become cold. The IAPS has an internal heater which will automatically operate if the temperature falls below -41 °C and will only switch off again if the temperature rises above -35 °C.

The Aircraft Maintenance Manual (AMM) requires the operation of the pitot and static drains every 200 hours in order to remove moisture which may have entered the system. The process requires the removal of the blanking caps on the bottom of the drains and the turning of a red spring-loaded lever on each of the drain traps for the two independent (left and right) static and pitot systems (see Figure 2). This should allow any moisture to drain. The system must be leak-checked following the procedure. Figure 4 shows the location for the right system drains in the right avionics bay.

There have been previous incidents on the Premier 1 of moisture ingress leading to loss of air data information, and temperatures in the right avionics bay can be sufficiently low to allow any moisture present to freeze. This operator has reported that the operation of the pitot and static drains is not always sufficient to clear moisture, and that the systems can require purging to ensure that all moisture is removed. This was the case following this incident, where no water was found in the pitot and static lines by operating the drains; however, some water was found by purging.

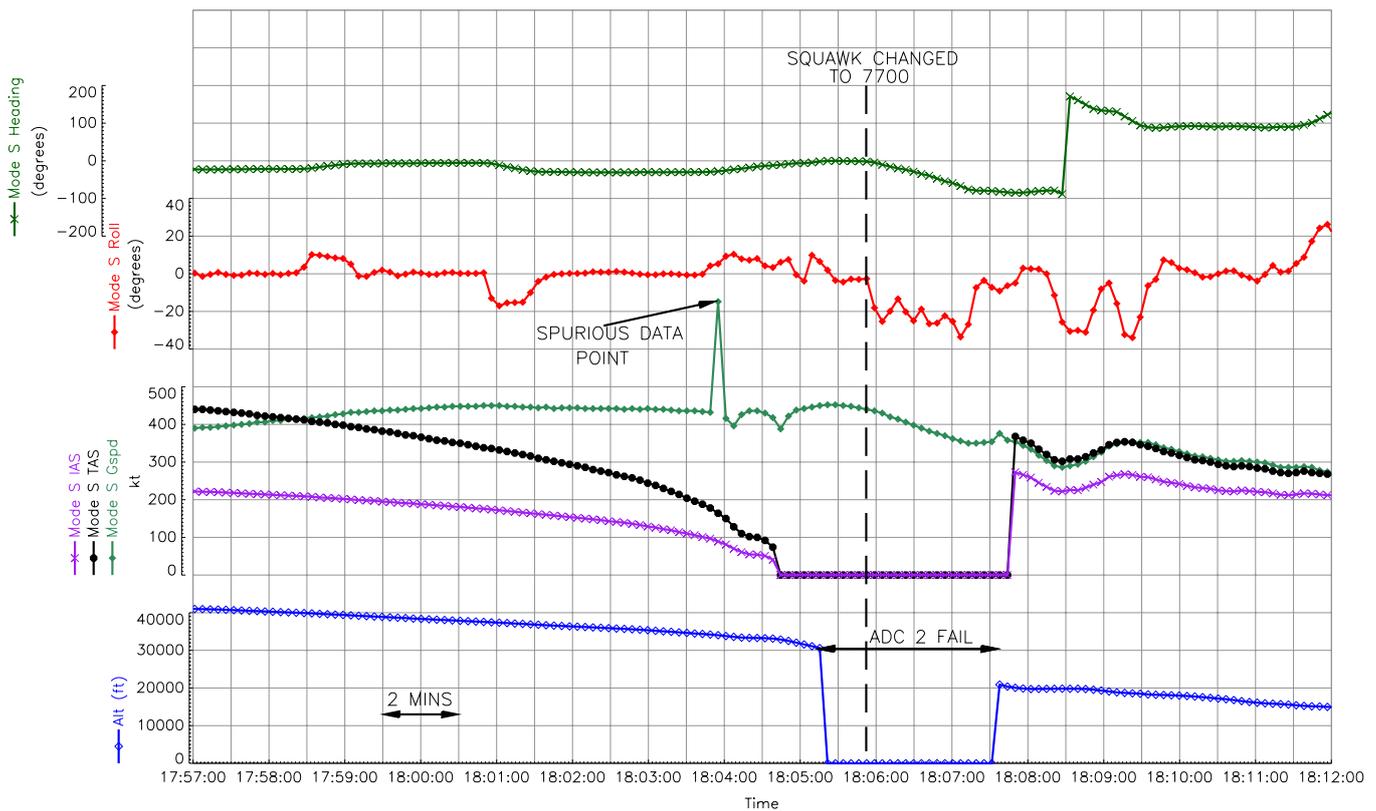
Figure 5

The Mode S radar recording data from Debden covered most of the flight from Copenhagen and included airspeed and altitude data in addition to positional information (see Figure 5).

The aircraft was cruising at FL410 before beginning a descent at about 1757 hrs. The Mode S IAS, which had been stable at 220 kt, then began to reduce. However, both the Mode S and radar groundspeeds, which had been around 390 kt, began to increase. Mode S IAS continued to reduce until 1804:30 hrs when, passing through approximately 33,000 ft, having decelerated to 50 kt, the recording suddenly reduced to zero. At the same time, the recorded groundspeed was about 430 kt. Approximately 30 seconds later, with the aircraft passing through 31,000 ft, the altitude indication also suddenly reduced to zero. The recorded groundspeed was 450 kt which then subsequently reduced to approximately

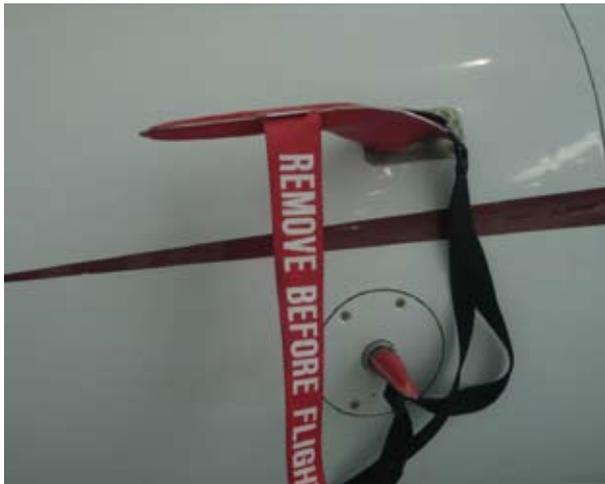
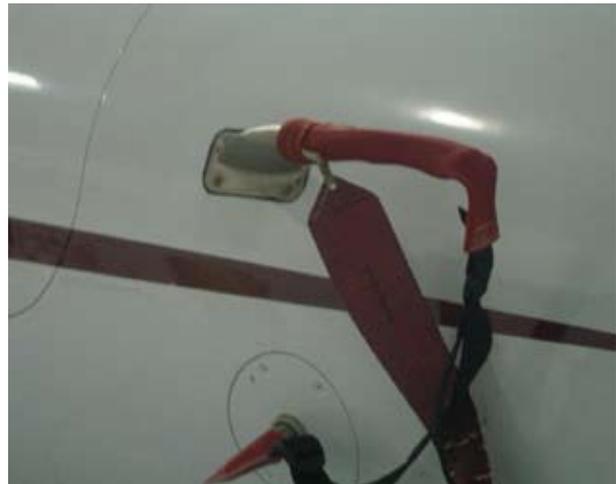
Figure 6

Left pitot probe and AOA vane below
Standard cover

Right pitot probe and AOA vane below
Kevlar cover

As a result of these two MORs, the operator's maintenance organisation checked another four Premier 1 aircraft and found significant amounts of water in the pitot/static systems on each aircraft. It was noted that water could remain in the system after operating the drains and it was found necessary to purge the system with nitrogen for complete removal. The operator also chose to introduce the use of the alternative Kevlar pitot probe cover.
