BULLETIN RE-ISSUED

INCIDENT

Aircraft Type and Registration:	Cessna 208 Caravan I amphibious floatplane, G-MDJE
No & Type of Engines:	1 Pratt & Whitney Canada PT6A-114A turboprop engine
Year of Manufacture:	2001
Date & Time (UTC):	24 May 2008 at 1930 hrs
Location:	Overhead Partick, Glasgow
Type of Flight:	Commercial Air Transport (Non-Revenue)
Persons on Board:	Crew - 2 Passengers - None
Injuries:	Crew - None Passengers - N/A
Nature of Damage:	Water rudder detached in flight
Commander's Licence:	Commercial Pilot's Licence
Commander's Age:	34 years
Commander's Flying Experience:	4,615 hours (of which 6.5 were on type) Last 90 days - 32 hours Last 28 days - 6.5 hours
Information Source:	Aircraft Accident Report Form submitted by the pilot and AAIB examination

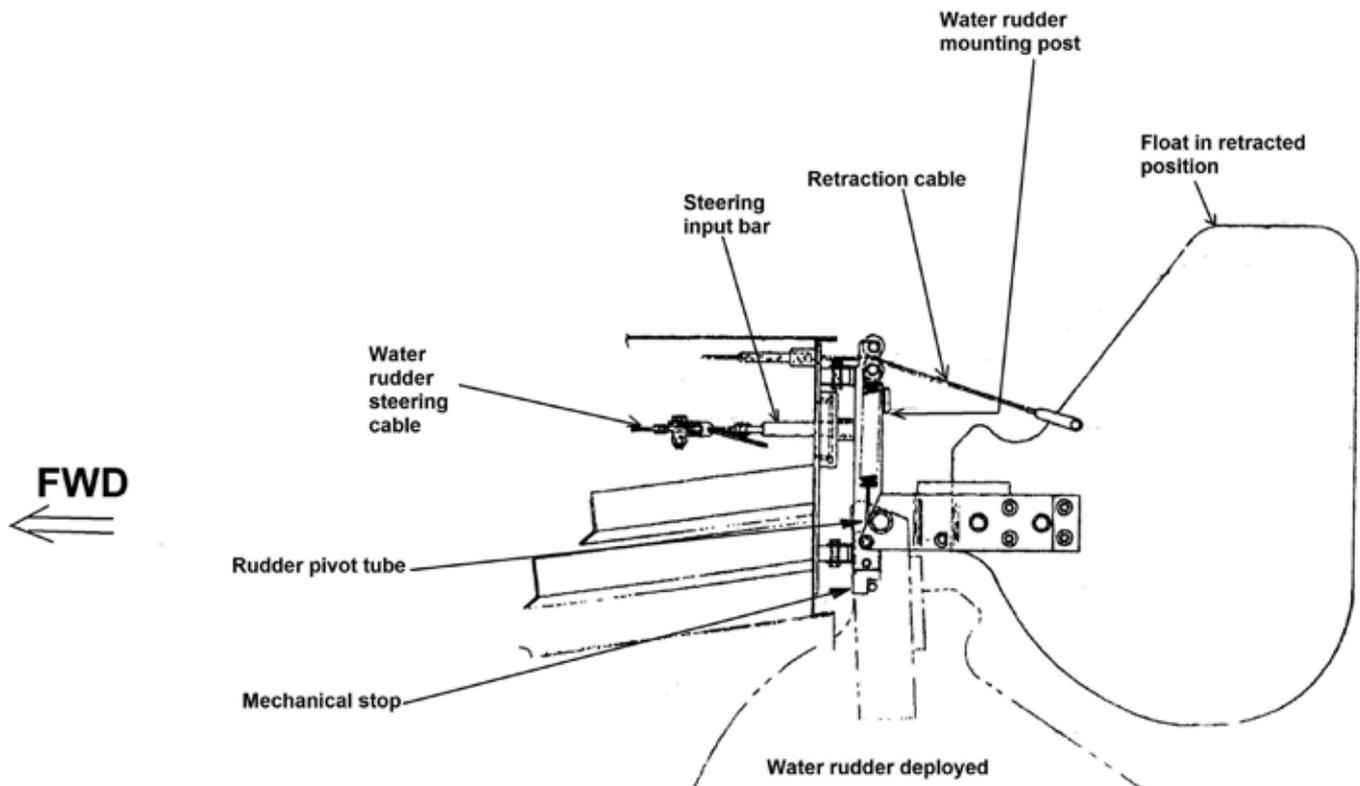
Figure 2

Water rudder installation diagram

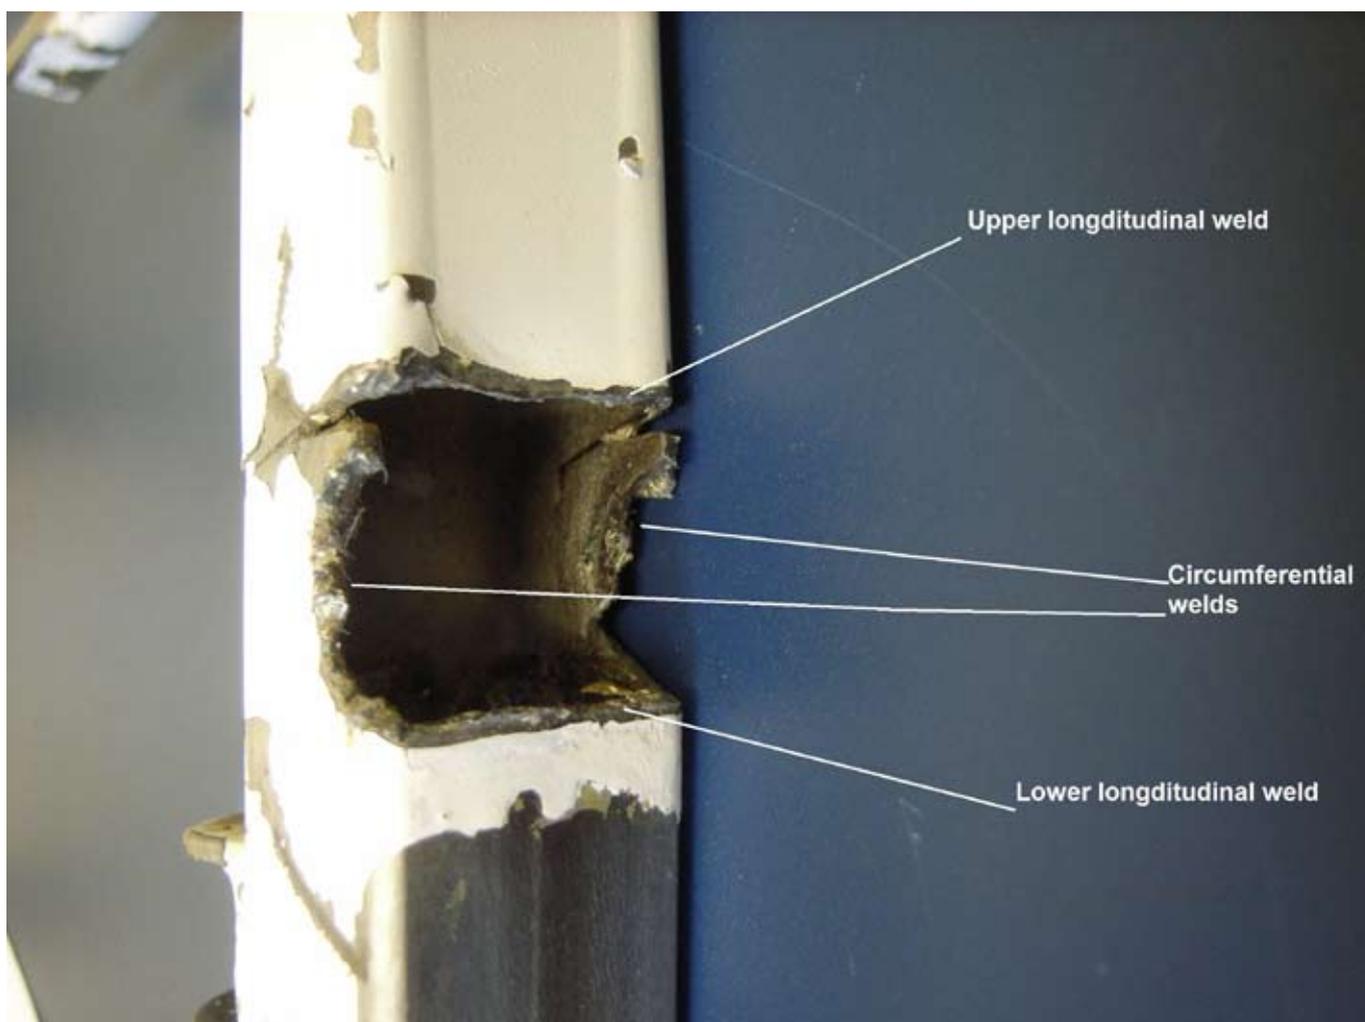
Figure 4
Rudder post weld details

The deformation of the rudder mounting post indicated that the rudder pivot tube had been pulled aft, causing the aft wall of the rudder post to fail where the pivot tube was attached. The ‘tears’ in the post sidewalls illustrate that, despite the welds securing the pivot tube having only partial material penetration, they were able to transmit sufficient load to damage the rudder post sidewalls without failing. The damage observed was consistent with a force being applied to the lower portion of the rudder from the rear whilst deployed. This caused the rudder to ‘pivot’ about the lower mechanical stop, producing the rearward

bending of the post where the pivot tube was attached. The force was of sufficient magnitude to cause the failure in overload of the two longitudinal welds securing the pivot tube. The distortion of the post sidewalls close to the circumferential welds showed that a torsional load had been applied through the pivot tube, in a clockwise sense (aft looking forward), after the failure of the upper and lower longitudinal welds which resulted in the failure of the sidewalls. The subsequent failure of the remaining circumferential welds allowed the rudder to separate from the aircraft. It could not be determined when the damage to the
