**ACCIDENT**

<b>Aircraft Type and Registration:</b>	Bombardier Challenger 604, D-ABCD	
<b>No &amp; Type of Engines:</b>	2 General Electric CF34-3B turbofan engines	
<b>Year of Manufacture:</b>	2003	
<b>Date &amp; Time (UTC):</b>	5 February 2006 at 1233 hrs	
<b>Location:</b>	London Luton Airport	
<b>Type of Flight:</b>	Non-scheduled Commercial Air Transport (Passenger)	
<b>Persons on Board:</b>	Crew - 3	Passengers - 1
<b>Injuries:</b>	Crew - None	Passengers - None
<b>Nature of Damage:</b>	Damage to landing gear and airport approach lighting	
<b>Commander's Licence:</b>	Airline Transport Pilot's Licence	
<b>Commander's Age:</b>	41 years	
<b>Commander's Flying Experience:</b>	9,041 hours (of which 688 were on type) Last 90 days - 102 hours Last 28 days - 41 hours	
<b>Information Source:</b>	AAIB Field Investigation

**Synopsis**

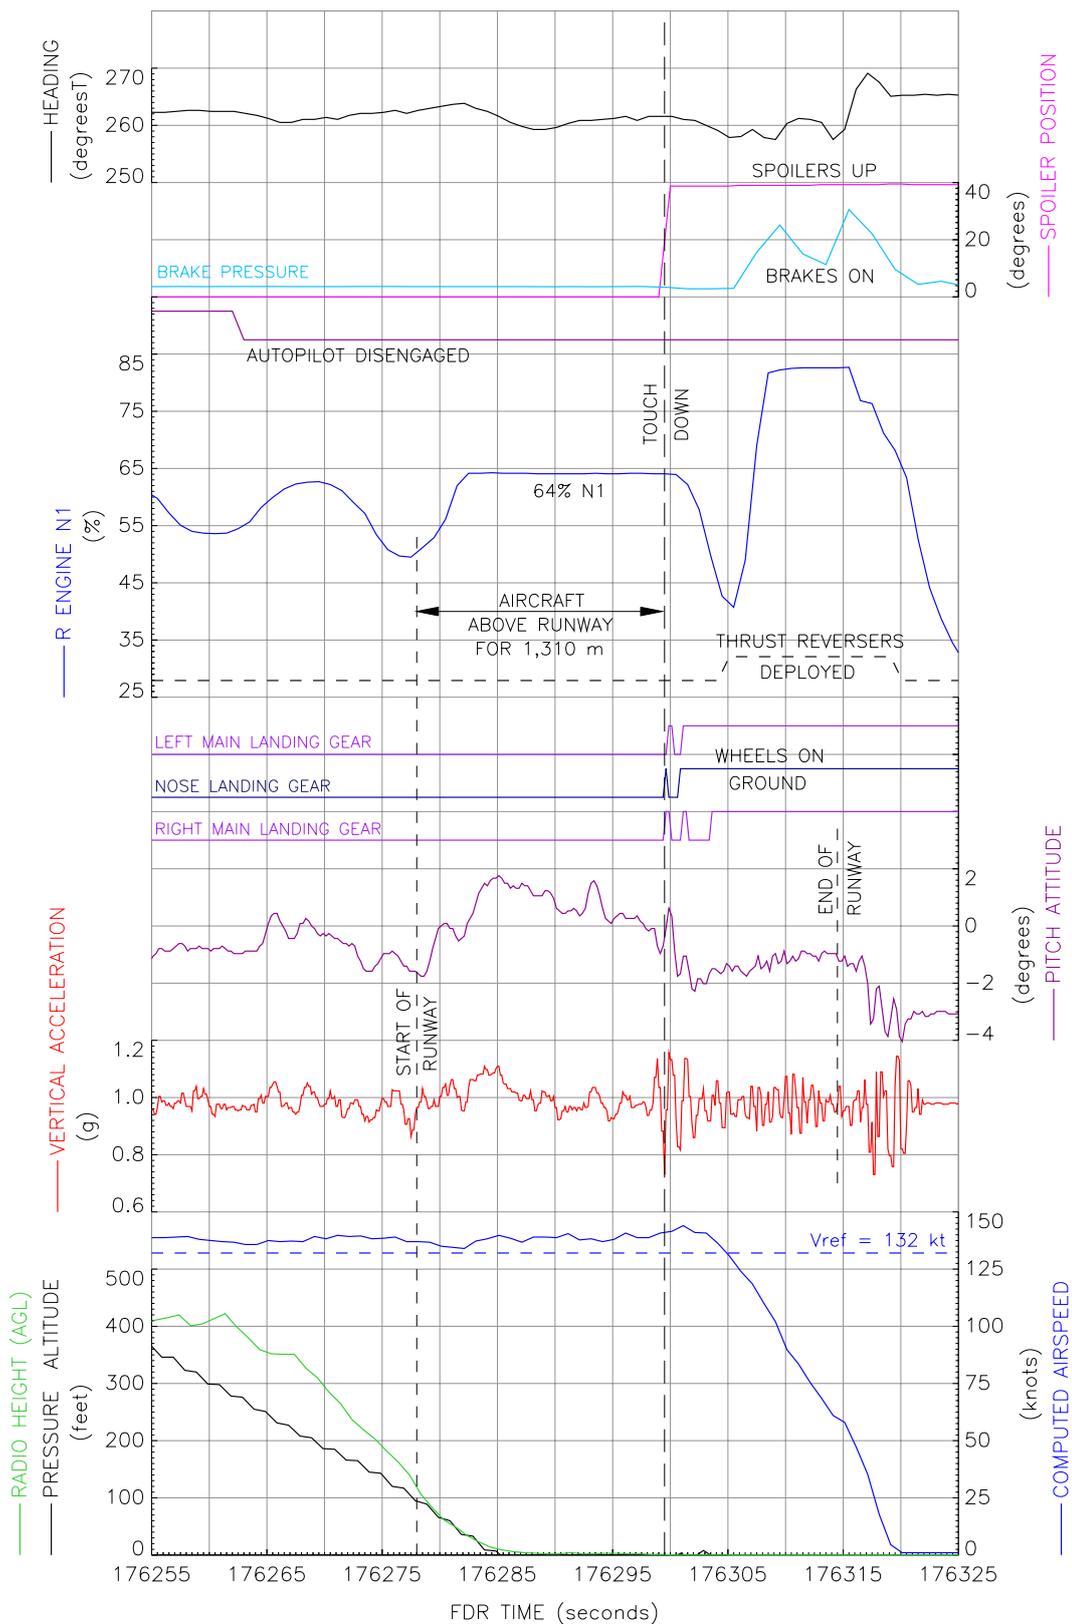
**Figure 1**  
 Salient FDR Parameters  
 (Accident to D-ABCD on 5 February 2006)

A time-history of the relevant parameters during the accident is shown at Figure 1. The data presented at Figure 1 starts 45 seconds before touchdown, with the aircraft on the extended centreline to Runway 26, 0.8 nm from the threshold. The aircraft's height was 370 ft aal and airspeed was 138 kt ( $V_{REF} + 6$ ), descending at about 720 feet/minute, with the trailing edge flaps at 45° and the landing gear down. The autopilot was ON before being disengaged seven seconds later as D-ABCD passed through 300 feet aal<sup>4</sup>.

with the engine  $N_1$ <sup>5</sup> parameters fluctuating between 50% and 63%, crossing the threshold at about 110 feet aal. At this point, the aircraft started to flare, pitching from -1.8° to 1.7° nose-up over seven seconds, while the thrust was increased to 64%  $N_1$ . Over the next 15 seconds the pitch attitude slowly decreased to zero at touchdown when the right main and nose landing gears contacted the runway first. The distance travelled over the runway before touchdown was calculated as 1,310 m. During this period the  $N_1$  remained at 64% and the airspeed varied between 134 and 141 kt.

The spoilers deployed immediately at touchdown. All three main landing gear 'weight-on-wheels' switches then showed a slight 'bounce' and the right main landing gear 'bounced' momentarily again. The thrust reversers were deployed and the brakes were applied five seconds later, after the aircraft had travelled 400 m along the runway. The aircraft then travelled a further 450 m to the end of the runway, and 130 m beyond, over the runway's stopway and onto the grass (indicated by the fall in pitch attitude as the aircraft followed the ground as it sloped down from the runway), before coming to a stop. The time from touchdown to stopping was 20 seconds.

The approach was unremarkable, and well within the appropriate parameters, until the thrust increased to 64%  $N_1$  and remained at this level until touchdown. The commander later recalled having disconnected the autothrottle close to 60 ft and the values of engine thrust (derived from the engine  $N_1$  parameter) below 50 feet radio height appear inconsistent with the operation of the autothrottle system at this point.
