**SERIOUS INCIDENT**

<b>Aircraft Type and Registration:</b>	Agusta A109C, N109TK	
<b>No &amp; Type of Engines:</b>	2 Allison 250-C20 turboshaft engines	
<b>Year of Manufacture:</b>	1991	
<b>Date &amp; Time (UTC):</b>	5 July 2011 at 0845 hrs	
<b>Location:</b>	Near Kew Bridge, London	
<b>Type of Flight:</b>	Private	
<b>Persons on Board:</b>	Crew - 2	Passengers - None
<b>Injuries:</b>	Crew - 1 (Minor)	Passengers - N/A
<b>Nature of Damage:</b>	Left windshield shattered	
<b>Commander's Licence:</b>	Private Pilot's Licence	
<b>Commander's Age:</b>	47 years	
<b>Commander's Flying Experience:</b>	1,980 hours (of which 1,400 were on type) Last 90 days - 60 hours Last 28 days - 20 hours	
<b>Information Source:</b>	Aircraft Accident Report Form submitted by the pilot and further investigation by the AAIB

**Synopsis**

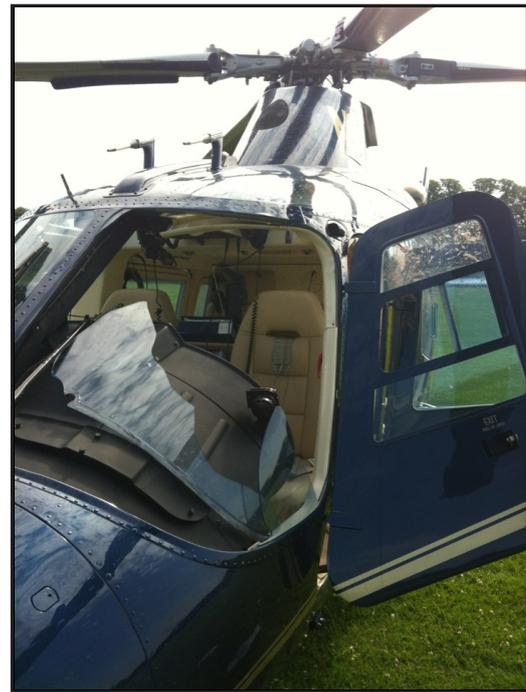
**Figure 1**

The upper portion of the left windshield, which was made of acrylic, had shattered into multiple sections

(Figure 1). The maintenance organisation's engineer reported that the largest of these was about 30 cm by 45 cm, several pieces were about 15 cm by 15 cm, and many other pieces were much smaller. He reported that none of the pieces had broken into sharp fragments. The windshield was of a type that had a thickness of  $3.81 \text{ mm} \pm 0.5 \text{ mm}$  (part number 109-0310-27-3).

The photographic evidence revealed substantial blood spatter on the left door post adjacent to the commander's seat indicating that the bird probably struck this post after shattering the windshield. The bird, which was mostly intact, was found inside the helicopter and was identified as a Herring Gull. The bird was not sent for analysis but the typical weight of a Herring Gull is 690 to 1,495 g and the species is classified as 'High' on the Hazard Probability list<sup>1</sup>.

Damage to the left windshield of N109TK

This serious incident was caused by a Herring Gull striking the helicopter's left windshield at a relative speed of about 150 kt. The commander suffered cuts and grazes as a result of being struck by pieces of acrylic and bird remains, but the bulk of the bird appears to have hit the left door post to the left of the commander's head. The Agusta A109C's windshield is not designed to withstand bird strikes and the applicable Part 27 regulations only require that it does not break into dangerous fragments. Larger helicopters, certified to Part 29, are required to be fitted with a birdstrike-resistant windshield and the NTSB has recommended to the FAA that a similar requirement be developed for Part 27 helicopters. As of December 2011 the FAA had not published a decision on the recommendation.
