INCIDENT

Aircraft Type and Registration:	Douglas DC-8-63F, YA-VIC
No & Type of Engines:	Four Pratt & Whitney JT3D-7 turbojet engines
Year of Manufacture:	1970
Date & Time (UTC):	11 August 2010 at 1045 hrs
Location:	Manston Airport (Kent International)
Type of Flight:	Commercial Air Transport (cargo)
Persons on Board:	Crew - 3 Passengers - 9
Injuries:	Crew - None Passengers - None
Nature of Damage:	Tail skid damage within operational limits. Damage to runway and adjacent surface, single approach light destroyed
Commander's Licence:	Airline Transport Pilot's Licence
Commander's Age:	55 years
Commander's Flying Experience:	15,000 hours (of which 3,000 were on type) Last 90 days - 0 hours on type Last 28 days - 0 hours on type
Information Source:	AAIB Field Investigation

Synopsis

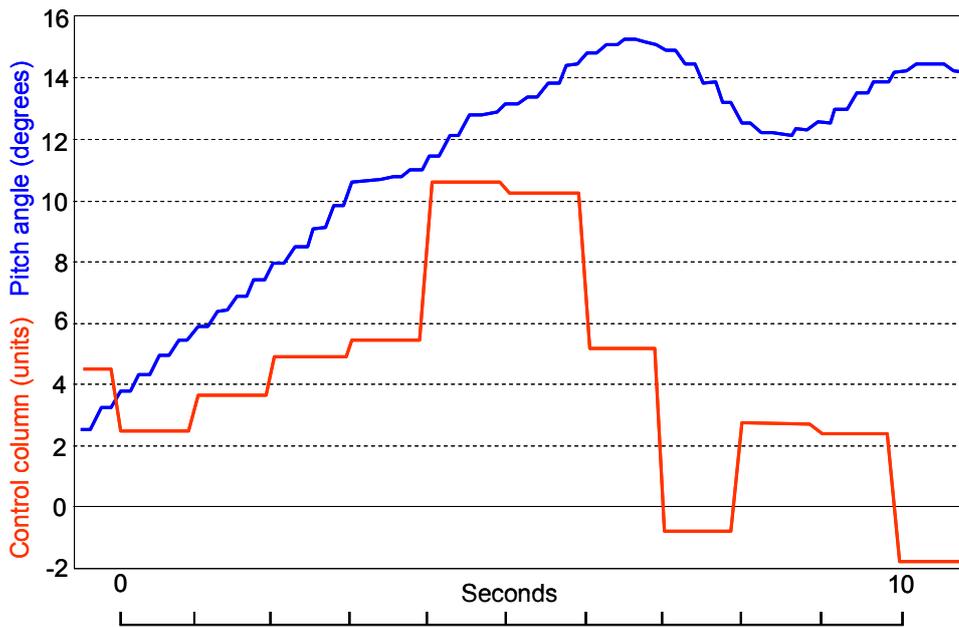
Figure 1

Aircraft pitch attitude and control column position during rotation

For the majority of the initial rotation, there was a steady aft movement of the control column (as far as can be determined, given the relatively infrequent update rate of once per second), resulting in a constant pitch rate. The aircraft reached 8° pitch in about five seconds and continued to increase at a constant rate until nearly 11°, at which point there was a marked reduction in pitch rate. A significant aft control column input was made at about this time, after which the pitch attitude continued to increase to a recorded maximum of 15.2°.

The FDR data suggests that the initial tailstrike occurred at about 11° pitch attitude, identified by a marked slowing of the rotation rate. As the AOM warned that tailstrike would occur at 8.95° pitch, the aircraft had probably just become airborne when the tail skid contacted the runway. After the initial tail strike the right main gear struck the raised approach light.
