SERIOUS INCIDENT

Aircraft Type and Registration:	DHC-8-402 Dash 8, G-JECJ	
No & Type of Engines:	2 Pratt & Whitney Canada PW150A turboprop engines	
Year of Manufacture:	2005 (Serial no: 4110)	
Date & Time (UTC):	23 October 2013 at 0540 hrs	
Location:	Manchester Airport	
Type of Flight:	Commercial Air Transport (Passenger)	
Persons on Board:	Crew - 4	Passengers - 20
Injuries:	Crew - None	Passengers - None
Nature of Damage:	None	
Commander's Licence:	Airline Transport Pilot's Licence	
Commander's Age:	51 years	
Commander's Flying Experience:	4,360 hours (of which 1,145 were on type) Last 90 days - 162 hours Last 28 days - 58 hours	
Information Source:	Aircraft Accident Report Form submitted by the pilot and additional enquiries by the AAIB

Synopsis

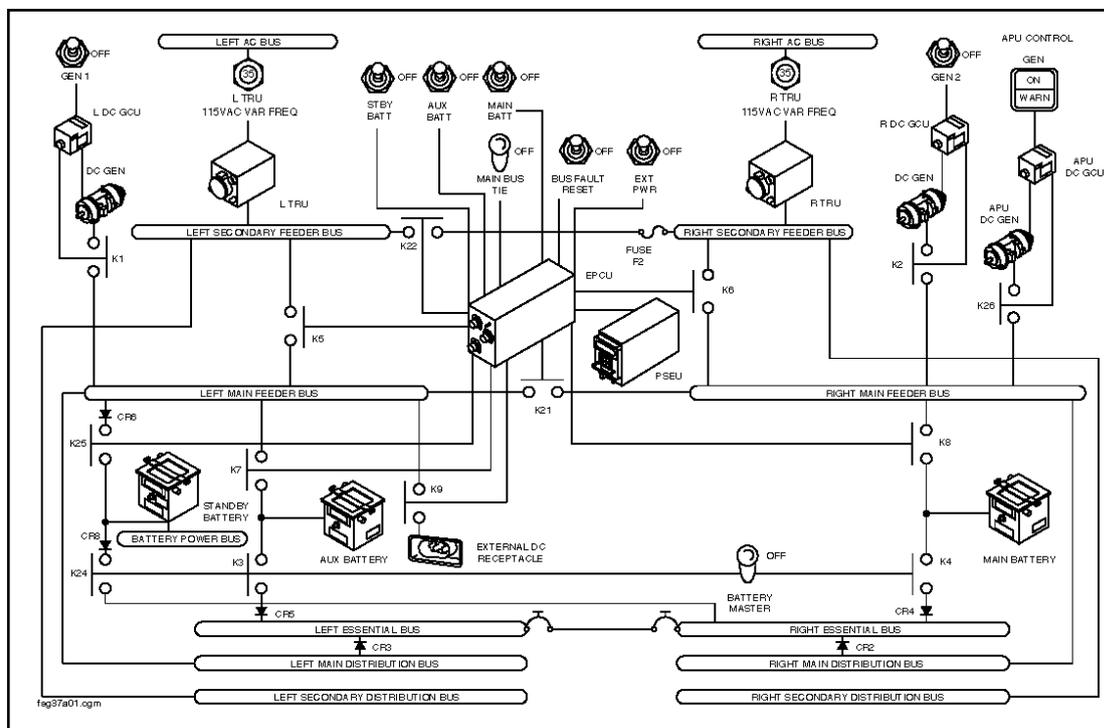
Figure 1

The Dash-8 400 has three 28v DC starter/generators associated with the left (No 1) and right (No 2) engines and the APU. In addition, the AC generation system can supply the left and right DC busses through Transformer Rectifier units. The system is designed to reconfigure automatically to cater for individual power source and bus malfunctions, by the automatic closing and opening of bus tie contactors (Figure 1)

Initial analysis of the available data (flight recorder and crew accounts) by the aircraft manufacturer suggested that there had been a malfunction of either the No 2 starter/generator, which powers the right main DC bus, or its GCU. In this condition contactor K2, which connects the No 2 generator to the right main DC bus, should open. Auxiliary contacts within K2 send a signal that this has happened to the Electrical Power Control Unit (EPCU), which closes contactor K21 and ties the right DC bus to the left, thus maintaining services supplied by the right bus. The auxiliary contacts also send a signal to the CWP to display a NO 2 DC GEN caution. It was considered likely that the auxiliary contacts within K2

had remained open either through severe pitting or interference by a foreign object. In this case there would be no indications to the EPCU or the flight crew that there was a problem, the bus tie contactor would remain open and the right bus would draw its power from the main battery, progressively losing services as the battery discharged. The series of failures reported by the crew was consistent with such an event.
