ACCIDENT

Aircraft Type and Registration:	Piper PA-30 Twin Comanche, G-ATEW	
No & Type of Engines:	2 Lycoming IO-320-B1A piston engines	
Year of Manufacture:	1965	
Date & Time (UTC):	30 May 2009 at 1340 hrs	
Location:	Sturgate Airfield, Lincolnshire	
Type of Flight:	Private	
Persons on Board:	Crew - 1	Passengers - 1
Injuries:	Crew - None	Passengers - None
Nature of Damage:	Damage to both propellers and damage to fuselage and wing underside (beyond economic repair)	
Commander's Licence:	Private Pilot's Licence	
Commander's Age:	66 years	
Commander's Flying Experience:	711 hours (of which 475 were on type) Last 90 days - 0.6 hours Last 28 days - 0 hours	
Information Source:	Aircraft Accident Report Form submitted by the pilot and further enquiries by the AAIB

Synopsis

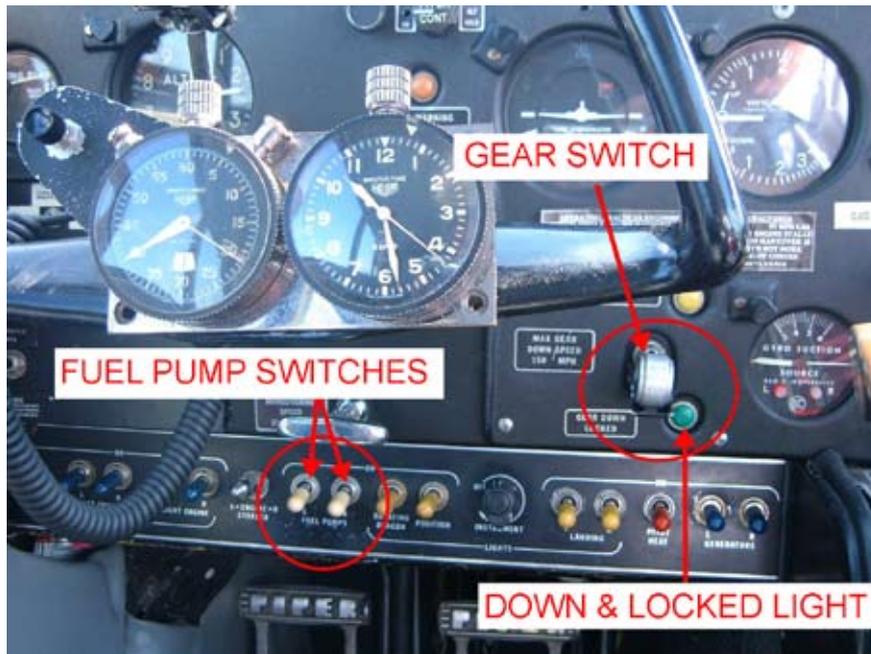
Figure 1

The position of the fuel pump switches in relation to the position of the gear switch is shown in Figure 1.

The pilot considered that either the landing gear had collapsed or retracted. He thought that a retraction might have been caused by the landing gear switch not latching down or perhaps his arm catching it when he moved his hand to turn off the fuel pumps. Since it was a flaps-up landing he did not believe he had made the mistake of reaching for the gear lever instead of the flap lever.

Location of gear switch and fuel pump switches on G-ATEW

It is possible that the gear switch was inadvertently and briefly selected up when the pilot decided to turn the fuel pump switches off. However, the action to turn the fuel pump switches off would have been to move the switches down, whereas the action to raise the gear would have been to move the gear switch up. Furthermore, the anti-retraction switch should have prevented a commanded gear retraction when there was weight on the left main gear leg. The aircraft had landed with its flaps up and following a 300-foot ground roll there would probably have been sufficient weight on the gear leg to trip the switch. However, since the anti-retraction switch was not tested, a fault with the switch or its rigging could not be ruled out.
