## ACCIDENT

<b>Aircraft Type and Registration:</b>	Extra EA 300, G-SIII	
<b>No &amp; Type of Engines:</b>	1 Lycoming AEIO-540-L1B5 piston engine	
<b>Year of Manufacture:</b>	1994	
<b>Date &amp; Time (UTC):</b>	12 September 2008 at 1825 hrs	
<b>Location:</b>	On the runway at White Waltham Airfield	
<b>Type of Flight:</b>	Private	
<b>Persons on Board:</b>	Crew - 1	Passengers - 1
<b>Injuries:</b>	Crew - None	Passengers - None
<b>Nature of Damage:</b>	Damage to the propeller, left hand landing gear strut, left wing and the fuselage	
<b>Commander's Licence:</b>	Airline Transport Pilot's Licence	
<b>Commander's Age:</b>	43 years	
<b>Commander's Flying Experience:</b>	9,500 hours (of which 25 were on type) Last 90 days - 130 hours Last 28 days - 28 hours	
<b>Information Source:</b>	AAIB Field Investigation

### Synopsis

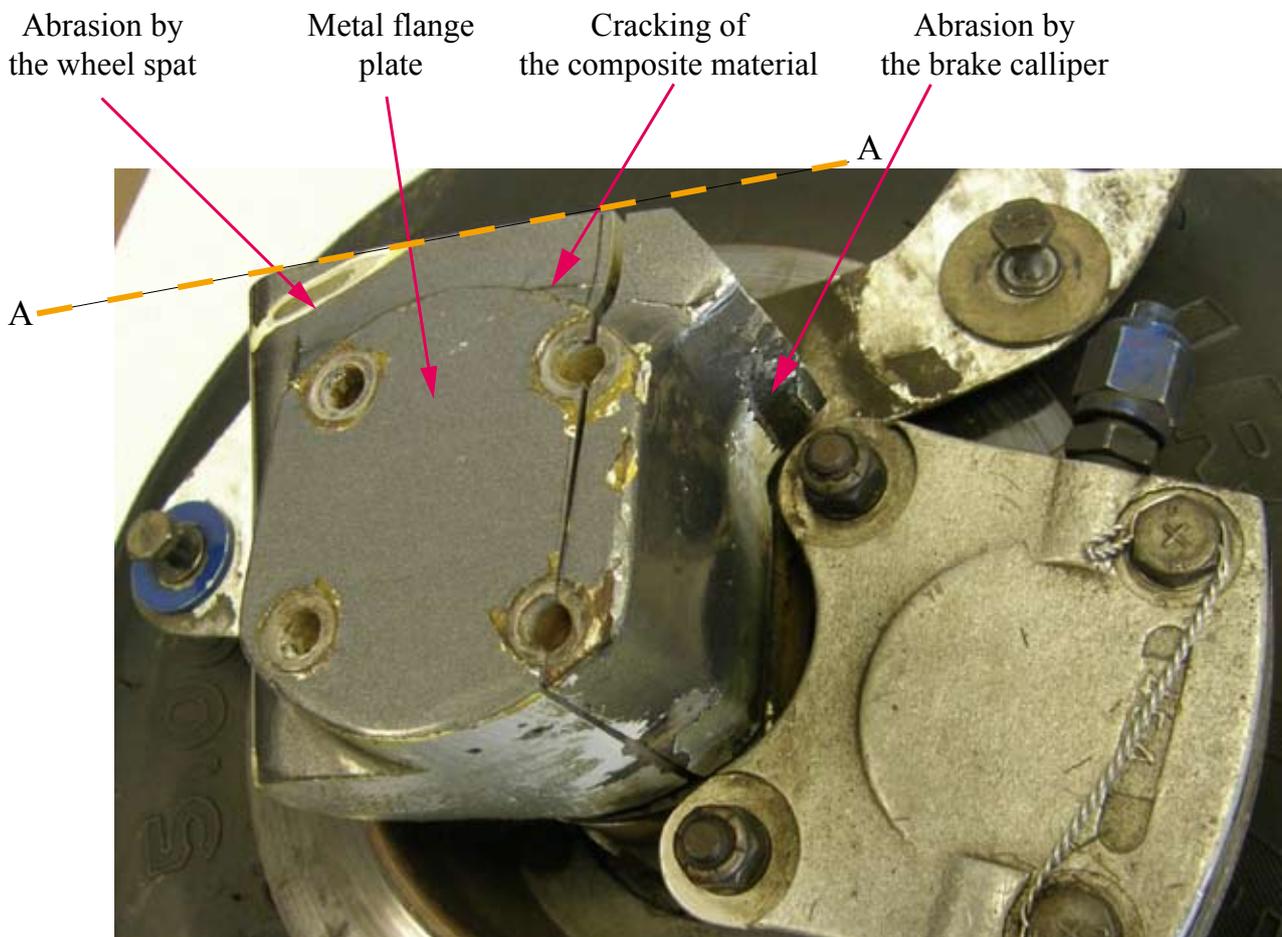
**Figure 1**

A study of the right landing gear leg in the area of the wheel attachment, which had not failed, revealed the presence of composite material abrasion and cracking in similar locations to those identified on the left side. In common with the left side fractures, the cracks on the right side also showed signs of staining, indicating a progressive accumulation of damage, although in both cases the time period could not be determined. The similarity between the damage in the right and left landing gears suggests that both were subject to the same failure mechanisms, with the left failing first due to a single high load. The damage accumulating on the inboard and aft surfaces would have significantly weakened the composite material around the wheel attachment, leading to failure.

As a result of the findings of the QinetiQ examination the right wheel, wheel spat and wheel brake assembly were refitted to the composite landing gear (Figure 1) and it was found that the inner upper corner of the brake calliper had abraded the composite material to the extent that it exposed the glass fibre fabric. This allowed contaminants such as moisture, brake dust and hydraulic fluid to penetrate the inner structure of the composite leg. The abrading of the outer layer of the cotton-flock filled composite material was deeper on the failed left landing gear leg than the right.

The reassembled ‘original design’ right landing gear from G-SIII (wheel and brake mounting cut from main U-shaped carrier along line A - A)

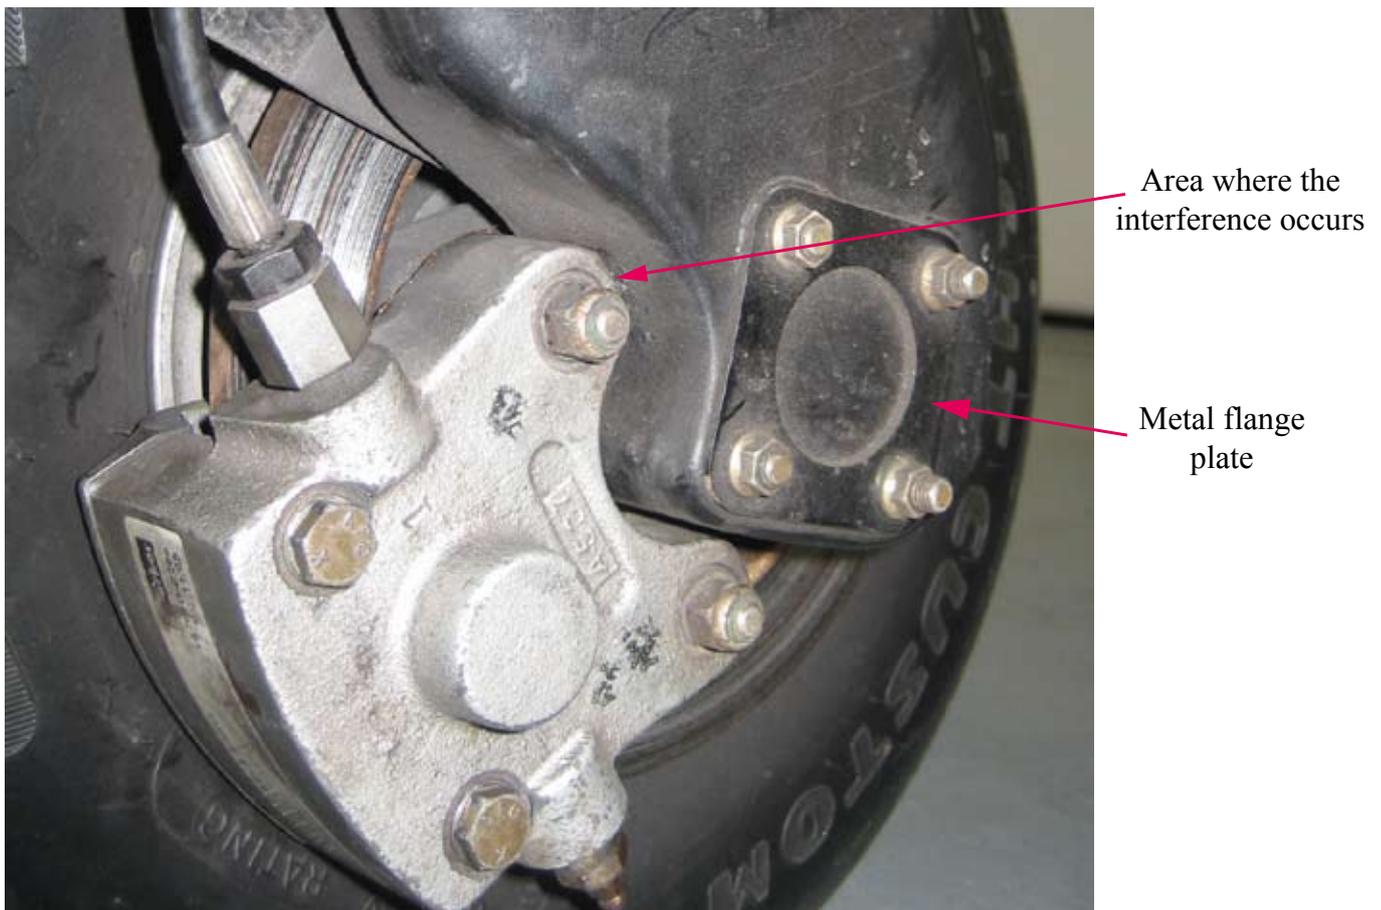
**Figure 2**

A number of other Extra 300 model aircraft were examined, some with and some without the redesigned composite U-shaped carrier. All of them showed varying degrees of abrasion of the composite material by the brake calliper and, to a lesser degree, the wheel spat. Cracking of the composite material in the area of the metal flange plate was only seen on the 'original design' composite U-shaped carrier.

Interference between the brake calliper and the 'redesigned' landing gear leg

*'Visually inspect complete main landing gear spring for dents, cracks and deformations, especially in the area of the mounting clamps and the axle attachments, when wheels and brake callipers are removed.'*

It is recommended that the Luftfahrt-Bundesamt (LBA) review the continued airworthiness of the main landing gear fitted to Extra EA 300 aircraft to ensure the integrity of the outer layer of the cotton flock filled composite material.
