**ACCIDENT**

<b>Aircraft Type and Registration:</b>	Cessna 152, G-BHYX	
<b>No &amp; Type of Engines:</b>	1 Lycoming O-235-L2C piston engine	
<b>Year of Manufacture:</b>	1978 (Serial no: 152-81832)	
<b>Date &amp; Time (UTC):</b>	19 May 2014 at 1327 hrs	
<b>Location:</b>	Westfield Farm, 7 miles SSW of Cranfield Airport	
<b>Type of Flight:</b>	Private	
<b>Persons on Board:</b>	Crew - 1	Passengers - 1
<b>Injuries:</b>	Crew - None	Passengers - None
<b>Nature of Damage:</b>	Damage to propeller, fuselage, engine mounting frame, engine cowlings, front and rear screens, rudder and tailplane	
<b>Commander's Licence:</b>	Private Pilot's Licence	
<b>Commander's Age:</b>	29 years	
<b>Commander's Flying Experience:</b>	173 hours (of which 165 were on type) Last 90 days - 43 hours Last 28 days - 21 hours	
<b>Information Source:</b>	Aircraft Accident Report Form submitted by the pilot

**Synopsis**

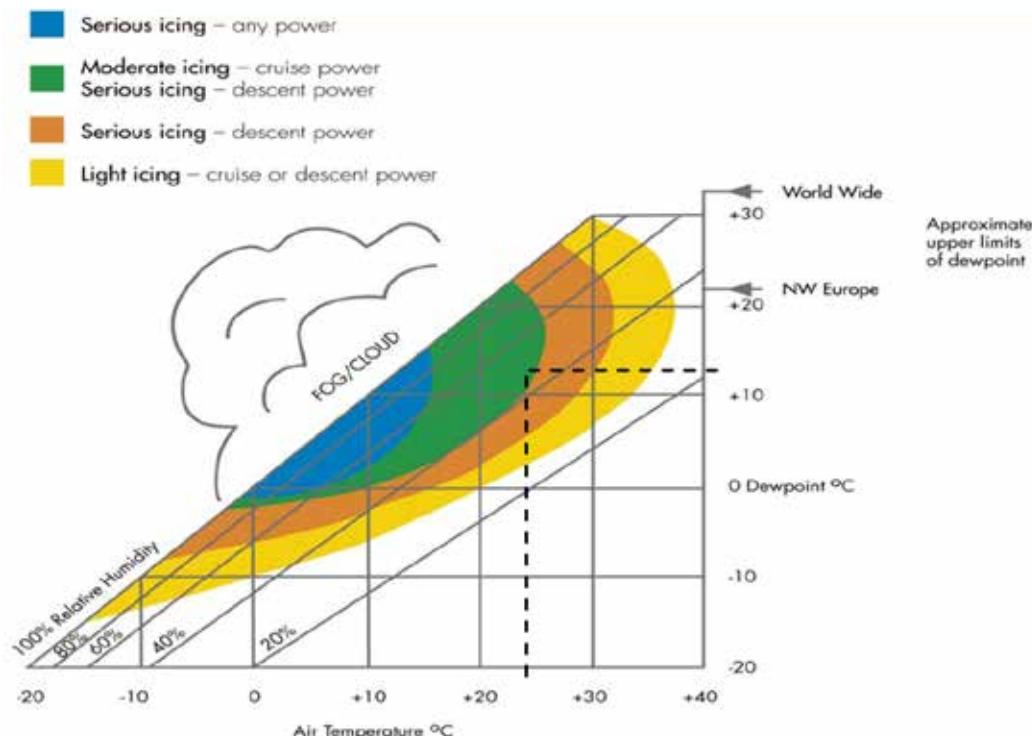
**Figure 1**  
CAA Carburettor icing chart

CAA Safety Sense Leaflet 14 provides advice on carburettor icing and at the temperature and dew points reported at the time of the accident there would have been a moderate risk of icing during the cruise. Figure 1 shows the CAA Carburettor icing chart. The CAA advise that carburettor heat should be applied for at least 15 seconds in order to prevent and clear any carburettor icing.
