ACCIDENT

Aircraft Type and Registration:	Eurocopter AS350B3 'Ecureuil', G-BZVG	
No & Type of Engines:	1 Turbomeca Arriel 2B turboshaft engine	
Year of Manufacture:	2000	
Date & Time (UTC):	18 October 2004 at 1300 hrs	
Location:	Oxford Kidlington Airport	
Type of Flight:	Training	
Persons on Board:	Crew - 2	Passengers - None
Injuries:	Crew - 1 (Serious)	Passengers - N/A
Nature of Damage:	Extensive damage to fuselage and main rotors	
Commander's Licence:	Airline Transport Pilot's Licence with Instructor Rating	
Commander's Age:	53 years	
Commander's Flying Experience:	6,862 hours (of which 420 were on type) Last 90 days - 144 hours Last 28 days - 20 hours	
Information Source:	Aircraft Accident Report Form submitted by the commander plus further enquiries and examination of the helicopter and its control system components

Synopsis

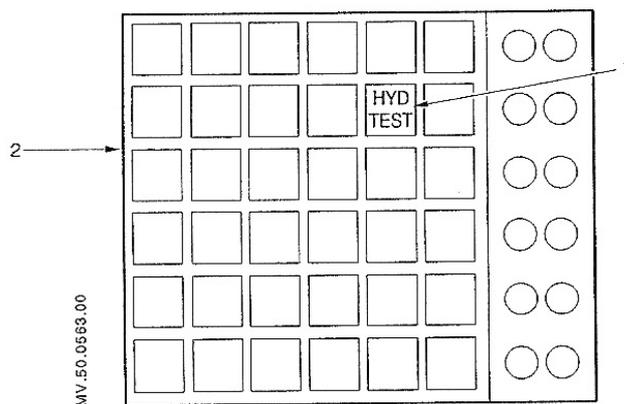
Figure 1

In steady cruise flight, actuating the "HYD TEST" (1) pushbutton on the central console (2) produces the same effects as a real failure :

- . The hydraulic pump pressure is by-passed.
- . The main rotor accumulators give hydraulic assistance for a limited time.

The only difference from the real failure is that the tail rotor accumulator is discharged by this action and the pedal control loads are increased.

In stabilized cruise flight conditions, depress the "HYD TEST" (1) (Figure 1) pushbutton.

Reset the "HYD TEST" (1) pushbutton (up position) to restore hydraulic pressure in tail rotor accumulator.

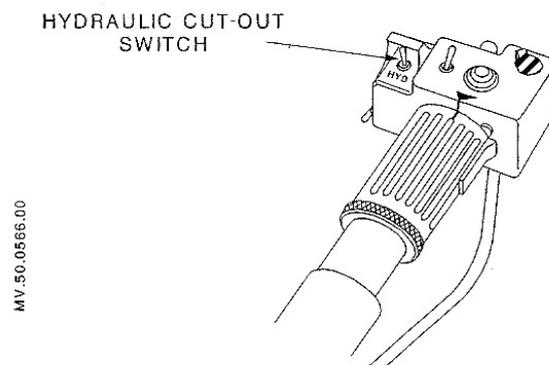
Figure 2

Cut-off the hydraulic pressure switch (Figure 2) on the collective lever, the control loads are felt within 1 or 2 seconds. The "gong" sounds again.

After landing, and before any other take-off or hovering flight, reset the hydraulic pressure switch (3) forward to restore hydraulic pressure, check that the red HYDR light goes off within 3 seconds.
