Aircraft type and registration: Gemini/Striker G-MMXX (Microlight)

Date and time (GMT): 28 September 1985 at 1530 hrs

Location: Fordingbridge, Hampshire

Information Source: AIB Field Investigation.

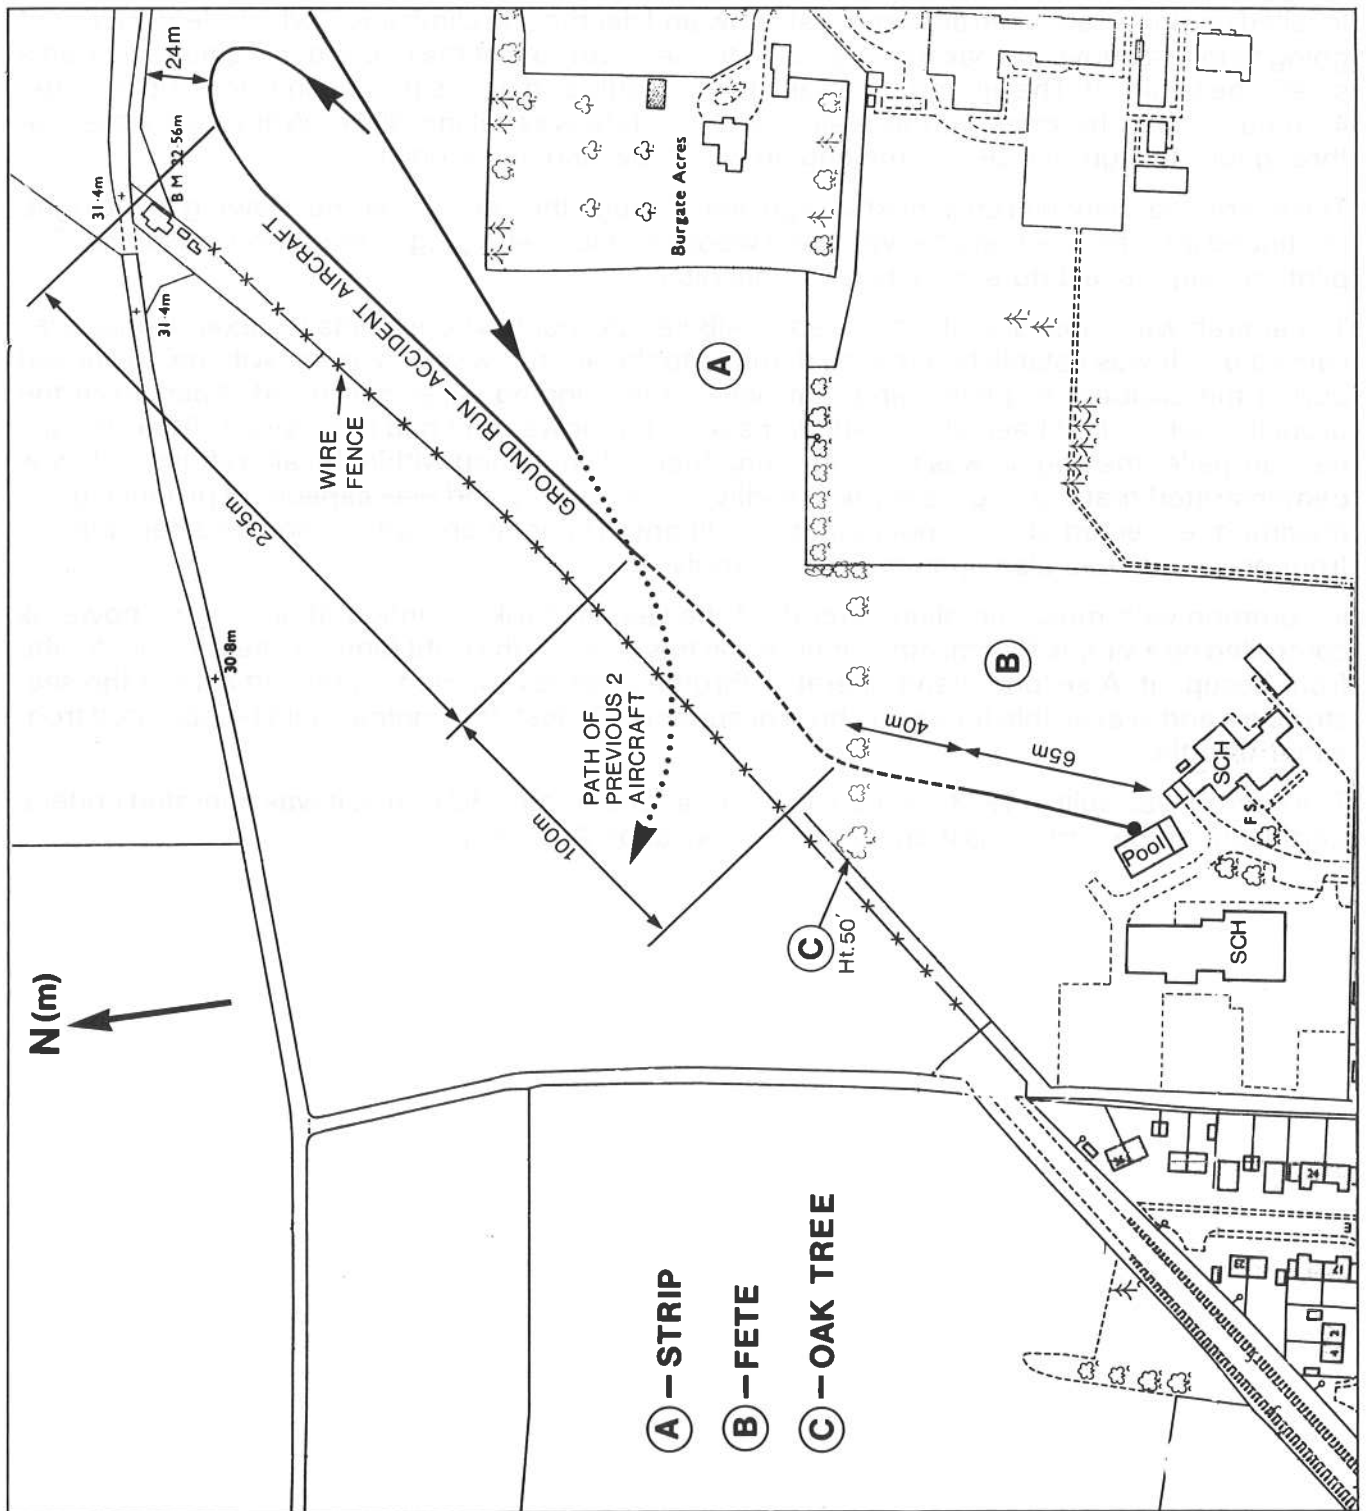
The local Schools Association had organised a fete, to be held on playing fields 'B' (see diagram) behind Fordingbridge school, and had asked the owner of a Mistral microlight aircraft to carry out a fly past. The pilot refused this request on the grounds of danger to the public and legality but, having inspected the area on foot, asked if he could land in field 'A' in order to attend the fete. This was agreed and the pilot decided that the presence of a farm, a road, and some powerlines at the north east end of the strip dictated that take-off and landing would, wind permitting, be in a south westerly direction. The wind at the time of the accident, later that day, was less than 5 knots and variable but generally from the south.

Following a short stay at the fete, two of the aircraft taxied out to the take-off point, at the north east end of the strip, and aligned their aircraft to aim slightly to the north of an oak tree 'C'. With about one minute separation they took off and turned to the right to cross the north west boundary of the strip, a wire fence, about two thirds of the way along its length. They then circled the field on the other side of the fence whilst the accident aircraft taxied out and took off.

The Gemini/Striker taxied down the southern side of the strip and the pilot later stated that he performed the take-off and power checks whilst taxiing. Some 25 metres from the boundary fence he made a left 'U' turn and, without stopping, began the take-off run. This manoeuvre provided a Take-Off Distance available (TODA) of 335 metres to the 50 feet high oak tree at the far

end of the strip. The aircraft manual states that 180 metres are required to clear a 50 feet 'screen' height. The ground marks indicated that the take-off run was approximately parallel to the fence on the north west side of the strip and some 24 metres from it. It was also apparent that the aircraft veered slightly to the left just before lift off.

The aircraft was seen to climb rapidly to a height estimated as 10 to 30 feet where it successively levelled or dipped and then assumed a shallow and decreasing climb angle which clearly was not going to take it above the oak tree. It passed to the south east of the oak and marginally cleared a small tree beside it. The aircraft then sank fairly rapidly and hit the ground in a nose-up attitude, 40 metres past the trees, in the area where the fete was taking place. Witnesses state that throughout this ground period the engine was providing some power.

The aircraft continued in an almost straight line through the fete stands and, slewing to the right, continued into the junction of a wall and a wooden fence belonging to the school buildings. The pilot and eight spectators were taken to hospital.
