**ACCIDENT**

<b>Aircraft Type and Registration:</b>	Cirrus SR22, N404RW	
<b>No &amp; Type of Engines:</b>	1 Continental Motors IO-550-N piston engine	
<b>Year of Manufacture:</b>	2009	
<b>Date &amp; Time (UTC):</b>	5 April 2010 at 1253 hrs	
<b>Location:</b>	White Waltham Airfield, Berkshire	
<b>Type of Flight:</b>	Private	
<b>Persons on Board:</b>	Crew - 1	Passengers - 1
<b>Injuries:</b>	Crew - None	Passengers - None
<b>Nature of Damage:</b>	Aircraft destroyed	
<b>Commander's Licence:</b>	Private Pilot's Licence	
<b>Commander's Age:</b>	51 years	
<b>Commander's Flying Experience:</b>	400 hours (of which 15 were on type) Last 90 days - 45 hours Last 28 days - 10 hours	
<b>Information Source:</b>	AAIB Field Investigation

**Synopsis**

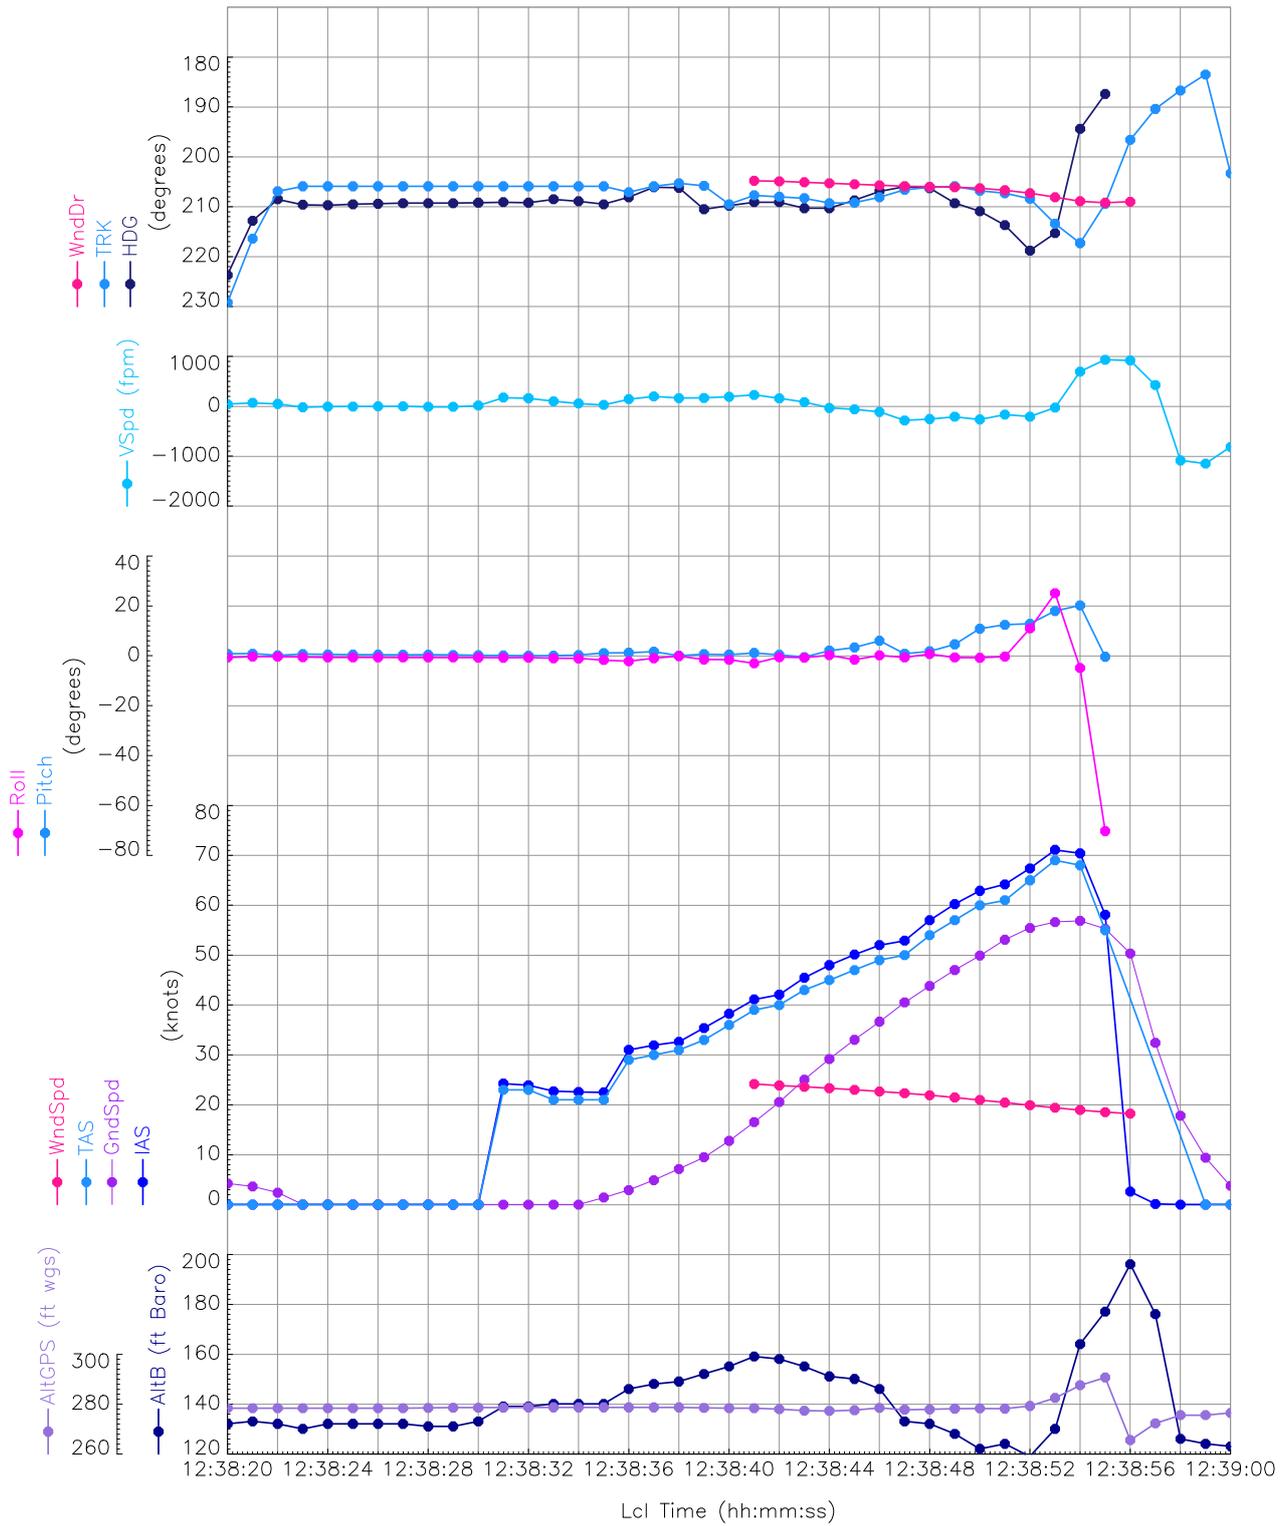
**Figure 1**  
Display data

The display data showed that following a small pitch oscillation at about 52 kt, the aircraft's pitch attitude began increasing at 57 kt, reaching 11° nose-up before the aircraft rolled right and then rapidly left (see Figure 1).

There was no evidence of a technical cause for the accident. It is probable that the undulating runway contributed to the aircraft becoming airborne at a low speed, and the pilot lacked training and experience on the aircraft type that might have assisted him in controlling the situation.
