ACCIDENT

Aircraft Type and Registration:	Team Himax 1700R, G-CCAJ	
No & Type of Engines:	1 Rotax 447 piston engine	
Year of Manufacture:	2003	
Date & Time (UTC):	30 August 2005 at 1216 hrs	
Location:	Rhigos, South Wales	
Type of Flight:	Private	
Persons on Board:	Crew - 1	Passengers - None
Injuries:	Crew - 1 (Serious)	Passengers - N/A
Nature of Damage:	Aircraft destroyed	
Commander's Licence:	Private Pilot's Licence	
Commander's Age:	67 years	
Commander's Flying Experience:	846 hours (of which 80 were on type) Last 90 days - 14 hours Last 28 days - 9 hours	
Information Source:	AAIB Field Investigation

The aircraft took off, carried out an abbreviated circuit and stalled at a low height on the base turn. The ground impact was in a steep nose-down attitude and the pilot suffered serious injuries. One safety recommendation was made.

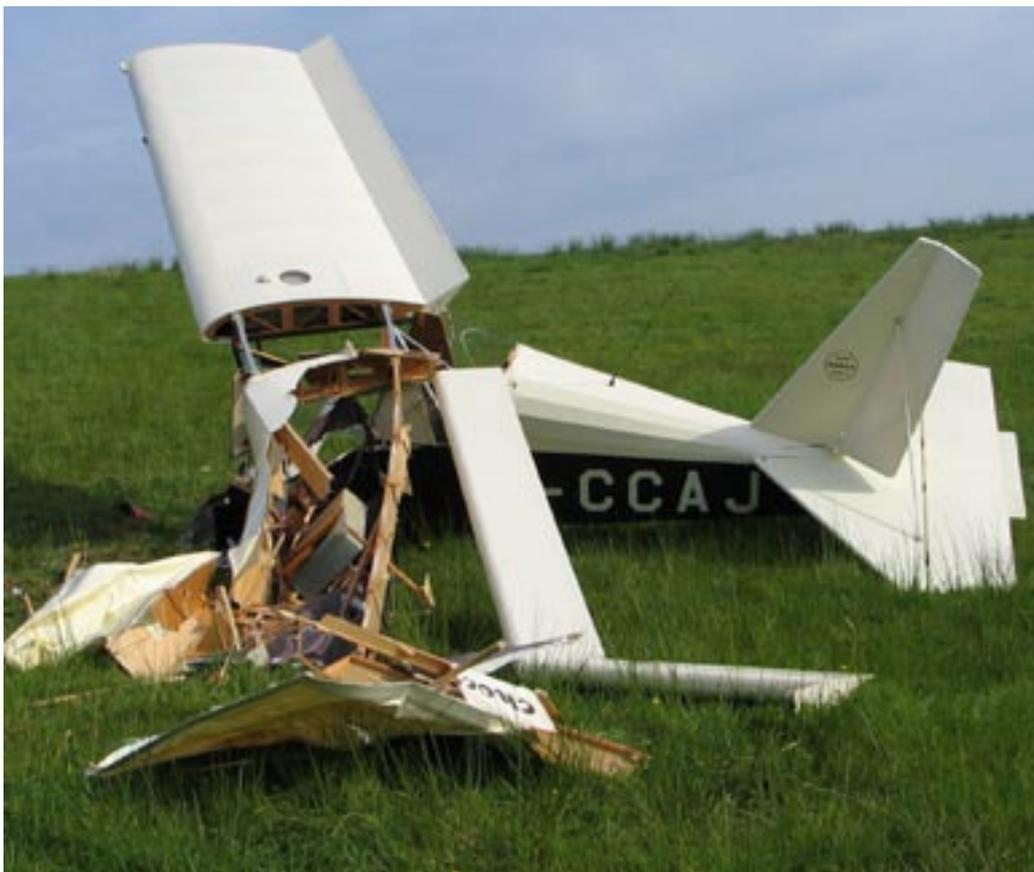
Figure 1
Crash site

From the wreckage and ground marks it was established that the aircraft crashed within the airfield boundary approximately 42 m south of Runway 07 on a heading of 231°. Ground marks from the left wing tip, which broke off on impact, and broken fragments from the

cockpit floor indicated that the aircraft struck the ground left wing first at a nose-down angle of between 60° and 80°. The left wing, the fuselage forward of the cockpit and the left side of the cockpit were totally destroyed. There was minor damage to the leading edge of the right wing; however the landing gear and structure aft of the cockpit were undamaged. The fuel tanks, which were $\frac{2}{3}$ full, were intact. One of the propeller blades had broken off close to the hub and fragments of the blade were discovered in a hole approximately 0.6 m wide and 0.12 m deep. The aircraft was equipped with a four-point harness of which the shoulder harness securing cable had failed at its anchor point. There were no ground marks beyond the immediate vicinity of the aircraft. See Figure 1.

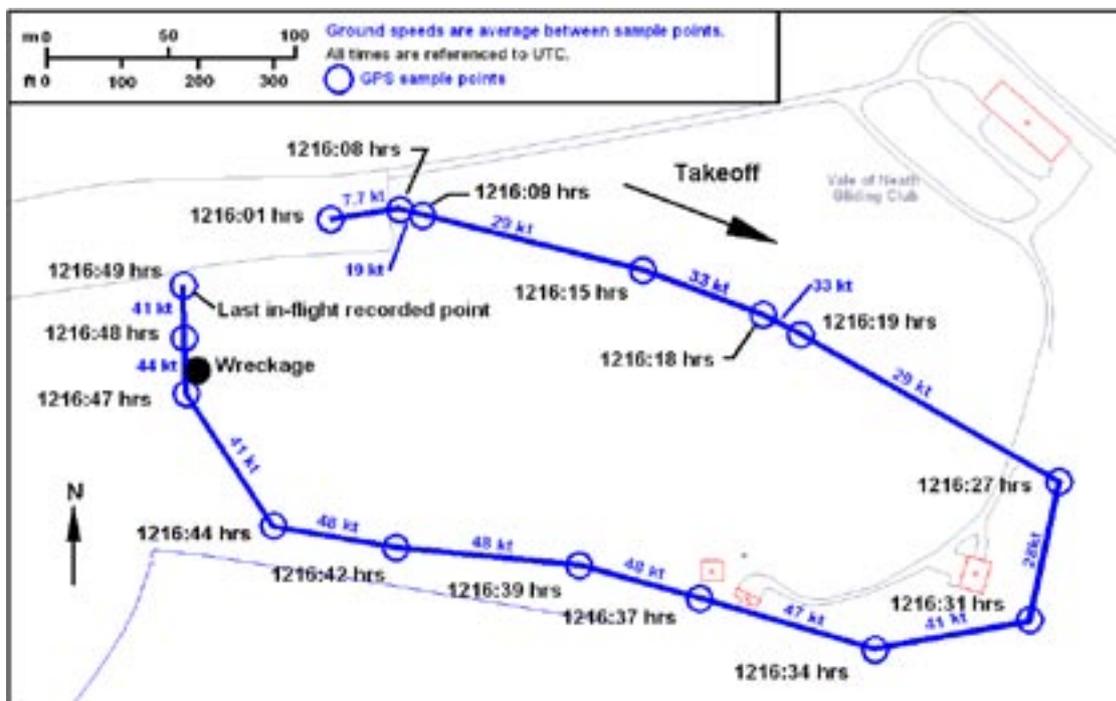
Figure 2
GPS plot

There were 11 track logs recorded on the GPS, the first recorded on 7 August 2005 and the last covered all the flying carried out on 30 August 2005. The flying on 30 August started at 0944 hrs near Gloucester. The aircraft landed at Rhigos at 1053 hrs. The take-off roll of the accident flight started at 1216:08 hrs with the aircraft's track varying between 107°M and 122°M. The aircraft became airborne and the ground speed peaked at approximately 33 kt. It then started to

decrease as the aircraft turned to the right, reducing to 28 kt on a track of 195°M. The ground speed then quickly increased to a maximum of 48 kt as the aircraft turned through west, reducing again to 41 kt as it then turned north. After this, no further track points were recorded. Figure 2 shows the GPS sample points of the final flight.

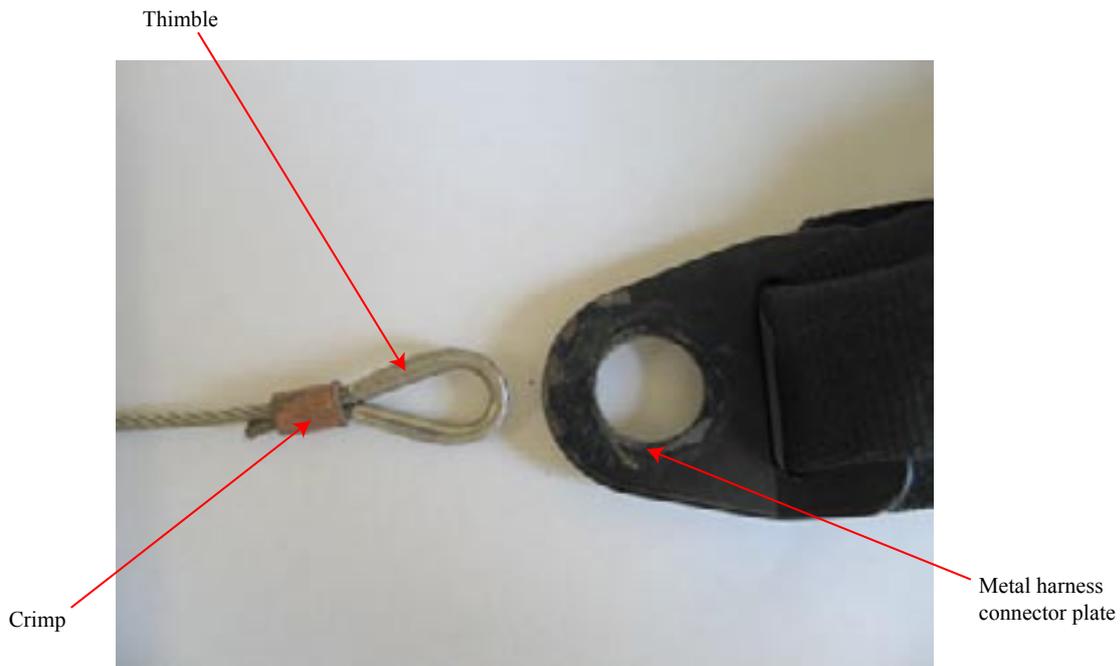
Figure 3

Connection of harness to cable (Note the thimble should be fitted over the lug of the harness connector, joining the cable directly to the connector plate)

by crimping the cable end around a thimble inserted through the lug of the harness connector plate. (Fig. 3) It did not indicate that the connector plates of the two shoulder straps should be constrained to stay together.

It was also observed that, at its forward end, the cable had not been connected to the shoulder straps in accordance with the design drawing. Instead both ends of the cable had been crimped around thimbles and both thimbles had then been connected to both shoulder straps using a single shackle passing through all four apertures. Whilst there was slight distortion to the pin in the shackle, the connection between the two straps remained intact. This deviation from the drawing had not been authorised by a concession issued by the PFA.

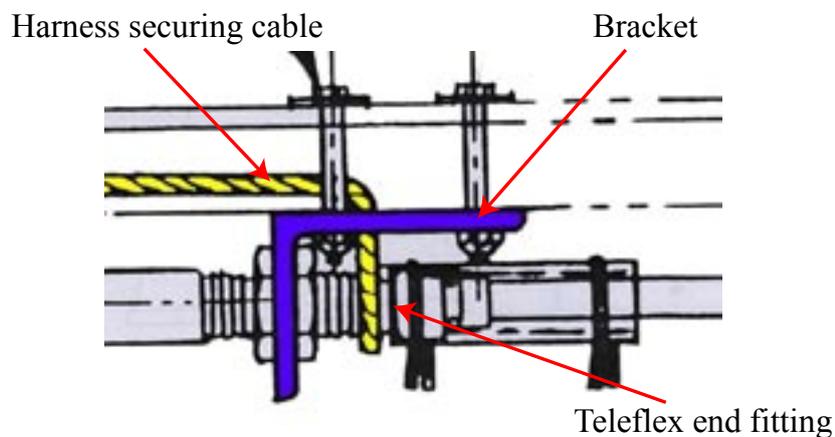
Figure 4

At the aft end of the fuselage, the cable passed downwards, with a tight 90° bend, through one hole in the horizontal

flange of the bracket which supported the aft ends of the two elevator Teleflex cables. The harness cable then was looped underneath the Teleflex outer sheath end fittings before passing up through another hole in the horizontal flange and, with another tight 90° bend, forward again to the pilot's shoulder harness. (Fig. 4)

Routing of shoulder harness securing cable in rear fuselage

It is recommended that the Popular Flying Association reviews the design of the attachments of the shoulder harness and its securing cable in the rear fuselage of Team Himax and Minimax aircraft, to reduce the possibility of the shoulder harnesses slipping off the pilot's shoulders and to ensure that all bends in the restraining cable are of greater than the minimum bend radius recommended by the cable manufacturer and not routed over sharp edges.

Following circulation of this Report and Safety Recommendation, in draft form, the PFA has issued an approved modification (MOD/186/009) which introduces an improved fixing of the aft attachment of the harness cables.

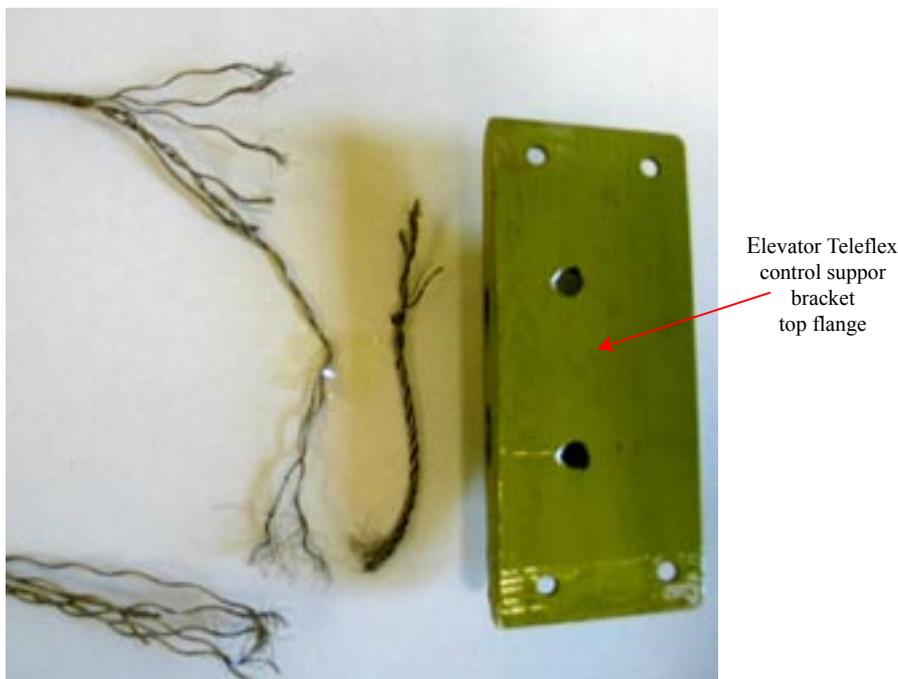
Figure 5

The shoulder harness attachment cable was found to have failed at the two points where it passed through the holes in the elevator Teleflex cable mounting bracket. (See Figure 5.) The failed shoulder harness cable and attachment bracket were subjected to further analysis.

Further examination by optical and scanning electron microscope techniques revealed that the cable was in good condition with no evidence that any of the strands in the cable had broken or been subject to fretting prior to the accident. Assessment of the failure of individual strands indicated that the cable had failed in shear. It was concluded that the damage to the cable was consistent with a tensile load having been applied to the cable and the cable failing in shear at the edges of the holes where the cable turned through a tight radius.

Shoulder harness cable and elevator Teleflex cable mounting bracket

The PFA confirmed that the design called for a galvanised carbon steel cable rather than the stainless steel cable fitted to this aircraft. Notwithstanding this discrepancy, the damage to the cable indicates that it was a combination of the tensile load and the tight radius through which the cable turned around the holes

in the mounting bracket that caused it to fail in shear. It was considered unlikely that the change of material of the harness cable had significantly affected its mode of failure or the load at which it failed. Whilst the method used on this aircraft of securing the shoulder harness to the forward ends of the cable, by a shackle, had a number of advantages over that required by the design, there was no evidence that the owner had either sought a concession, or undertaken any analytical work before selecting the particular shackle used. It is considered, however, that the intent of this deviation from design resulted in the shoulder restraint being more effective by reducing the likelihood of the straps slipping sideways off the pilot's shoulder. The following recommendation is made in order to improve the effectiveness of the safety harness on the Team Himax and Minimax aircraft:
