ACCIDENT

Aircraft Type and Registration:	BFC Challenger II, G-BYKU	
No & Type of Engines:	1 Rotax 582 piston engine	
Year of Manufacture:	2007	
Date & Time (UTC):	22 July 2008 at 0950 hrs	
Location:	On approach to Runway 25 at Otherton Airfield, Staffordshire	
Type of Flight:	Private	
Persons on Board:	Crew - 1	Passengers - None
Injuries:	Crew - None	Passengers - N/A
Nature of Damage:	Damage to propeller, fuselage fabric and dorsal longeron	
Commander's Licence:	Private Pilot's Licence	
Commander's Age:	71 years	
Commander's Flying Experience:	243 hours (of which 5 were on type) Last 90 days - 22 hours Last 28 days - 5 hours	
Information Source:	Aircraft Accident Report Form submitted by the pilot and AAIB inquiries

Synopsis

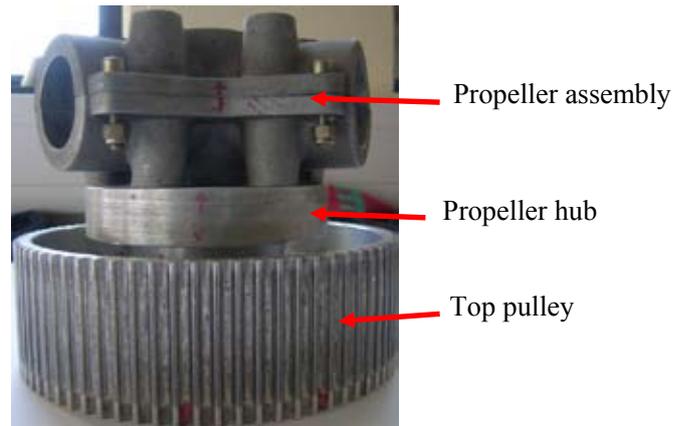
Figure 1

The propeller blades are mounted on a reduction drive assembly (Figure 1) which consists of a propeller assembly, propeller hub and top pulley, all of which are manufactured from aluminium alloy. The propeller hub is attached to the top pulley by six steel Allen head bolts, each of which screws into a threaded blind hole in the top pulley. Steel bolts are used to secure the propeller assembly to the hub.

Reduction drive assembly

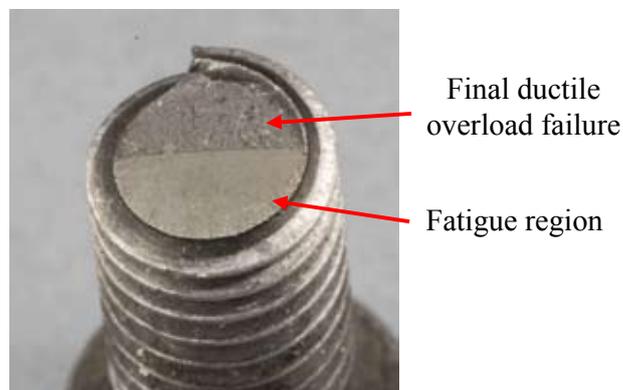
Figure 2

One bolt was recovered intact; the remaining five had all broken between 10 and 16 mm below the bottom of the bolt head. The fracture surfaces of the broken bolts all showed smooth and ductile overload regions indicative of fatigue progression leading to final failure in overload (Figure 2). The threaded portion of the bolts was approximately 29 mm long and the shank approximately 2 mm long.

Typical fracture surface on broken Allen head bolt

From the available evidence, it is probable that thread locking compound was not applied to the six propeller hub mounting bolts, which subsequently vibrated loose. This led to the initiation of fatigue cracks in the bolts which led to the bolts finally failing in ductile overload during the accident flight.

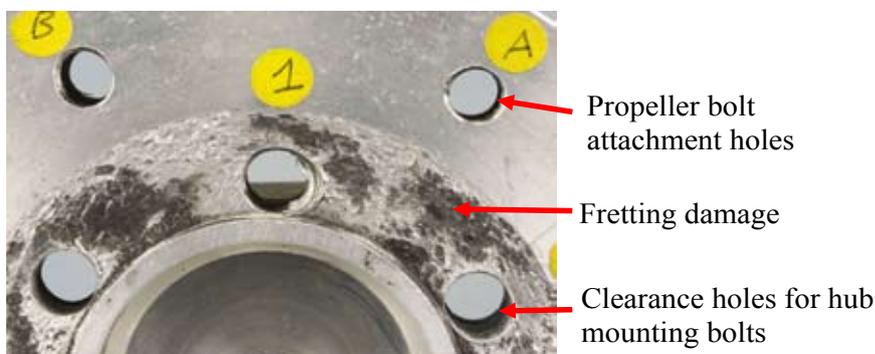
Figure 3

There was extensive fretting damage on the face of the propeller hub which was in contact with the top pulley (Figure 3). The clearance holes for the hub mounting bolts were all deformed and an impression of the thread from the bolts had formed on one side of each of the holes. The threads in five of the

six holes into which the propeller assembly attachment bolts fit were found to be intact. Part of the thread was missing from the sixth hole.

Damage to propeller hub

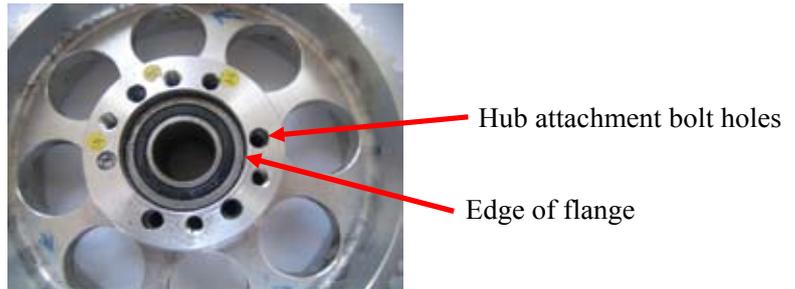
Figure 4

The top pulley had six blind threaded holes into which the hub mounting bolts were secured. One hole contained part of a bolt that had broken off approximately flush with the surface of the pulley, one hole was in relatively good condition and the remaining holes all showed some damage in the form of stripped threads and ovality. The depths of five of the blind holes were measured and found to range from 33.4 to 34.6 mm. It was not possible to establish accurately the depth of the hole containing the broken bolt.

Following this accident, the LAA were concerned that the distance between the side of the threaded hub attachment bolt holes and the edge of the flange of the top pulley might have been insufficient to prevent distortion of the hole and failure of the threads (Figure 4). Therefore, with the permission of the AAIB, the LAA drilled and tapped an additional hole in the flange of the top pulley and established that the threads failed at a torque of 35 lbf ft. This is approximately 2.3 times greater than the torque specified in the build instructions for the hub attachment bolts.

Top pulley
