ACCIDENT

Aircraft Type and Registration:	Luton LA4A Minor, G-ASEB	
No & Type of Engines:	1 Lycoming O-145-A2 piston engine	
Year of Manufacture:	1963	
Date & Time (UTC):	17 September 2009 at 1740 hrs	
Location:	1 mile north-east of Thatcham, near Newbury, Berkshire	
Type of Flight:	Private	
Persons on Board:	Crew - 1	Passengers - None
Injuries:	Crew - None	Passengers - N/A
Nature of Damage:	Damage to fuselage, landing gear and propeller	
Commander's Licence:	National Private Pilot's Licence	
Commander's Age:	62 years	
Commander's Flying Experience:	376 hours (of which 150 were on type) Last 90 days 12 hours Last 28 days - 4 hours	
Information Source:	Aircraft Accident Report Form submitted by the pilot and further enquiries by the AAIB

Synopsis

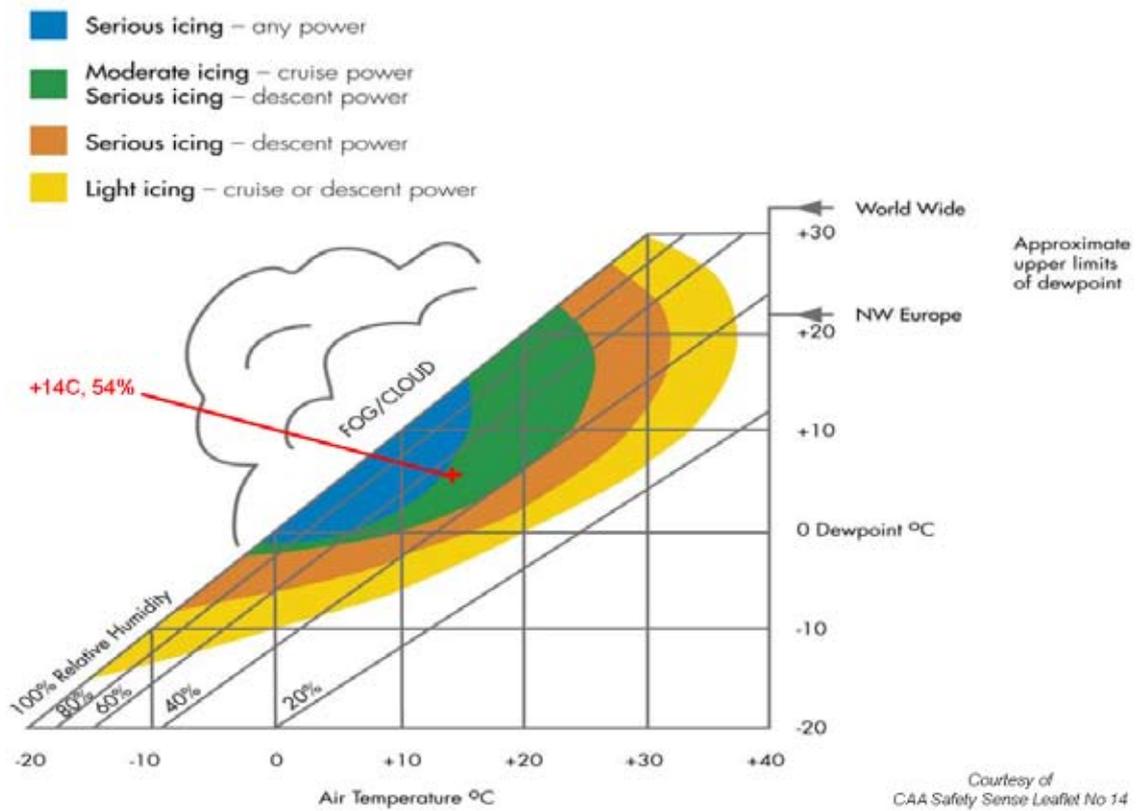
Figure 2
Carburettor icing probability chart from CAA Safety Sense Leaflet 14

slightly sooted but otherwise in satisfactory condition. The engine had not suffered from any mechanical failure, so the pilot concluded that the engine may have suffered from carburettor icing. The temperature and humidity at the time were 14°C and 54%, which placed the risk of carburettor icing on the borderline between '*Serious icing – any power*' and '*Moderate icing – cruise power*' based on the CAA's carburettor icing probability chart (see Figure 2).
