## ACCIDENT

<b>Aircraft Type and Registration:</b>	Europa XS, G-GBXS	
<b>No &amp; Type of Engines:</b>	1 Rotax 914-UL piston engine	
<b>Year of Manufacture:</b>	1998 (Serial no: PFA 247-13196)	
<b>Date &amp; Time (UTC):</b>	21 August 2013 at 1317 hrs	
<b>Location:</b>	Airstrip at Common Farm, Wymeswold, Leicestershire	
<b>Type of Flight:</b>	Private	
<b>Persons on Board:</b>	Crew - 1	Passengers - 1
<b>Injuries:</b>	Crew - 1 (Fatal)	Passengers - 1 (Fatal)
<b>Nature of Damage:</b>	Aircraft destroyed	
<b>Commander's Licence:</b>	Light Aircraft Pilot's Licence	
<b>Commander's Age:</b>	56 years	
<b>Commander's Flying Experience:</b>	About 460 hours (of which 104 were on type) Last 90 days - 20 hours Last 28 days - 1 hour	
<b>Information Source:</b>	AAIB Field Investigation

## Synopsis

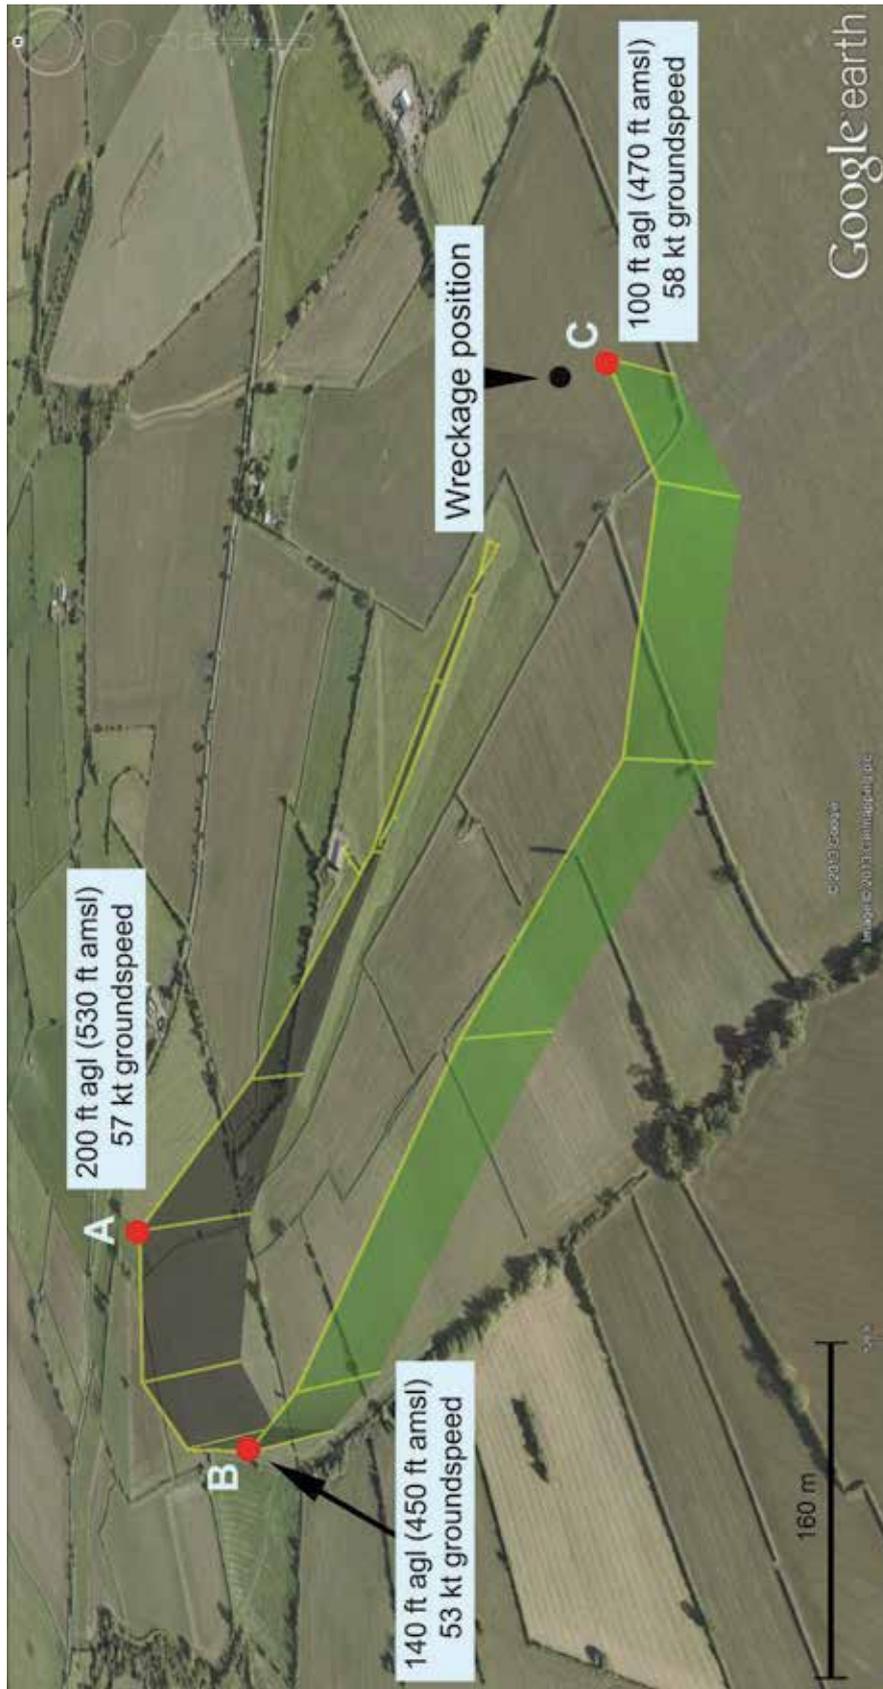
**Figure 1**  
Overview of G-GBXS GPS track

Having completed the left turn, the aircraft was established on a downwind track parallel to, and 210 m laterally displaced from, the runway. As it flew downwind, it climbed slowly at an average rate of about 70 ft/min, whilst its groundspeed remained at about 53 kt (based on a wind from 166° at 12 kt, the aircraft's airspeed would have been about 63 kt). The rate of climb was such that the aircraft maintained a relatively constant height of about 160 ft. When the aircraft was almost abeam the threshold of the north-westerly runway, it turned left towards the runway. At this point the aircraft's lateral distance from the runway was about 240 m. The final data point (Point C) was recorded with the aircraft at a height of about 100 ft (470 ft amsl) and a groundspeed of 58 kt. The corresponding airspeed would have been approximately 54 kt. The position of the final data point was 89 m from the wreckage site and 170 m from the threshold of the north-westerly runway.

The aircraft's position on the downwind leg was closer to the runway and at a lower height than on other flights recorded on the GPS. It was not possible to determine why the aircraft did not accelerate or climb to a greater height, but this may be indicative that, either by choice or circumstance, the pilot did not or could not use all of the available engine power.

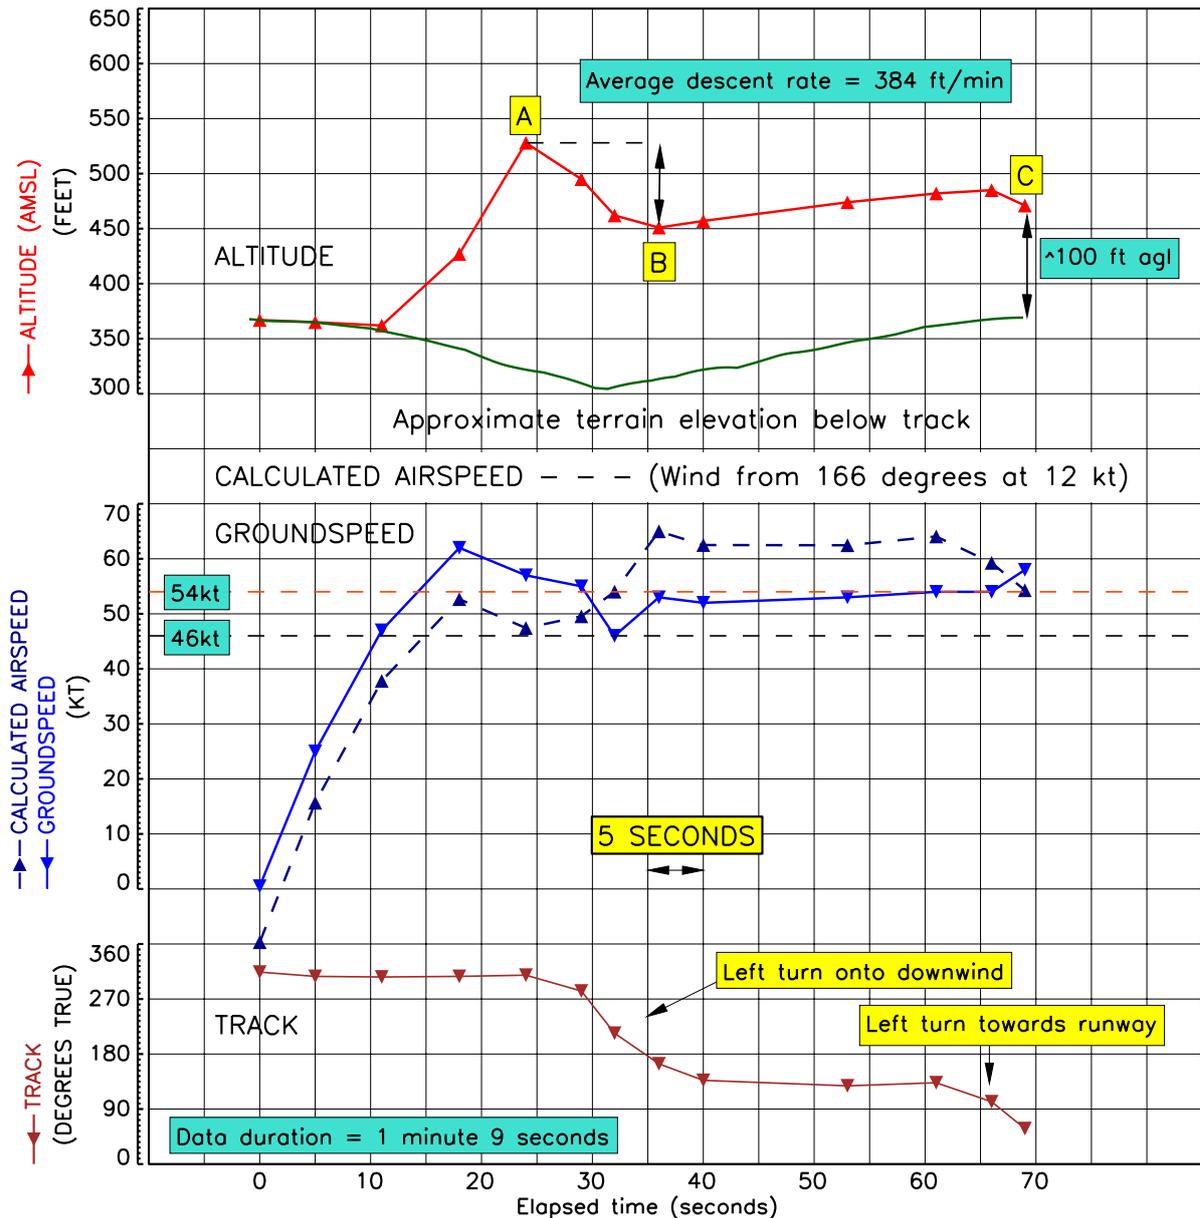
**Figure 2**  
Time series plot of GPS data

The GPS data show that the airspeed was approximately 10 kt above the clean stall speed during the downwind leg but during the base turn the airspeed decreased significantly. Given the increased stalling speed in the turn due to the load factor, it is likely that the reducing airspeed caused the aircraft to stall during the turn, leading to a loss of control from which the pilot was unable to recover.
