**AAIB Bulletin No: 1/96**

**Ref: EW/C95/11/7**

**Aircraft Type and Registration:** Piper PA-23-250 Aztec, G-BFBB

**Location:** Luton Airport

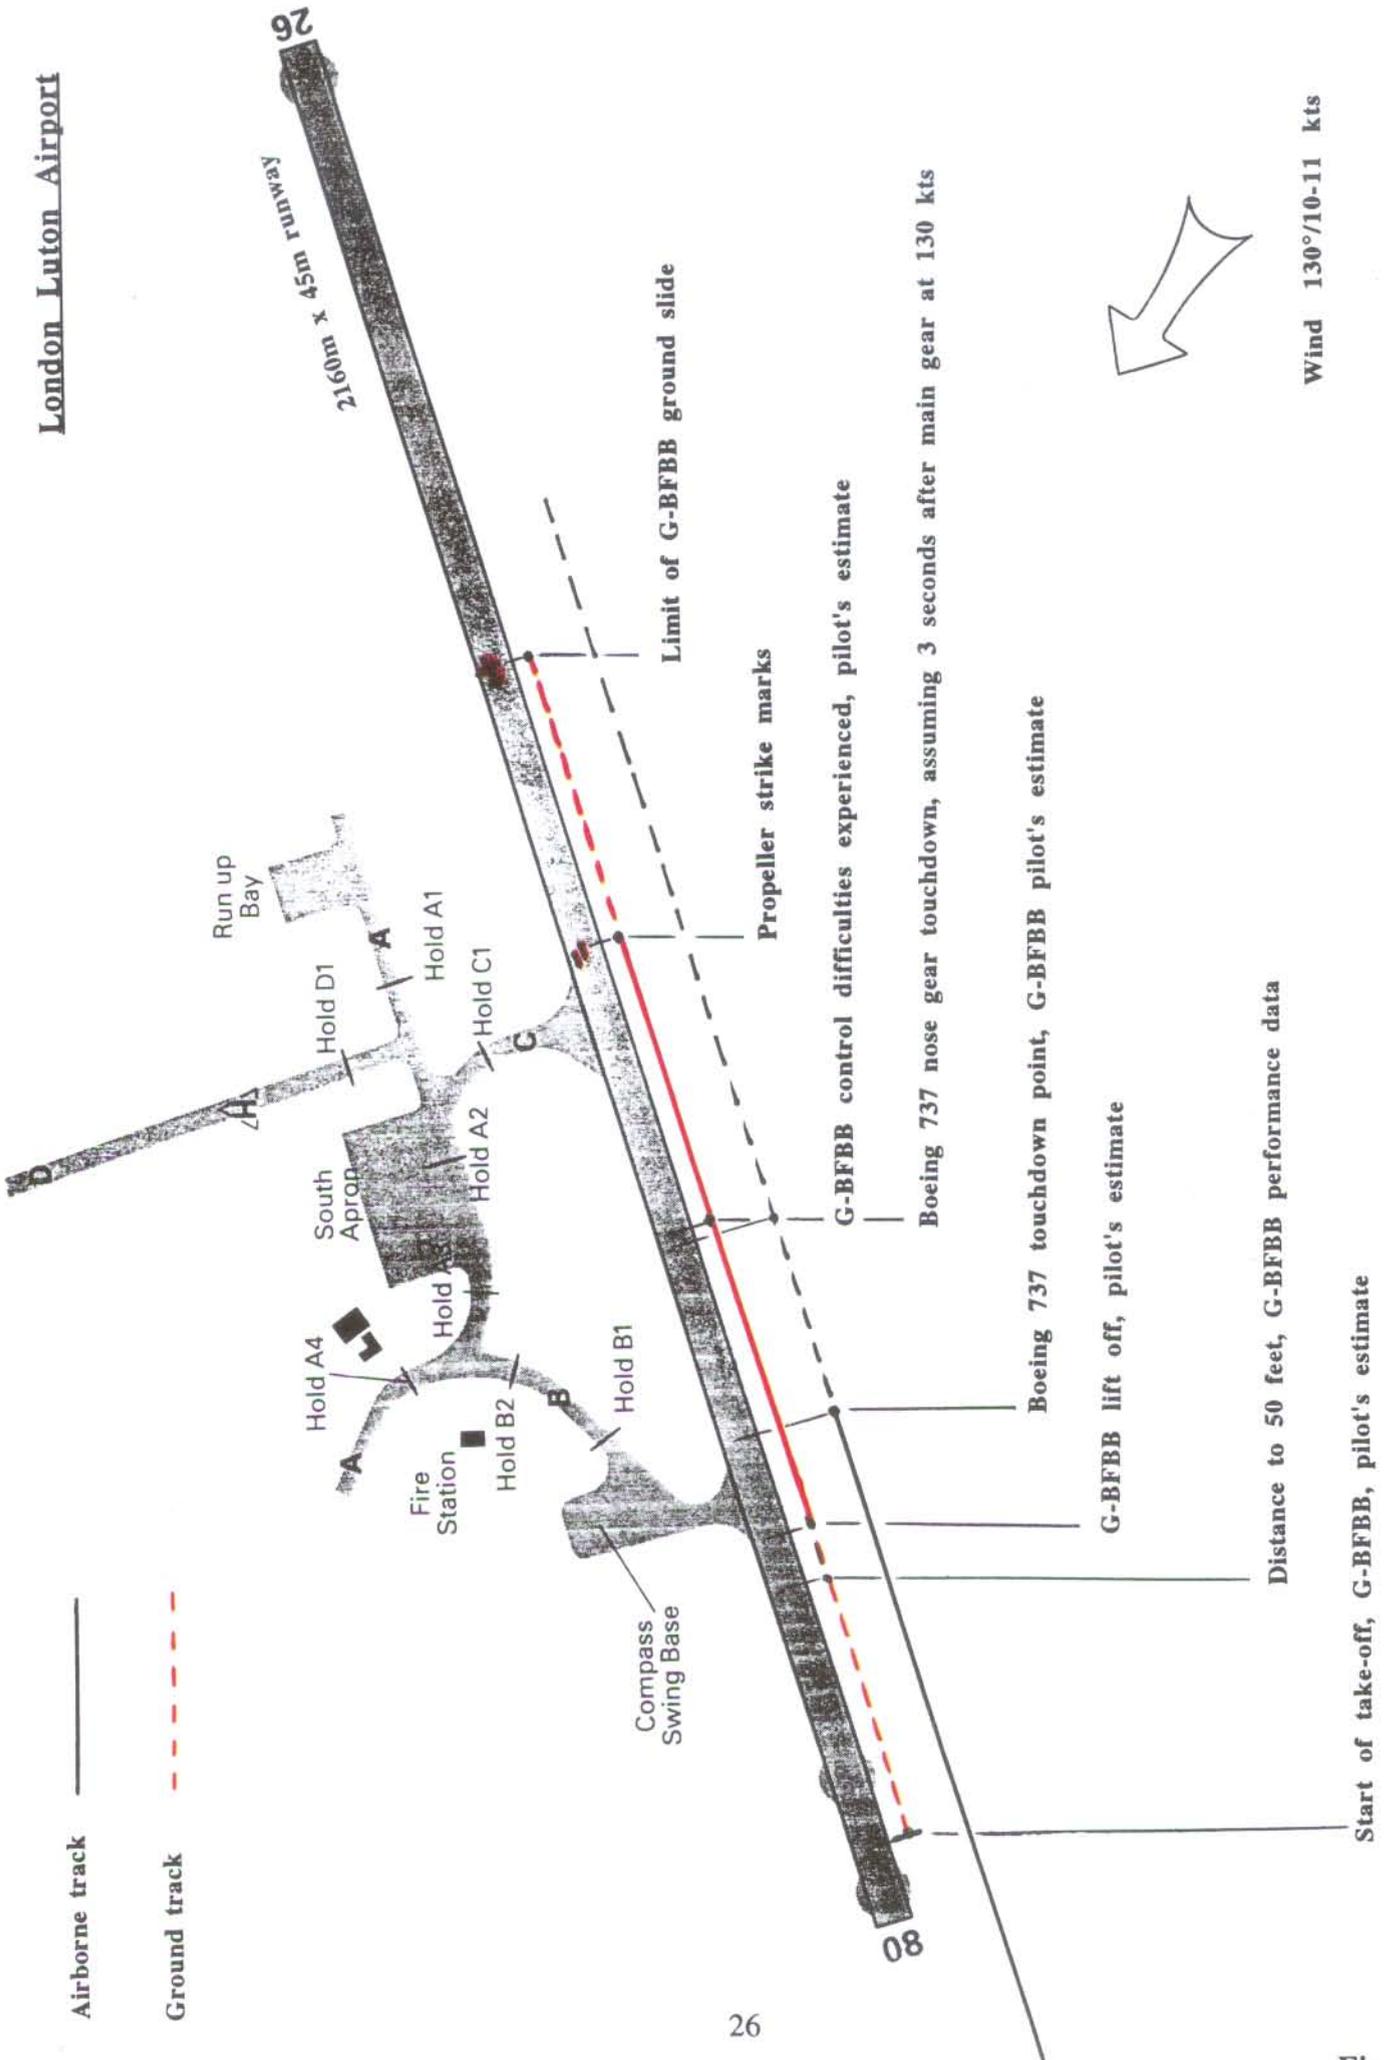
**Figure 1**

Examination of the runway marks revealed that the aircraft's propellers had struck the surface some 1,120 metres from the 08 threshold, significantly to the left of the centreline; the aircraft came to rest some 1,500 metres along the 2,160 metre runway. Analysis of these marks suggested that the aircraft had been travelling with a ground speed of around 80 kt to 90 kt, with low power on both engines, when it first made contact with the runway, and that the gear was retracted at the time. Data contained in the Information Manual for this model of aircraft indicates that the gear and flaps up stalling speed, for standard conditions and at maximum weight, is 74 mph (64 kt) and the minimum controllable single engine speed is 80 mph (70 kt). During the ground slide, the aircraft deviated to the left, demolishing three runway edge lights, before slewing to the right and coming to rest on the left side of the runway centreline. At no time did it depart the paved surface. The pilot, who was uninjured, turned off the fuel cocks and the master switch and vacated the aircraft unaided. The airport rescue services were quickly on the scene and attended to a small fuel spillage which had occurred. There was no fire. After the aircraft had been raised, the landing gear was lowered and the aircraft towed to a maintenance facility on the airfield, the airfield having been closed to traffic for some two hours. A later examination failed to reveal any pre-impact defects associated with the aircraft's flying controls.

Figure 1 illustrates the estimated points of landing and takeoff of the two aircraft, and it may be seen that G-BFBB probably became airborne at approximately the same point along the runway as its pilot remembered seeing the 737 touch down, although the take-off distance to a height of 50 feet, derived from the PA-23-250 manual, indicates that a shorter ground run was possible. Thus the initial flight path of G-BFBB after lift off overlapped the initial section of the 737 rollout, where its wing would have been generating vortices before the nose gear made contact with the runway. By this time, however, any residual vortices over the runway would have drifted towards the threshold, to a position around the estimated point that G-BFBB lifted from the runway.

Start of take-off, G-BFBB, pilot's estimate

Distance to 50 feet, G-BFBB performance data

G-BFBB lift off, pilot's estimate

Boeing 737 touchdown point, G-BFBB pilot's estimate

Boeing 737 nose gear touchdown, assuming 3 seconds after main gear at 130 kts

G-BFBB control difficulties experienced, pilot's estimate

Propeller strike marks

Limit of G-BFBB ground slide
