INCIDENT

Aircraft Type and Registration:	Boeing 747-2D7B, N523MC	
No & Type of Engines:	4 General Electric CF6-50 turbofan engines	
Year of Manufacture:	1979	
Date & Time (UTC):	12 December 2004 at 1611 hrs	
Location:	On approach to Runway 05 at London Stansted Airport, Essex	
Type of Flight:	Public Transport (Cargo)	
Persons on Board:	Crew - 3	Passengers - None
Injuries:	Crew - None	Passengers - N/A
Nature of Damage:	None	
Commander's Licence:	FAA Airline Transport Pilot Certificate	
Commander's Age:	56 years	
Commander's Flying Experience:	Approximately 14,000 hours (of which 6,000 were on type) Last 90 days - 196 hours Last 28 days - 66 hours	
Information Source:	AAIB Field Investigation and operating company report

Synopsis

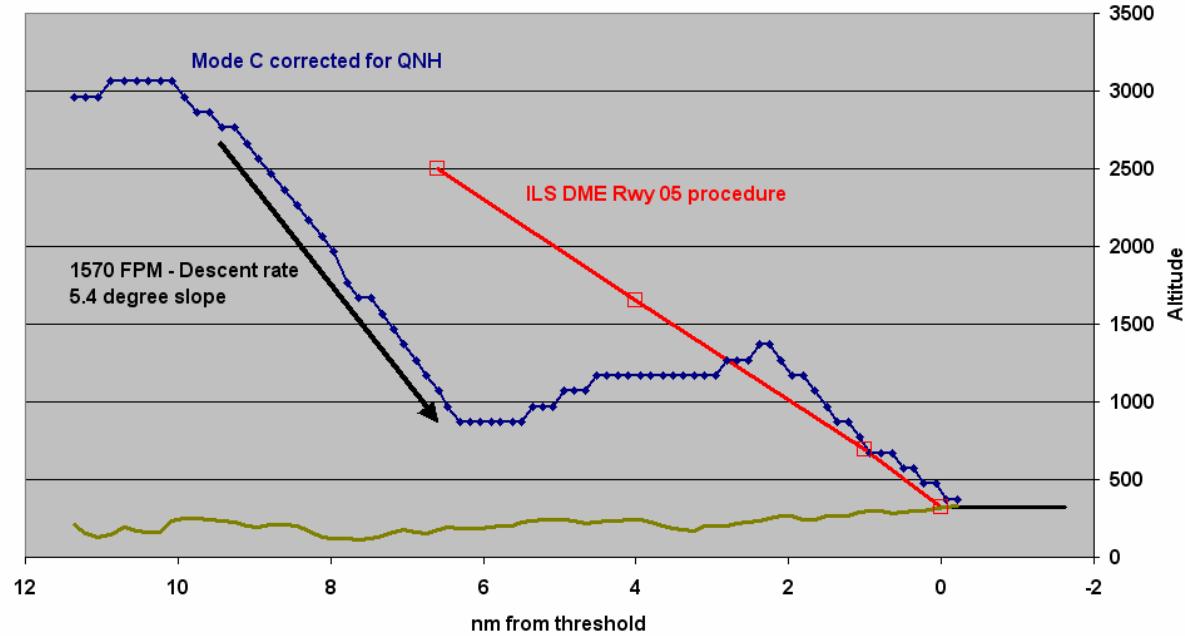
Figure 1 N523MC Approach and normal glideslope

The radar recording, based on Stansted Radar was evaluated by the AAIB. This indicated that the descent from 3,000 feet amsl was at an average descent angle of 5.4°. The rate of descent was fairly constant at 1,570 feet per minute until the level off at approximately 900 feet amsl; Stansted Airfield elevation is 348 feet amsl. Figure 1 shows the recorded descent path of the aircraft relative to the normal glideslope together with the range from touchdown and the ground elevation.
