ACCIDENT

Aircraft Type and Registration:	Vans RV-6, G-ORVG	
No & Type of Engines:	1 Lycoming O-360-A3A piston engine	
Year of Manufacture:	2001	
Date & Time (UTC):	16 October 2011 at 1630 hrs	
Location:	Biggin Hill Airport, Kent	
Type of Flight:	Private	
Persons on Board:	Crew - 1	Passengers - 1
Injuries:	Crew - None	Passengers - None
Nature of Damage:	Tail wheel and surrounding structure damaged	
Commander's Licence:	Private Pilot's Licence	
Commander's Age:	57 years	
Commander's Flying Experience:	1,252 hours (of which 246 were on type) Last 90 days - 7 hours Last 28 days - 3 hours	
Information Source:	Aircraft Accident Report Form submitted by the pilot

Synopsis

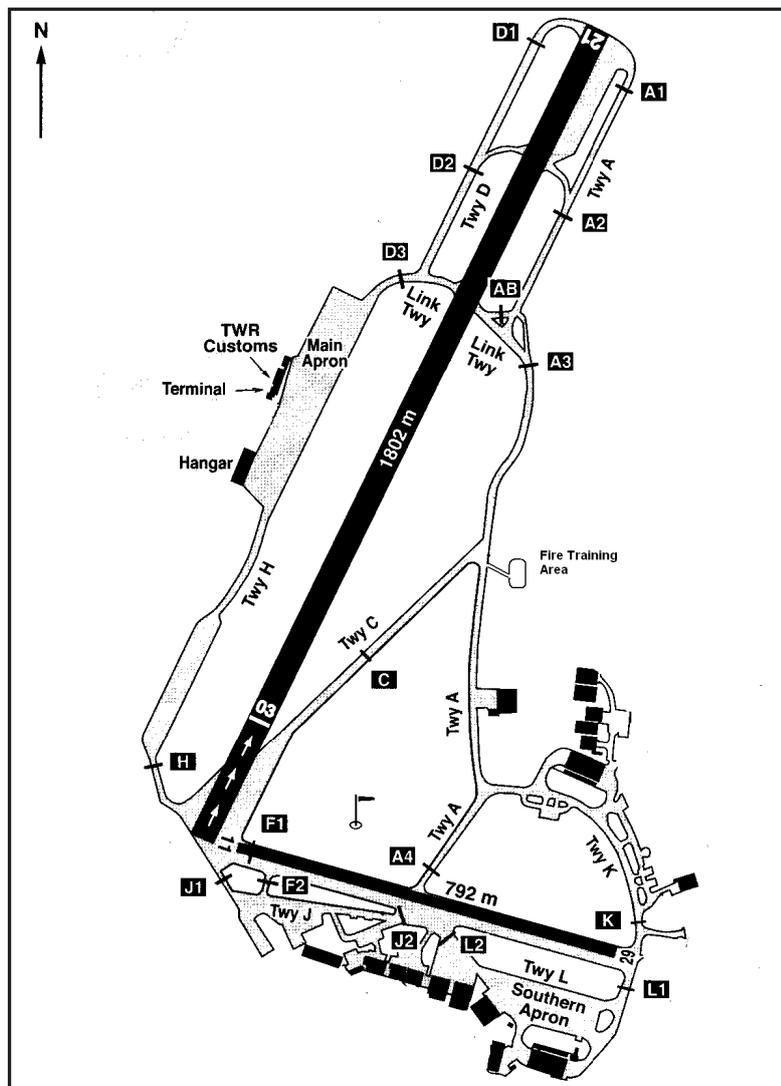
Figure 1
Biggin Hill Airport

After landing and completing customs formalities at the terminal building, the pilot was given clearance to taxi back to the aircraft's hangar. After crossing the runway at the Link taxiway intersection the aircraft entered Taxiway A heading in a southerly direction, see Figure 1. As the aircraft approached the airfield fire training area, the pilot observed an airfield security vehicle emerge from the bushes and trees surrounding

the fire training area and drive towards Taxiway A on a connecting roadway. The vehicle did not stop on the roadway and entered the taxiway ahead of the taxiing aircraft before coming to a halt. The pilot braked hard in an attempt to prevent a collision, causing the tail of the aircraft to rise and fall striking the ground hard. The aircraft stopped approximately 10 ft away from the vehicle. A subsequent examination of the aircraft revealed damage to the tail wheel and surrounding structure.

As a result of their investigation, the airfield operator has introduced a requirement for all vehicles leaving the fire training area to obtain permission from ATC prior to entering Taxiway A. As a result of this action no further safety action is considered necessary at this time.
