Streak Shadow SA, G-TTOY

AAIB Bulletin No: 5/2004	Ref: EW/C2003/09/05	Category: 1.3
Aircraft Type and Registration:	Streak Shadow SA, G-TTOY	
No & Type of Engines:	1 Rotax 618 piston engine	
Year of Manufacture:	1996	
Date & Time (UTC):	17 September 2003 at 1815 hrs	
Location:	Old Sarum, Wiltshire	
Type of Flight:	Private	
Persons on Board:	Crew - 1	Passengers - 1
Injuries:	Crew - None	Passengers - None
Nature of Damage:	Undercarriage and slipper (fuel) tank damaged	
Commander's Licence:	Private Pilot's Licence	
Commander's Age:	44 years	
Commander's Flying Experience:	2,300 hours (of which 320 were on type)	
	Last 90 days - 56 hours	
	Last 28 days - 8 hours	
Information Source:	Aircraft Accident Report Form submitted by the pilot, and follow up AAIB technical investigation of failed landing gear fitting

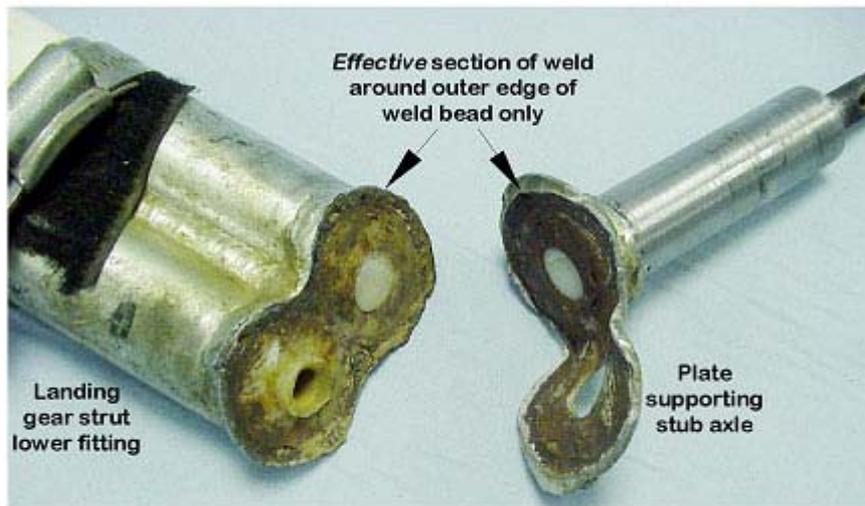
Detailed examination of the detached stub axle and the mating part of the landing gear strut showed that separation had occurred as a result of a fracture through a weld line. This weld joined a steel plate supporting the axle stub to twin tubes which form the body of the landing gear lower fitting. Although the externally visible part of the weld appeared normal, the effective cross-section at the interface between the weld bead and the plate was extremely narrow, typically around 1 mm or less, around the whole of the weld circumference. It was apparent that the fitting would have been significantly weaker than intended as a result. Figure 1 shows the failed lower fitting from G-TTOY, and Figure 2 illustrates the general layout of the landing gear and the form of construction used in the failed lower fitting.

Figure 1: Weld failure of lower fitting on G-TTOY

Weld failure of lower fitting on G-TTOY

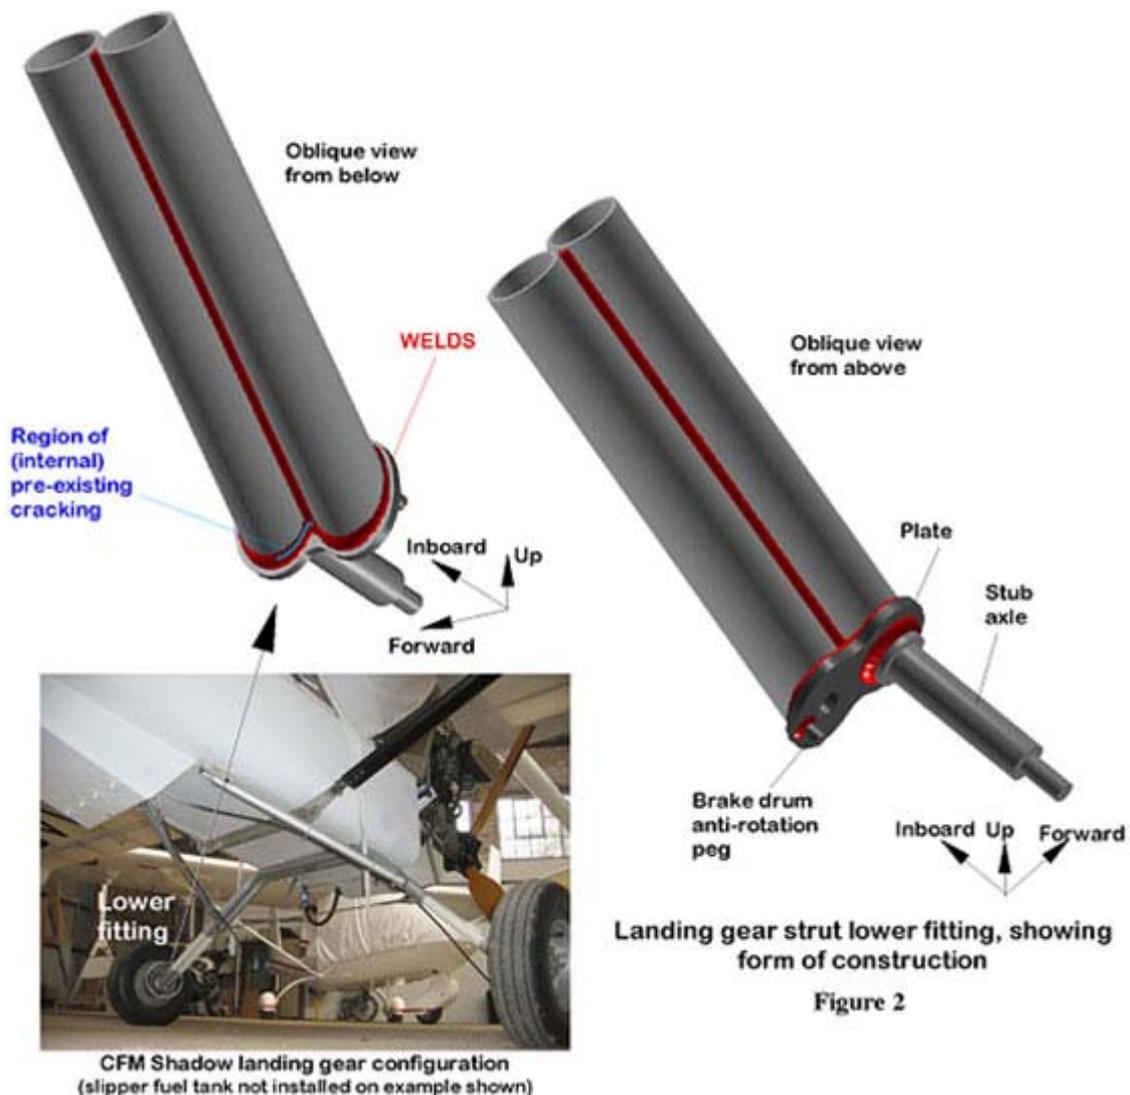
Figure 2: Landing gear strut lower fitting, showing form of construction

This connects with, and is bonded to, the lower ends of a pair of composite rods that function as spring-struts, and which are attached to the lower fuselage. The stub axle, which is welded directly to the forward end of the plate, supports a conventional wheel and cable-operated drum brake. A short peg welded to the rear end of the plate provides anti-torque reaction for the brake assembly.

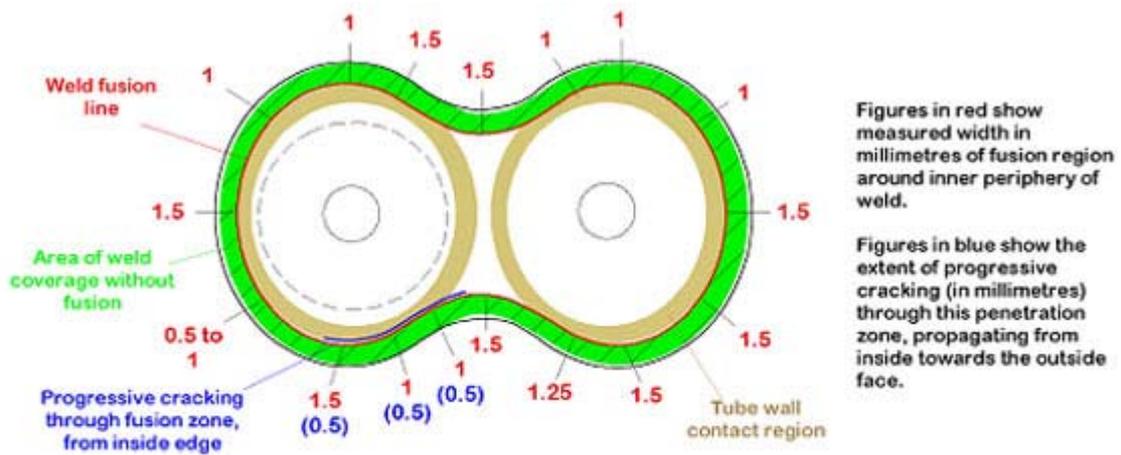
The failed weld was subject to specialist metallurgical examination, from which it was established that, although the coverage provided by the weld bead at its interface with the plate was adequate, the weld itself had failed to fuse properly into the plate, except at the very inside edge of the bead. This had resulted in the effective working section being very narrow around the whole of the weld line. A small region of the fracture surface at the bottom of the fitting exhibited corrosion and other features consistent with progressive fracture prior to final failure. The fracture had propagated from the inside towards the outer surface of the weld bead. Although this had not penetrated right through the (already very narrow) working section, it had evidently weakened the joint sufficiently to allow it to fail under relatively benign loading conditions. Figure 3 illustrates the approximate width of the working section of the weld around the periphery of the plate joint, and also the approximate position and extent of the region of pre-existing, progressive, fracture.

Figure 3: Sketch illustrating the position of the weld coverage

Sketch (not to scale) illustrating the position of the weld coverage which actually achieved fusion into the plate (red), and the approximate extent of progressive cracking (blue)

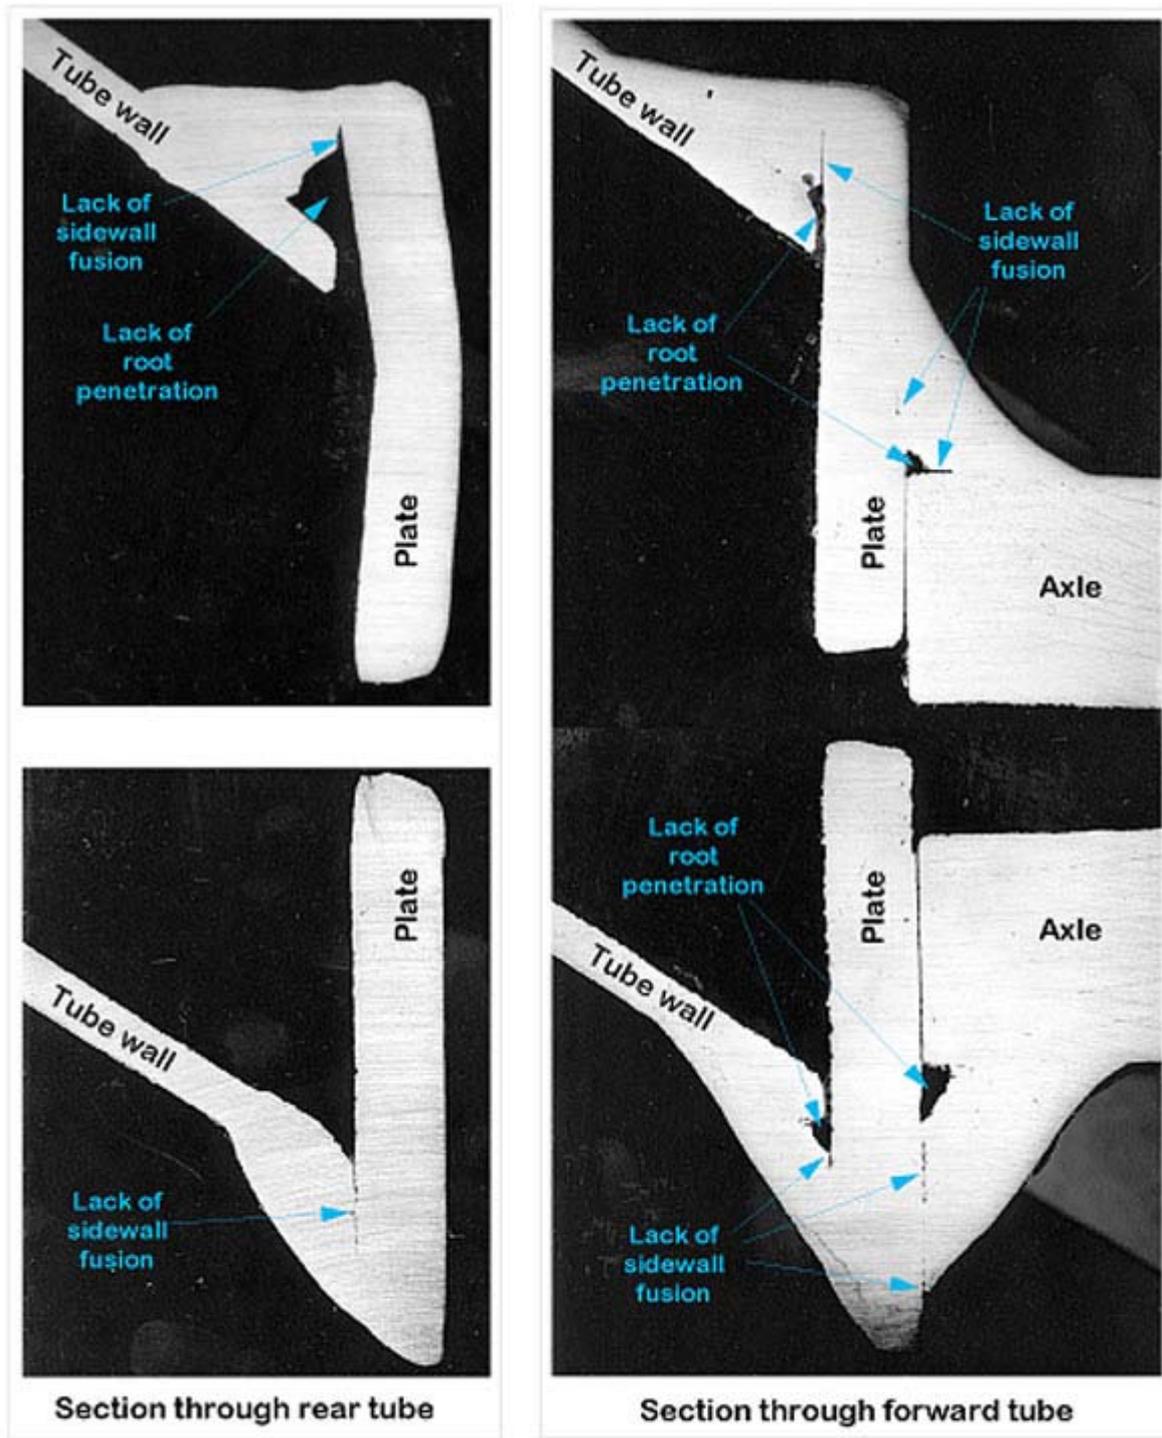
Figure 5 shows a series of section micrographs from one typical sample, in which both types of deficiency are clearly evident.

Figure 5: Section micrographs through welds in one of the sample lower fittings (not G-TTOY)

Section micrographs through welds in one of the sample lower fittings (not G-TTOY)

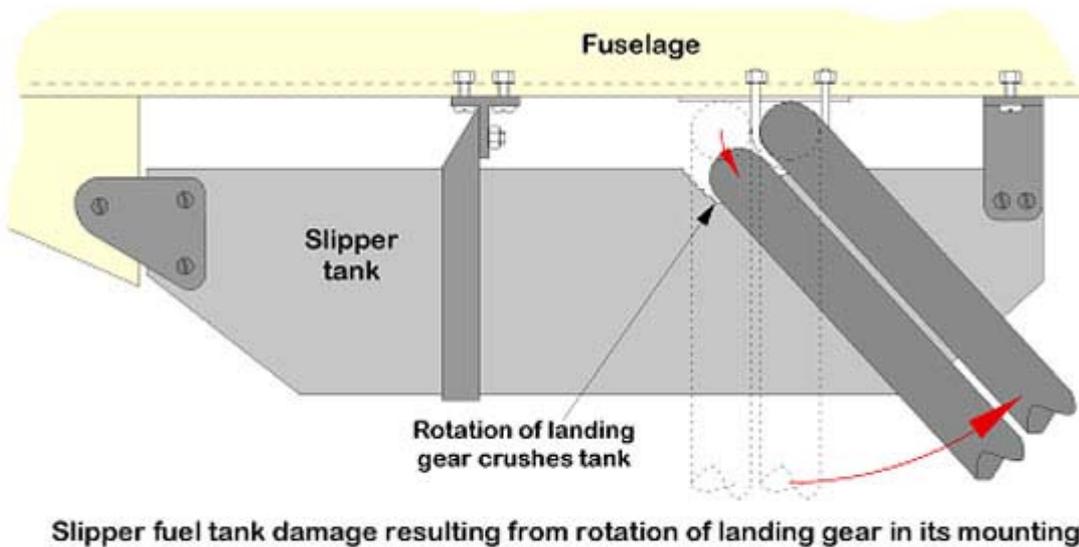
Figure 6

The slipper fuel tank on G-TTOY was fractured in the accident due to rotation of the main part of the landing gear at its attachment to the fuselage, and the attendant leverage imposed on the upper corner of the tank. The latter was restrained by its fore and aft fixings to the fuselage and, more significantly, by the support strap which passes underneath it. This crushing action, illustrated in the sketch at Figure 6, is an inevitable consequence of the method of landing gear attachment and the slipper tank position and its method of attachment.

Figure 6: Slipper fuel tank damage resulting from rotation of landing gear in its mounting

The UK Civil Aviation Authority, in conjunction with the British Microlight Aircraft Association (BMAA) and the Popular Flying Association (PFA), should review the adequacy of the slipper fuel tank mounting arrangement, insofar as this makes the tank vulnerable to fracture and leakage of fuel during any incident which causes a rearward rotation of the gear about its attachment to the fuselage.
