Aircraft Type and Registration:	Pulsar, G-MCMS	
No & Type of Engines:	1 Rotax 582 piston engine	
Year of Manufacture:	1993	
Date & Time (UTC):	25 July 2004 at 1305 hrs	
Location:	Near Taynuilt, Scotland	
Type of Flight:	Private	
Persons on Board:	Crew - 1	Passengers - None
Injuries:	Crew - 1 (Serious)	Passengers - N/A
Nature of Damage:	Damage to landing gear and fuselage belly	
Commander's Licence:	Private Pilot's Licence	
Commander's Age:	52 years	
Commander's Flying Experience:	408 hours (of which 50 were on type) Last 90 days - 24 hours Last 28 days - 4 hours	
Information Source:	Aircraft Accident Report Form submitted by the pilot and metallurgical examination of radiator failure

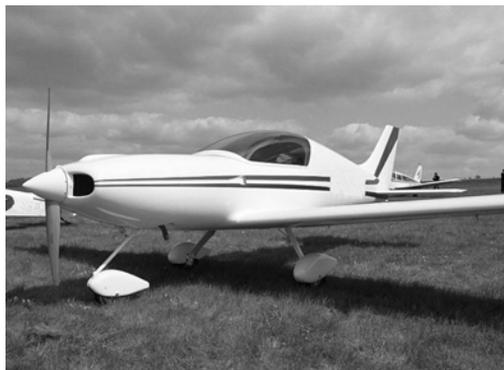
The Pulsar, pictured at right, is a low-wing composite single-seat kitplane operated under a Permit to Fly. The aircraft was on a cross-country flight from Perth to Oban. Ten miles away from Oban the pilot called Oban Radio and requested the airfield information. He did not receive a reply but he heard the wind direction and speed being passed to another aircraft. While at 4,000 feet on the Oban QFE the pilot detected a slight burning smell. He advanced the throttle but the engine did not respond.

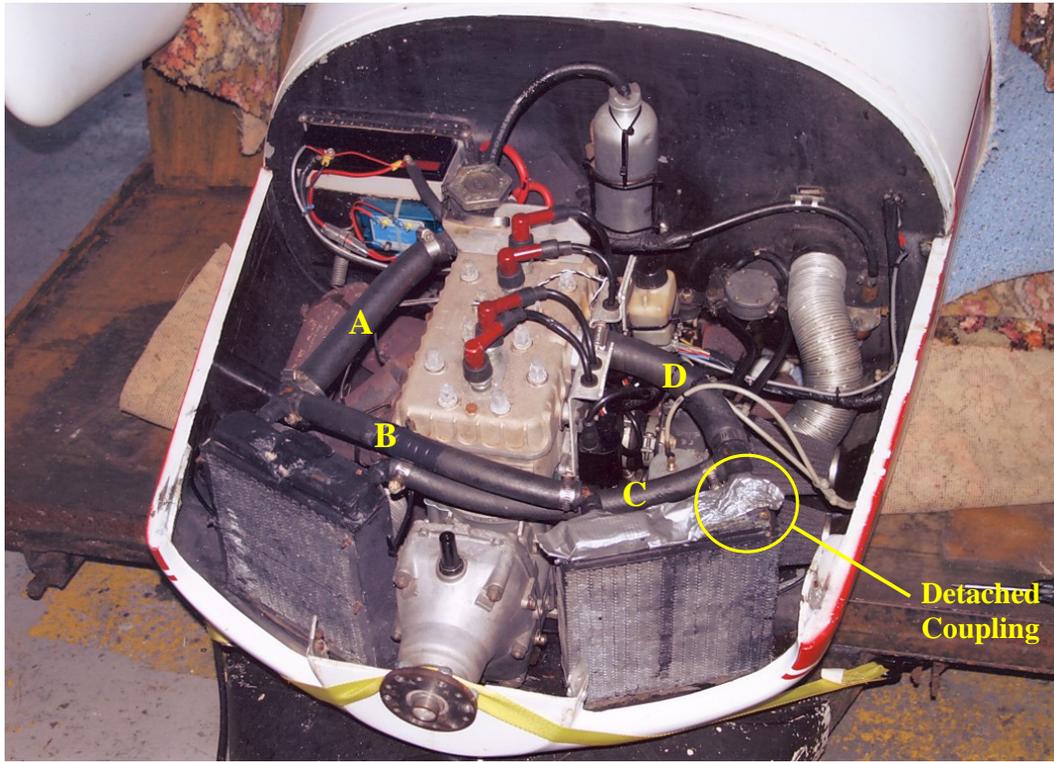
The aircraft's Rotax 582 engine is liquid cooled using two small radiators that are mounted within the forward cowling (see Figure 1). The primary hoses A and D between the engine and each radiator have an inside diameter of 1 inch. The cross-over hoses B and C between the radiators have an inside diameter of 5/8 inch. There are rectangular slots within the upper and lower cowlings to hold the radiators in place. The grey adhesive 'gaffer' tape that is visible on the port radiator in Figure 1 was, according to the owner, applied to ensure a snug fit within the upper cowling slot.

A Popular Flying Association (PFA) inspector examined the engine following the accident. He discovered that all the coolant had drained from the radiators. There was a small pool of coolant in the lower cowling and the port radiator's outboard hose coupling had detached from the radiator - circled area in Figure 1 and close-up in Figure 2. The failed coupling, the port radiator and the port radiator hoses were sent to the AAIB for a more detailed examination. An engine strip was subsequently performed by the PFA inspector which revealed severe over heating damage of piston number two.

There was no evidence of any leaks within radiator hoses C or D. Hose D had a slight bend in it but it was a straight hose that had retained some of its bend from having been bent into position for a long period. The Pulsar construction manual states that hose D should be constructed from two pieces of straight hose that are then joined together with the 45° copper fitting supplied with the kit

(the alternative is to use a curved moulded hose). This should ensure that no side load is imparted to the radiator coupling.

Figure 1 Engine and radiator layout inside G-MCMS post accident (photo courtesy P. Murray)

Regardless of the cause of the coupling failure, Pulsar owners would be well advised to ensure that their aircraft is fitted with the correct hoses as detailed in the engine manual or an alternative approved by the PFA. In light of this accident Pulsar owners should also be made aware of the importance of regularly checking the radiator couplings for leaks and cracks. The AAIB therefore made the following safety recommendation:

- a. Ensure that Pulsar aircraft owners are aware of, fit and use only radiator hoses approved for use by the Association or the Pulsar aircraft kit manufacturer.
- b. Encourage Pulsar owners to carry out regular checks of the integrity of the engine cooling system, especially in the regions of the radiator hose couplings.

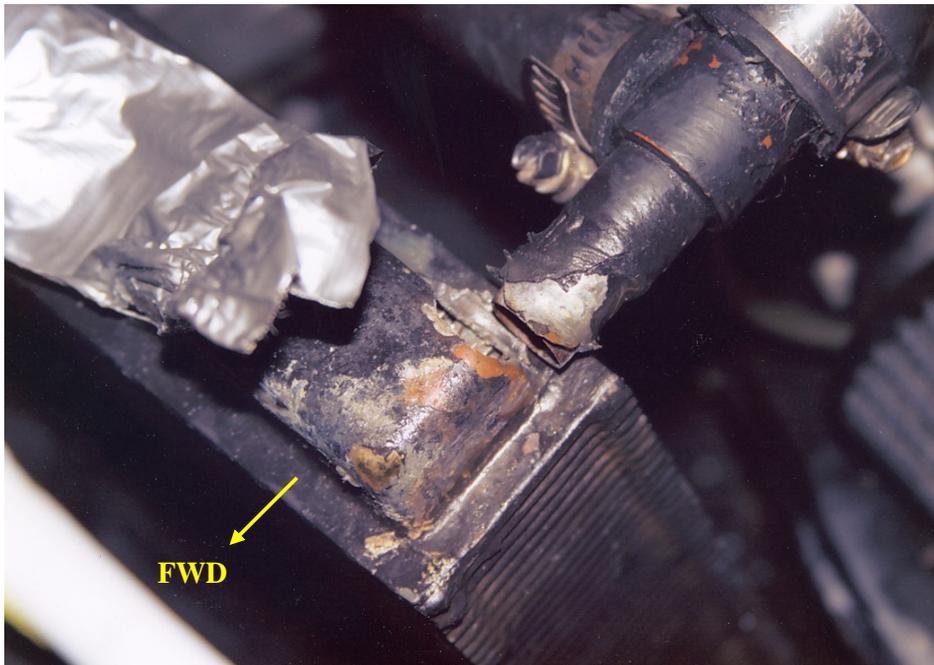
The port radiator and failed coupling were examined by an independent organisation with metallurgy and fracture expertise. The following is a summary of their findings. A visual examination of the brass radiator showed that the whole circumference of the detached area exhibited a fracture surface and that the corresponding coupling still had a section of the brass radiator attached to it (see Figures 3 and 4). This indicated that the failure occurred in the radiator material rather than in the brazed joint between the coupling and the radiator. A cross section of the failed coupling and the intact coupling on the other end of the radiator revealed their composition (see Figures 5 and 6). A brass connecting tube had been inserted into an opening within the radiator and then brazed with a silver based filler metal. A copper coupling had then been soldered to the brass connecting tube with a lead-tin based solder. The evidence of lead-tin solder on the inner surface of the brass connecting tube suggested that the copper coupling had been dip soldered. Lead-tin solder also coated the outer surface of the brass connecting tube and radiator joint. There were no differences in the construction of the failed and intact couplings although the connecting tube of the failed coupling appeared to be offset downwards at an angle of approximately 5°.

Figure 2 Detached coupling from outboard fitting of port radiator (photo courtesy P. Murray)

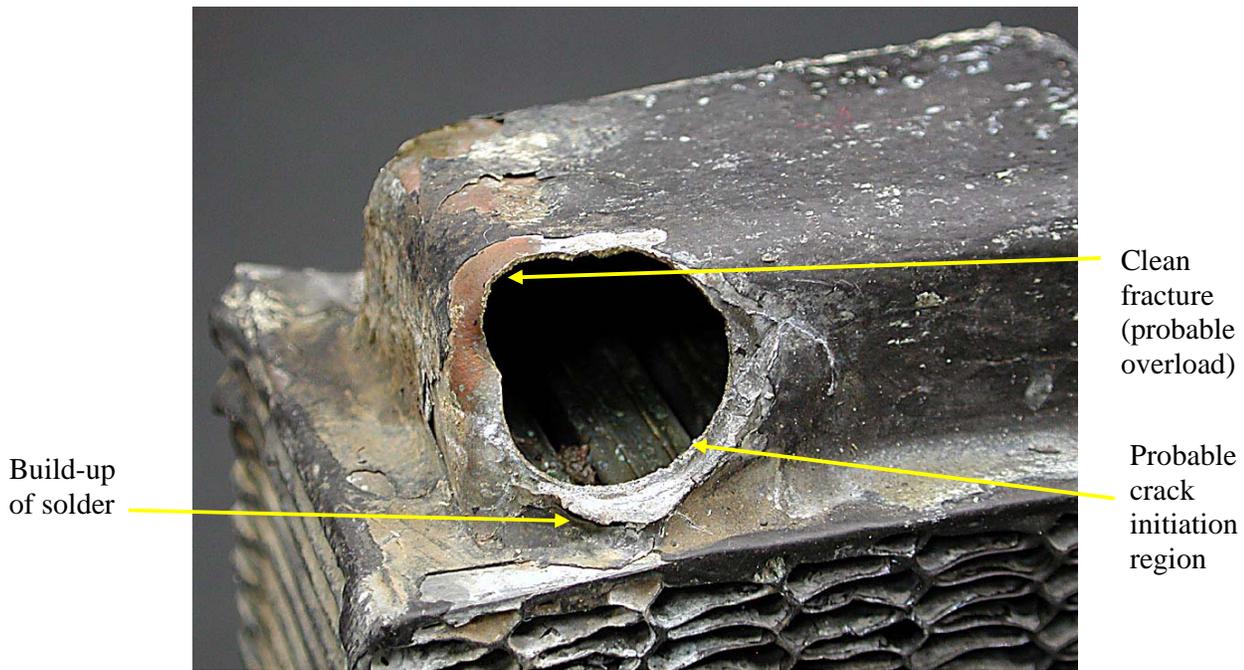
The majority of both the fracture surfaces on the radiator and on the coupling were masked by contaminants apart from a small area of the fracture in the upper left position of the radiator (see Figure 3) which was clean. The fracture surface of the detached section was examined under a Scanning Electron Microscope (SEM). The SEM examination did not reveal conclusive evidence of the failure mechanism but it was likely that the clean area of the fracture was the last section to detach and that it occurred due to overload. The lower half of the fracture (with reference to Figure 3) was more obscured by damage and surface contamination; however, small patches were observed which showed a transgranular fracture that appeared to have corroded. This evidence suggested that this part of the crack had been present for a longer period than the cleaner area hence the crack appeared to be progressive. The fracture surface in this area also showed some faint parallel markings that may be evidence of fatigue striations, although they were not clear enough to confirm this positively.

There was a build up of solder around the lower part of the fracture (see Figure 3) and there was solder contamination on the lower right area of the fracture – the area from which the crack is likely to have propagated. Lead-tin solder usually melts in the range of 180°C to 320°C depending on its exact composition. The solder contamination on the fracture surface may have been a result of local overheating during the engine failure which resulted in some of the solder melting and being drawn

into the crack. However, the radiator was not in direct contact with the engine and therefore the engine bay itself would have had to reach a temperature of 180°C to 320°C. It is also possible that the solder contamination is evidence of a repair. Because it is likely that the crack growth was progressive, it is possible that a coolant leak was observed at some point before final failure occurred. The leak around the area of failure could have been mistaken for a poor joint and re-soldering may have been carried out to rectify the leak. Re-soldering would have filled the crack and temporarily stopped any leaks but a fatigue crack in the brass radiator would still have propagated under the influence of cyclic loading from engine vibration through the hose.

Figure 3 Detailed view of fracture surface on radiator (photo courtesy of QinetiQ)

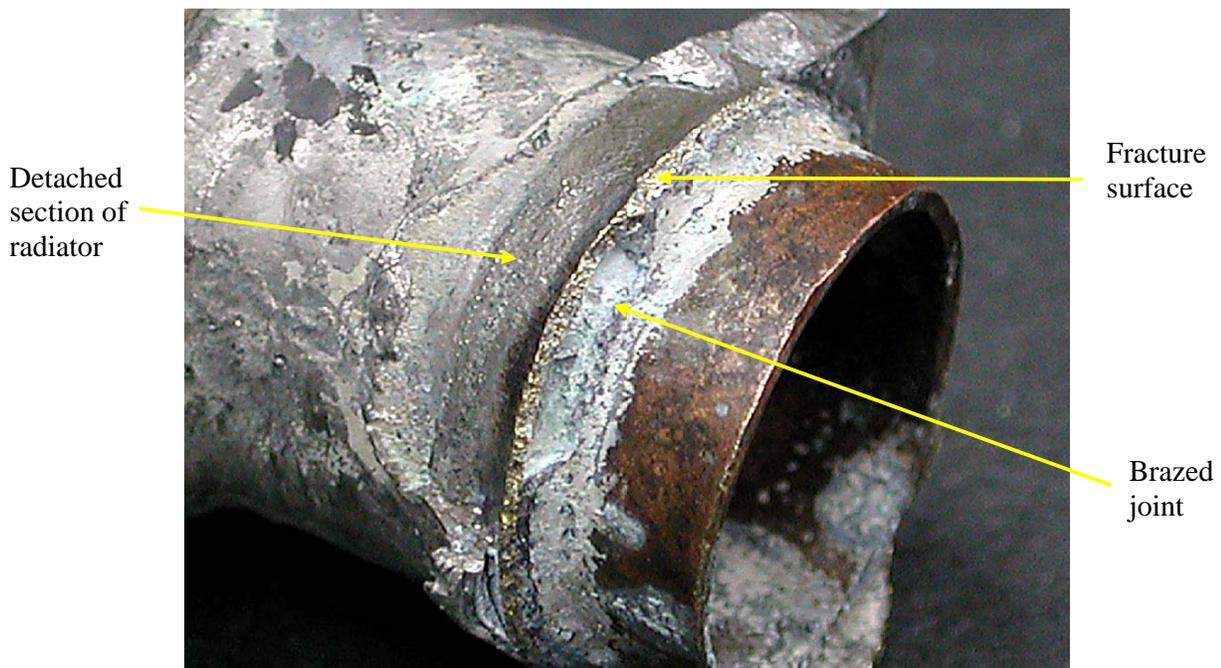
Figure 4 Detailed view of fracture on coupling (photo courtesy of QinetiQ)

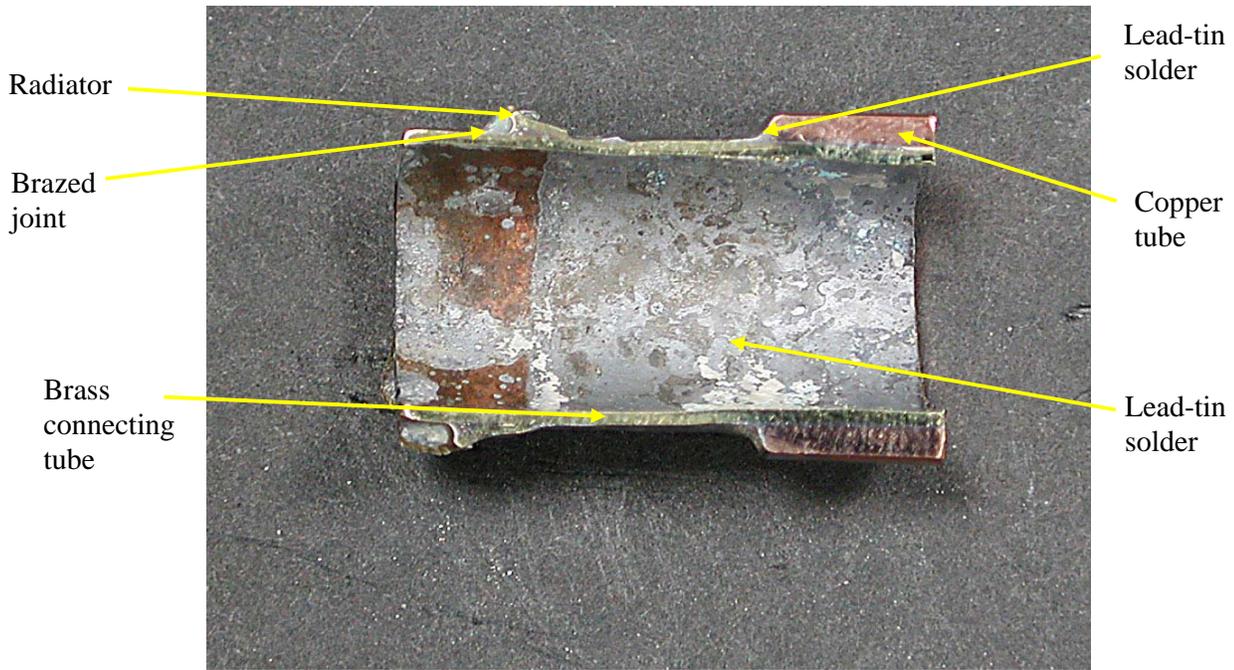
Figure 5 Cross-section through failed coupling (photo courtesy of QinetiQ)

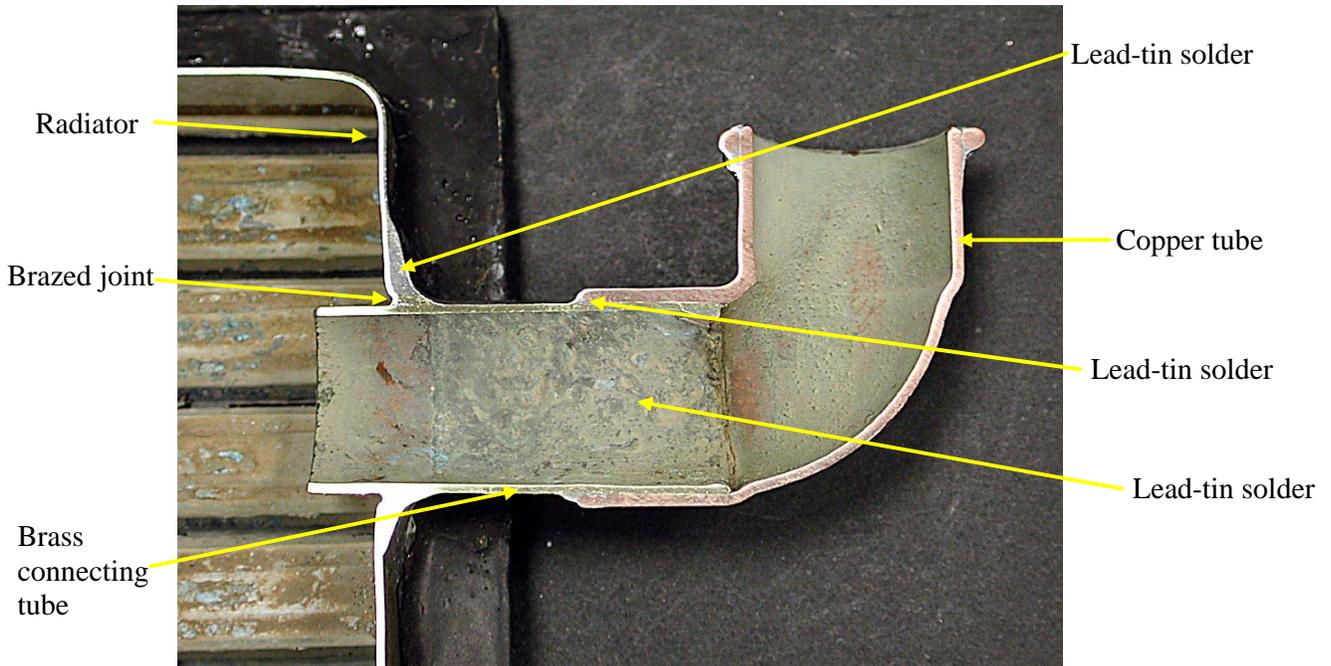
Figure 6 Cross-section through intact coupling on inboard end of port radiator (photo courtesy of QinetiQ)
